March 2019 Monthly Report

BJCJSTP Rehabilitation and Restoration Project

Contract 5 – BICJSTP
Restoration and
Rehabilitation, March 2019
Construction Progress
Photos

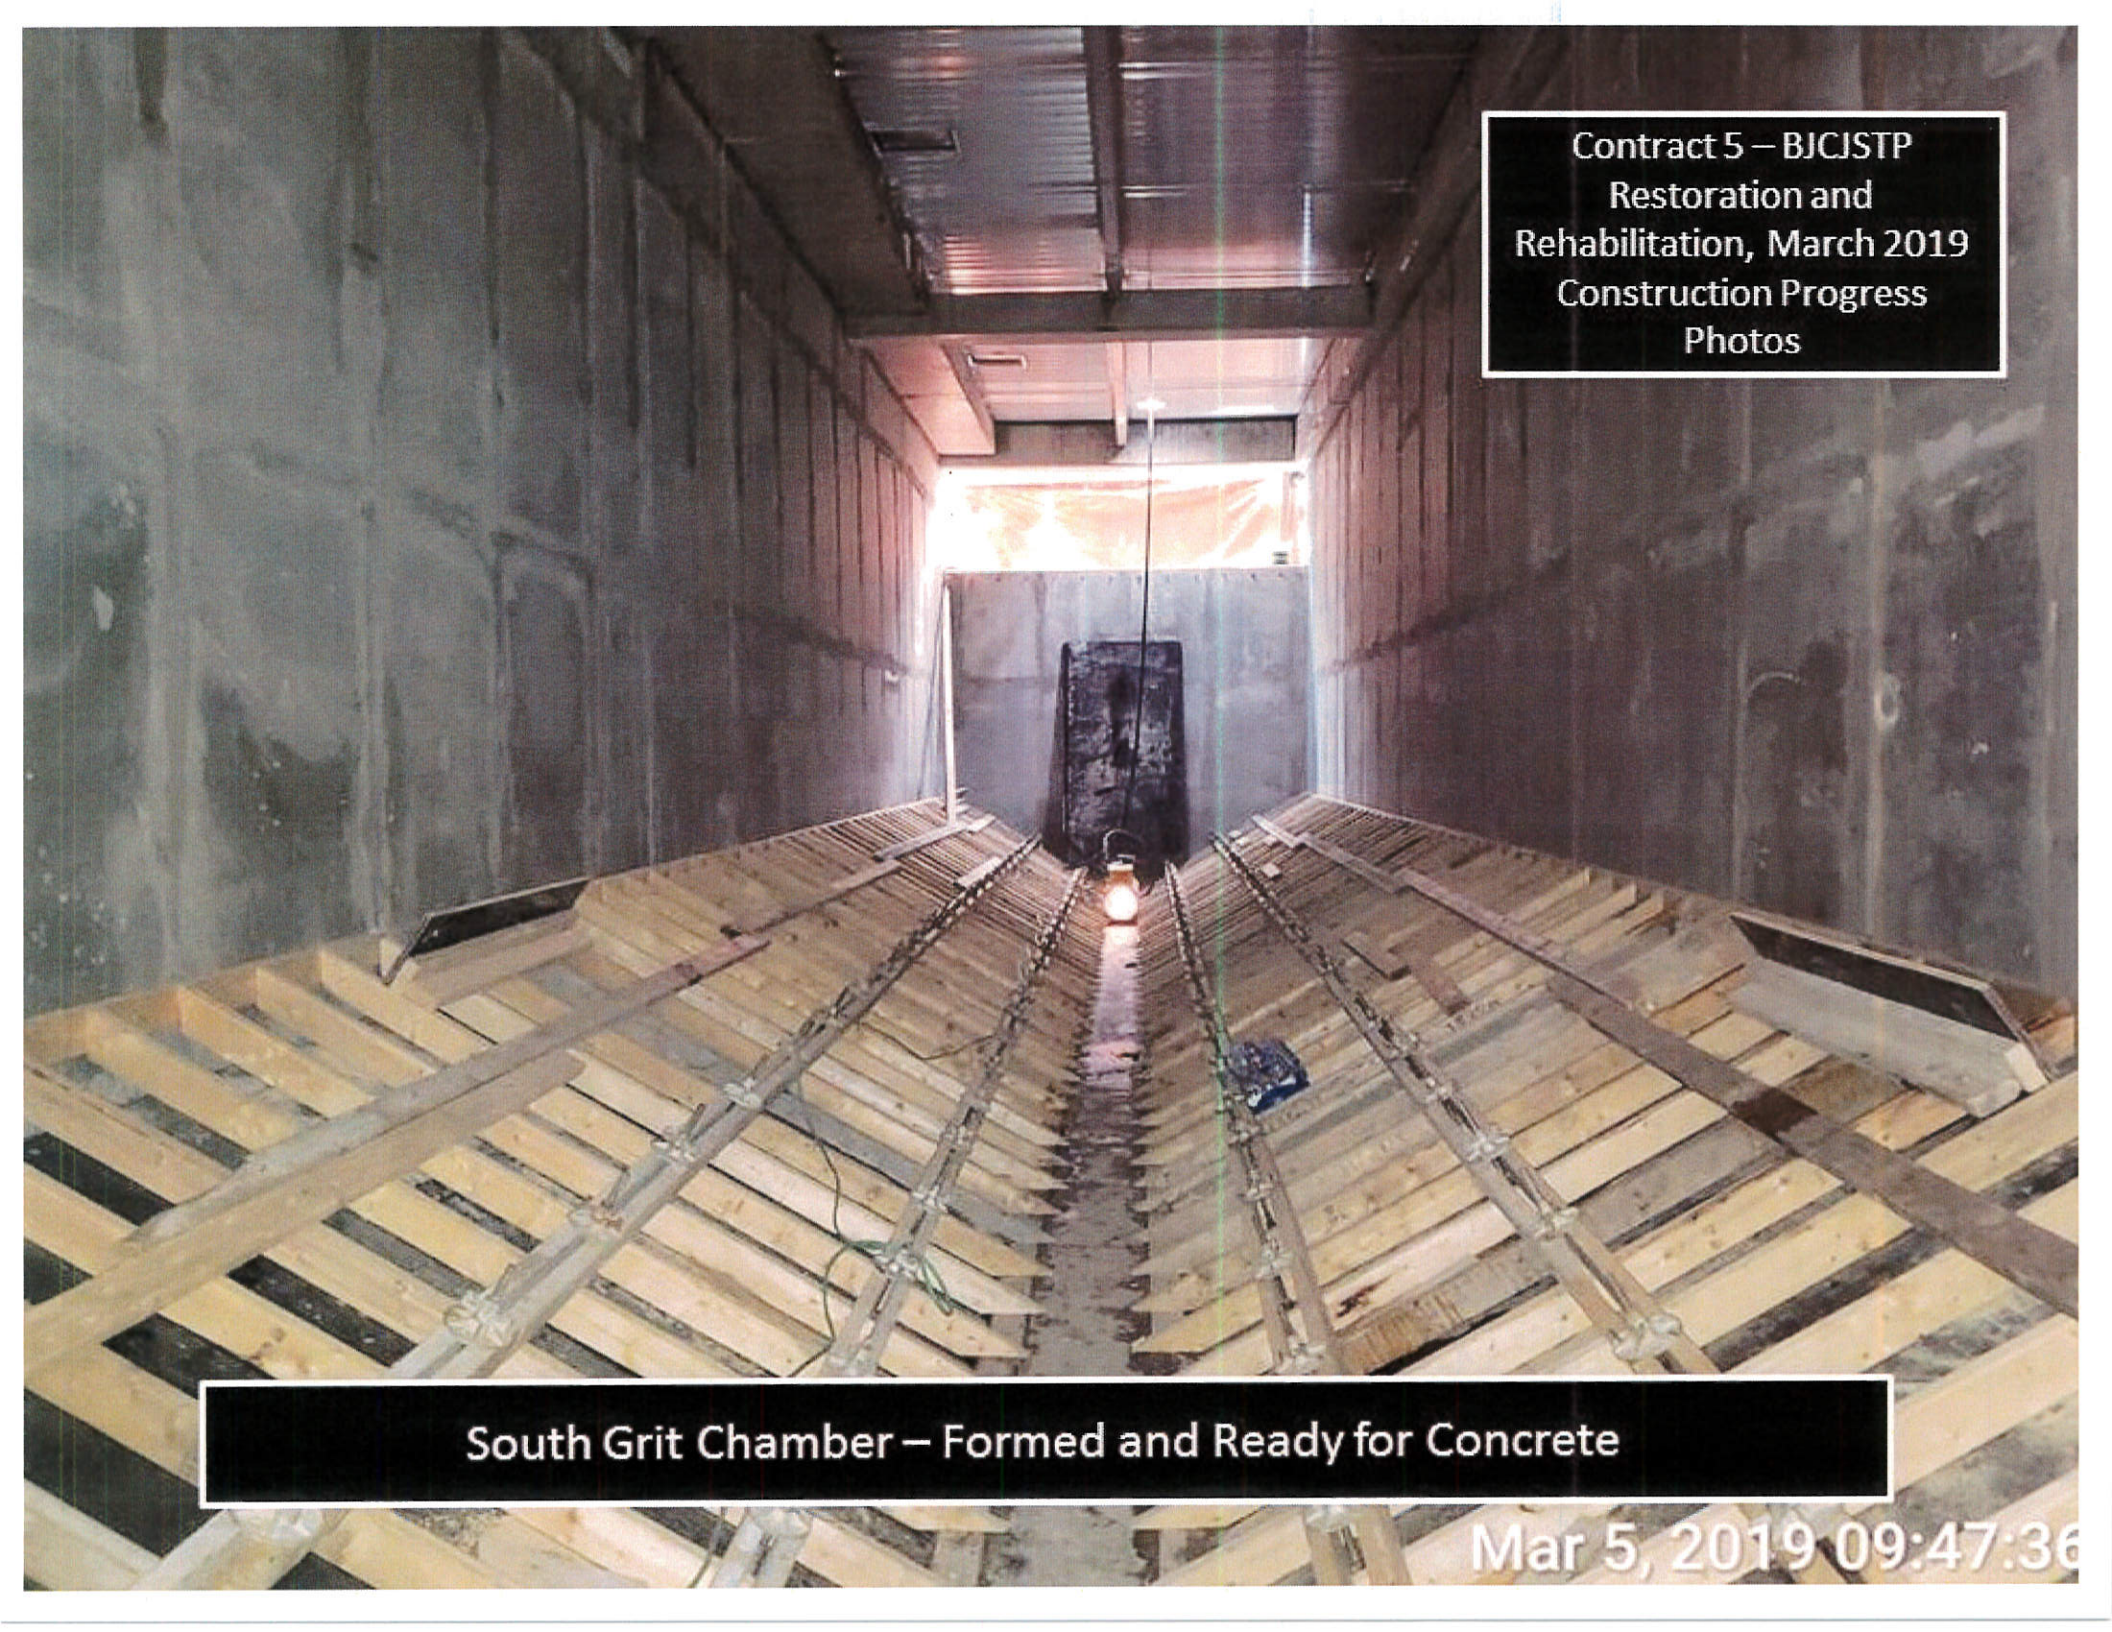
The image shows the interior of a large, rectangular concrete chamber during its construction phase. The walls and ceiling are made of dark, textured concrete. The floor is covered with a complex network of wooden formwork, including diagonal bracing and horizontal planks, designed to support a concrete pour. A narrow, central walkway is visible, illuminated by a single hanging light fixture. At the far end of the chamber, there is a doorway or opening, partially covered by an orange safety tarp. The overall atmosphere is industrial and focused on the structural preparation of the chamber.

South Grit Chamber – Formed and Ready for Concrete

PC completed leak testing grit trenches and tanks in the Headworks. They have installed the concrete in the bottom of the south trench to contour the trench bottom for the grit equipment. They still have about 65 CY of concrete to complete at the Headworks and the BAF Treatment Facility. Most of that concrete is the benching for the bottom of the north grit channel. They still have not yet completed backfill around the Headworks. The backfill between the Headworks and Generator Building is making the installation of the power feeds and conduits to the Headworks difficult for Matco. We have expressed our concerns that PC is delaying work on the electrical feeders to both the Headworks Building, and BAF Treatment Facility electrical feeds. PC continued installing the brick work at the headworks in February, but we do not believe they will complete the brickwork until sometime in late March. PC continues to provide insufficient manpower to complete the pipe work and masonry work at the Headworks. The underground ductbank west of the Headworks is now installed, and Matco has installed the cables in the ductbank. PC has finally dried in all areas of the Headworks sufficiently, and Matco has a substantial work crew to install the conduit in the Headworks.

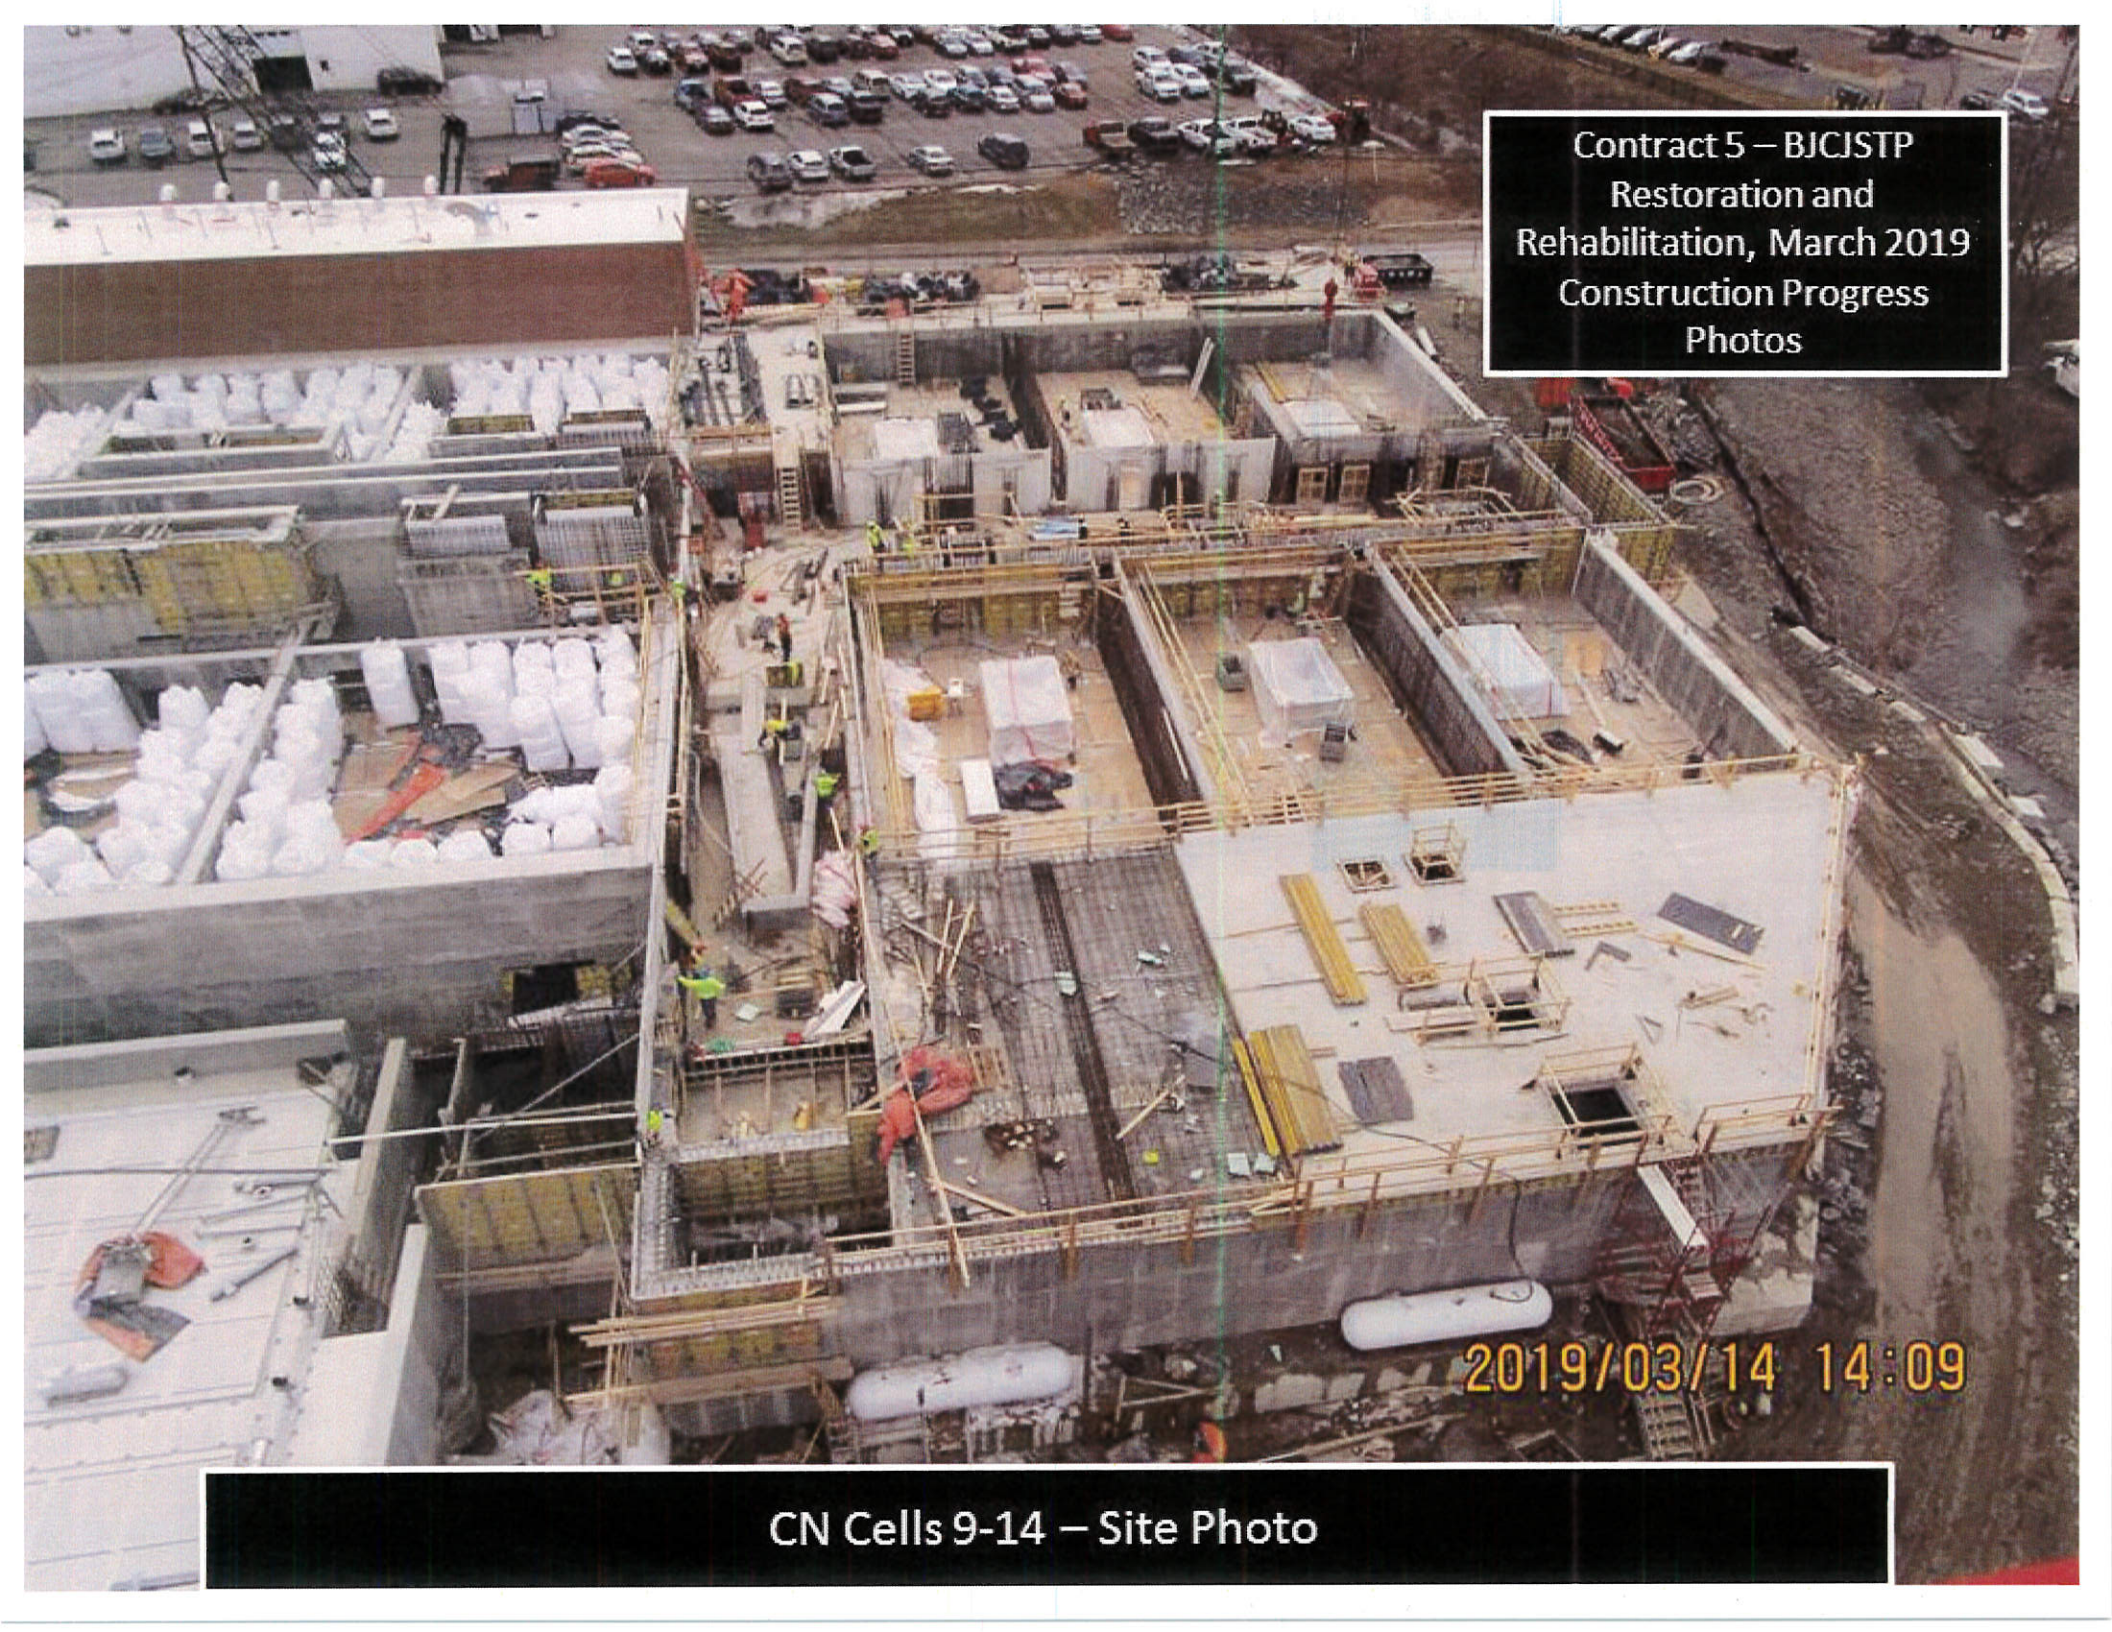
CN Cells 9-14 – Site Photo

CN Cells 9-14 walls are also being advanced. PC is nearing completion of the concrete work for the concrete decks over the gallery at CN 9-14. The remaining section of concrete deck in the north-south utility corridor was placed in the middle of February. PC is stripping the shoring in that corridor, and is still delaying Matco from doing their work between the Blower Building and the CN Galleries. PC continued working on the backwash header in the CN Cells 9-14. PC is nearing completion of the cells on the south side of the structure and has completed all of the benching in the lower level of the cells. PC has completed setting and grouting nozzle decks in CN Cells 9-14. PC's subcontractor is now reporting that they should complete the concrete work for CN Cells 9-14 by the end of April. We remain skeptical.

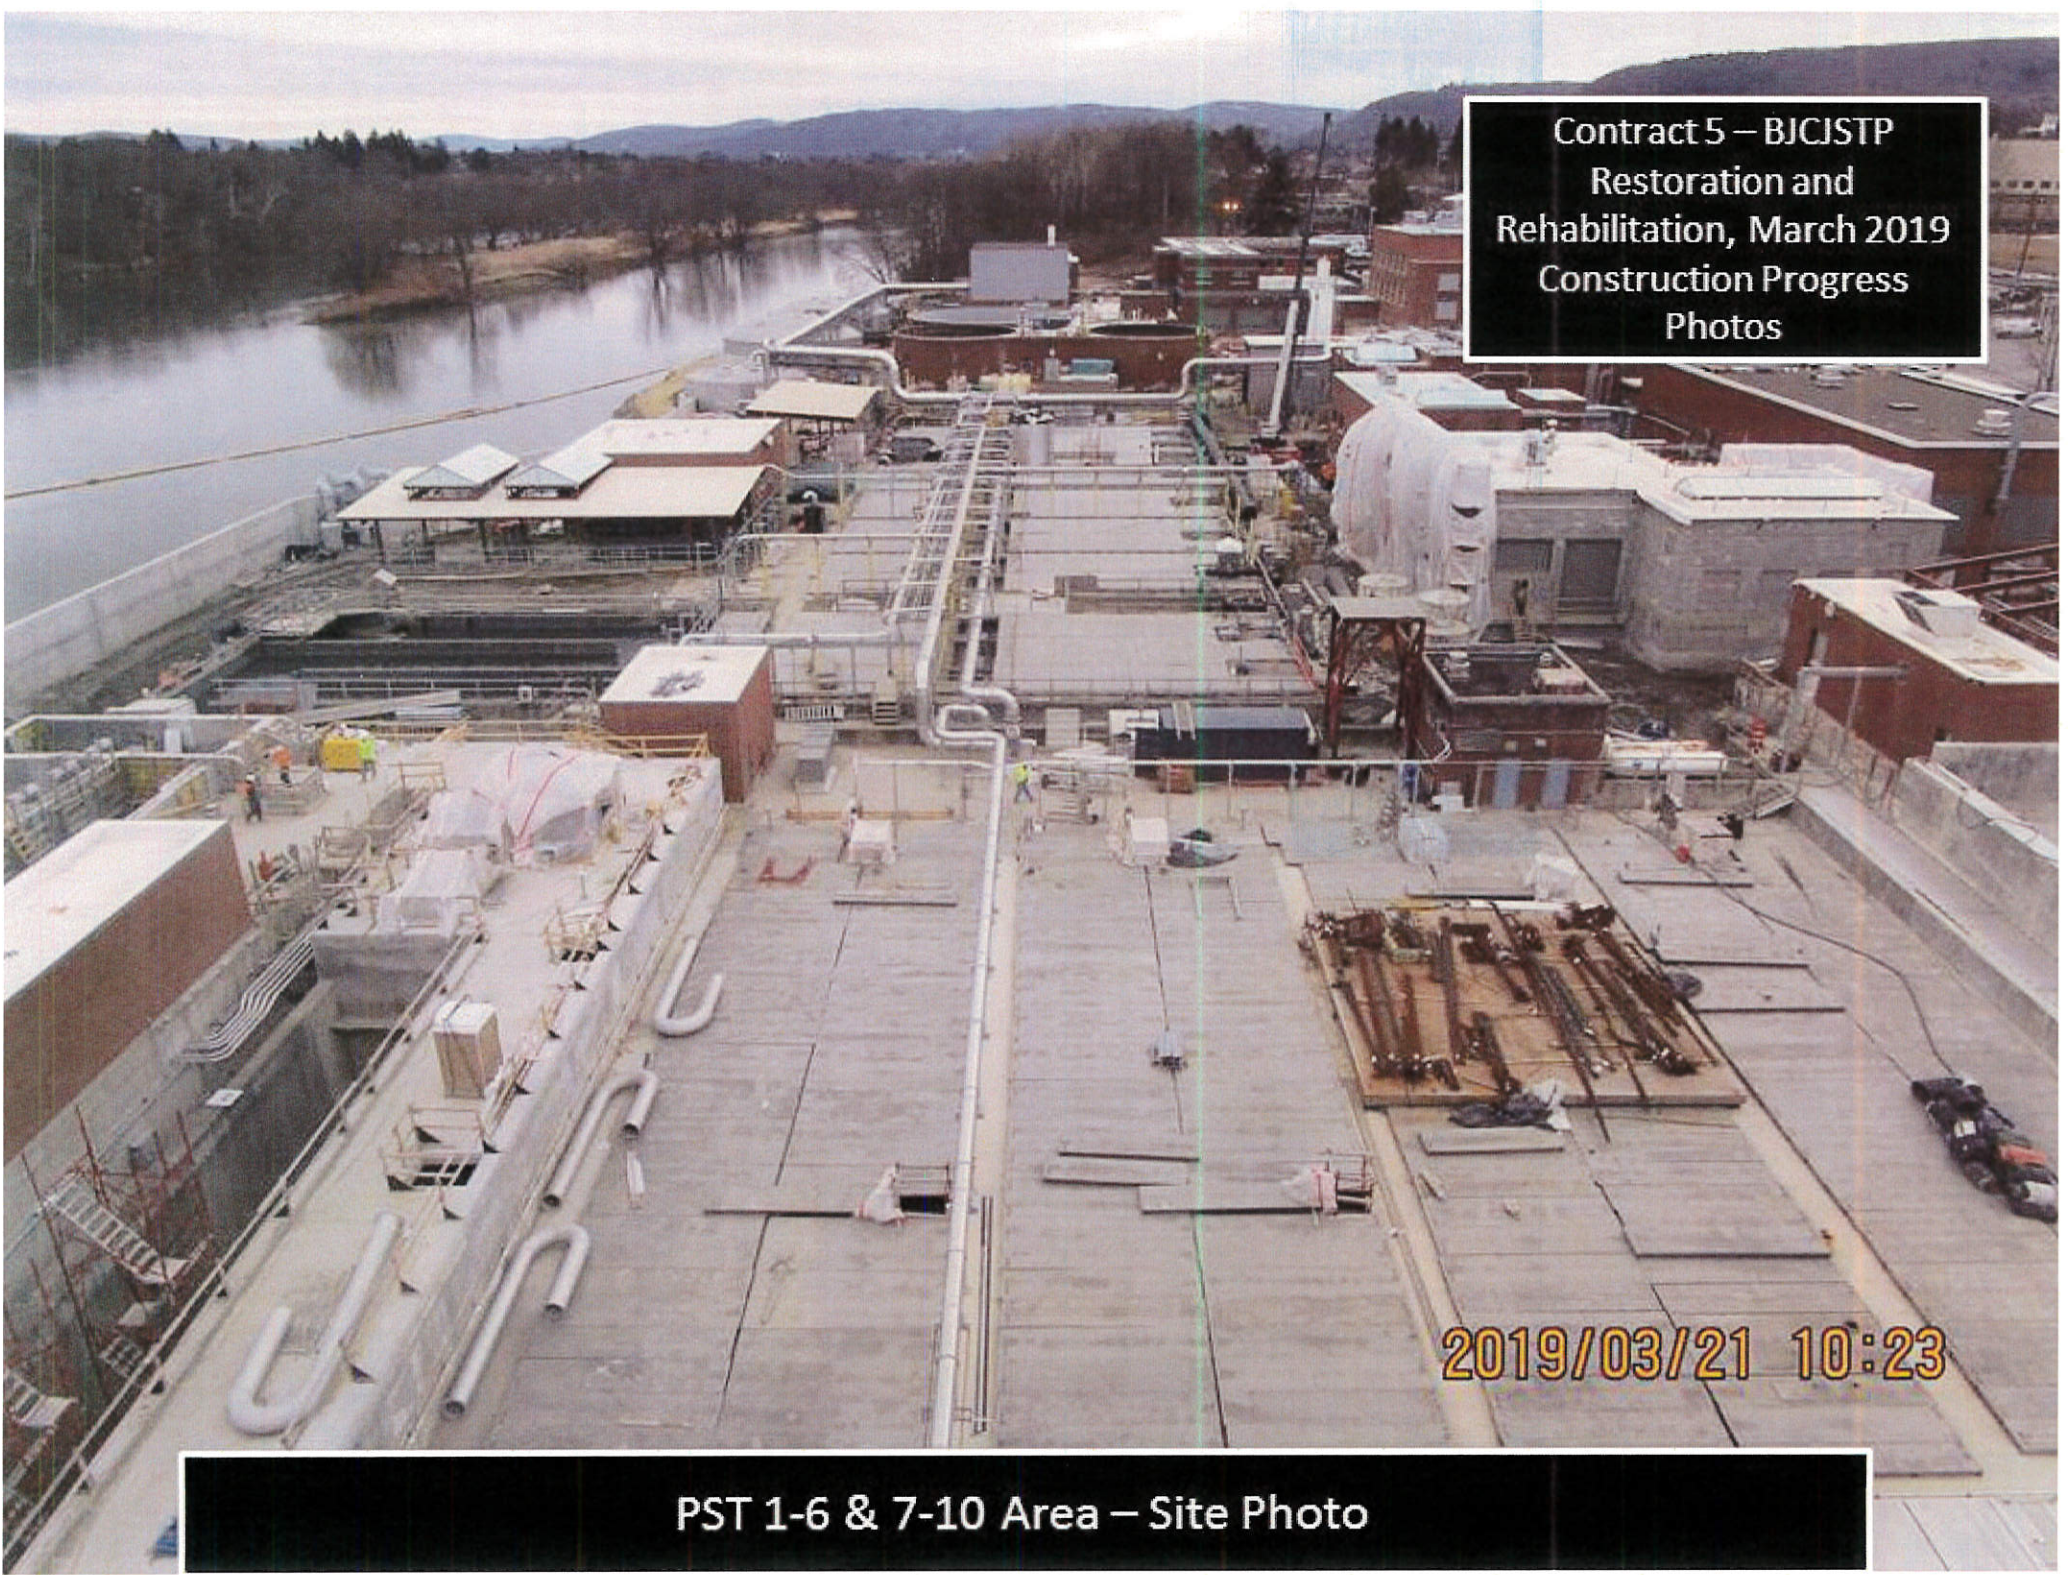
PST 1-6 & 7-10 Area – Site Photo

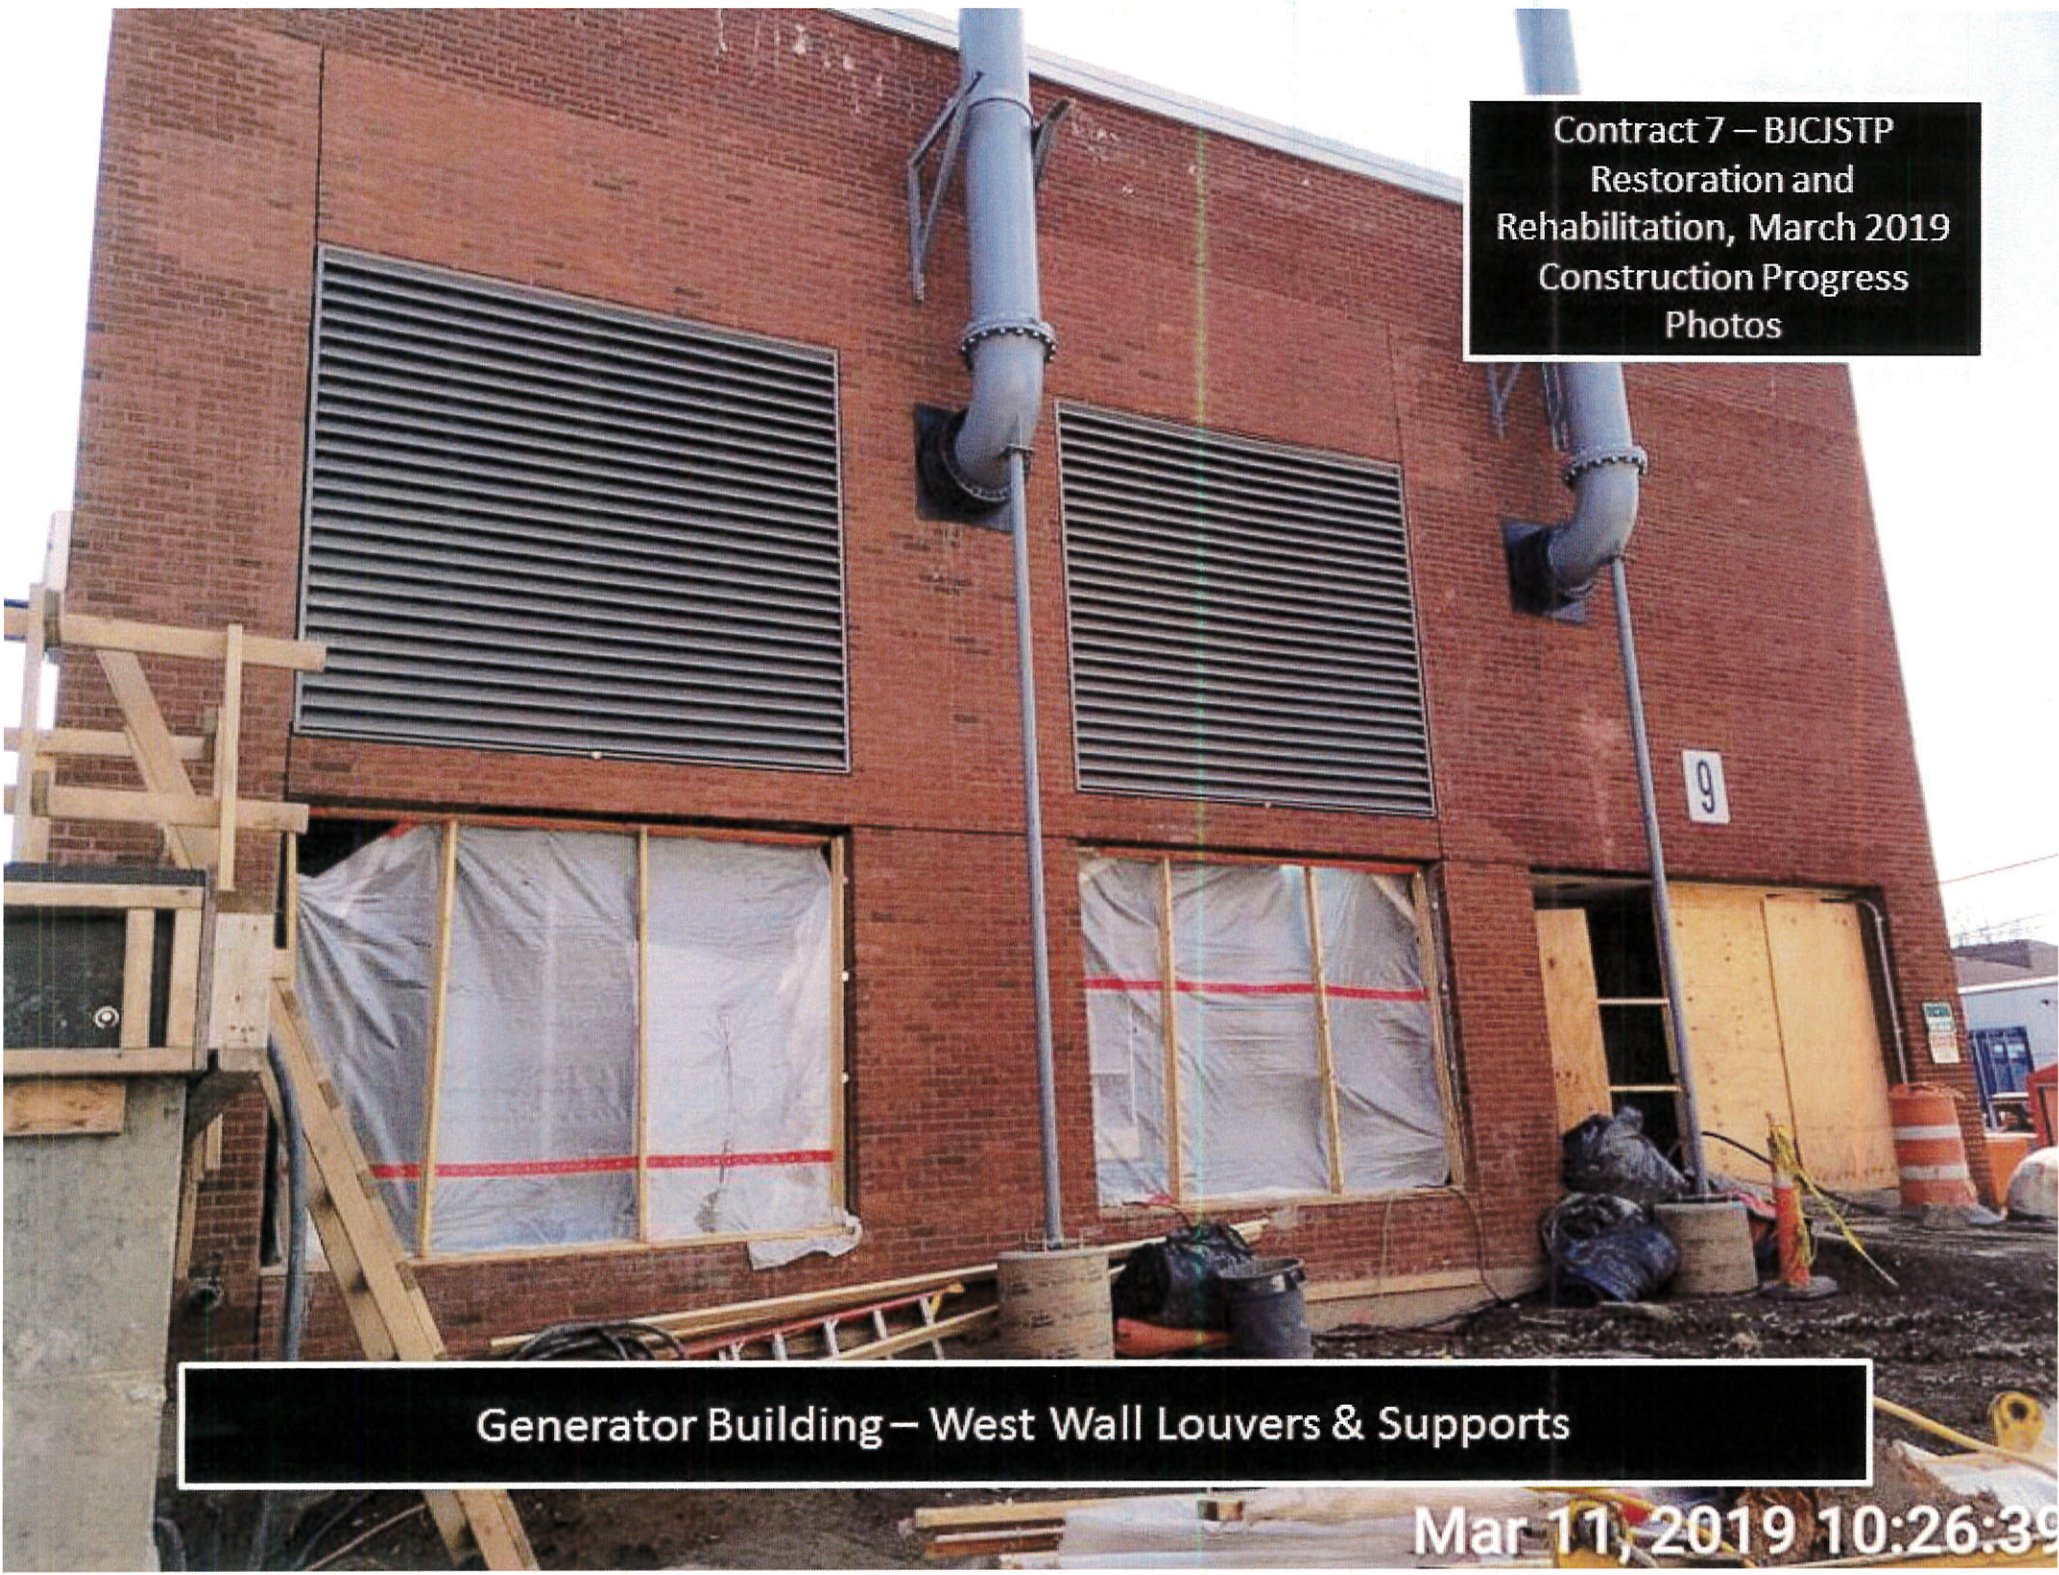
Generator Building – West Wall Louvers & Supports

Installation of the major conduits and wire for the generators are complete. MATCO is nearing commissioning of the generators, the ancillary gear, and the existing plant switchgear. They are now projecting completing the new generators in April, due to PC not completing the change order work to square the openings for the new louvers on the north side of the building. J&K has installed the generator exhaust systems. They are awaiting completion of the installation of the louvers on

the north and south sides of the generator building, which required extra work by PC to square the openings for the new louvers on the north and south sides of the building. The existing louver openings were not square, so the new louvers could not be installed prior to squaring up the openings.

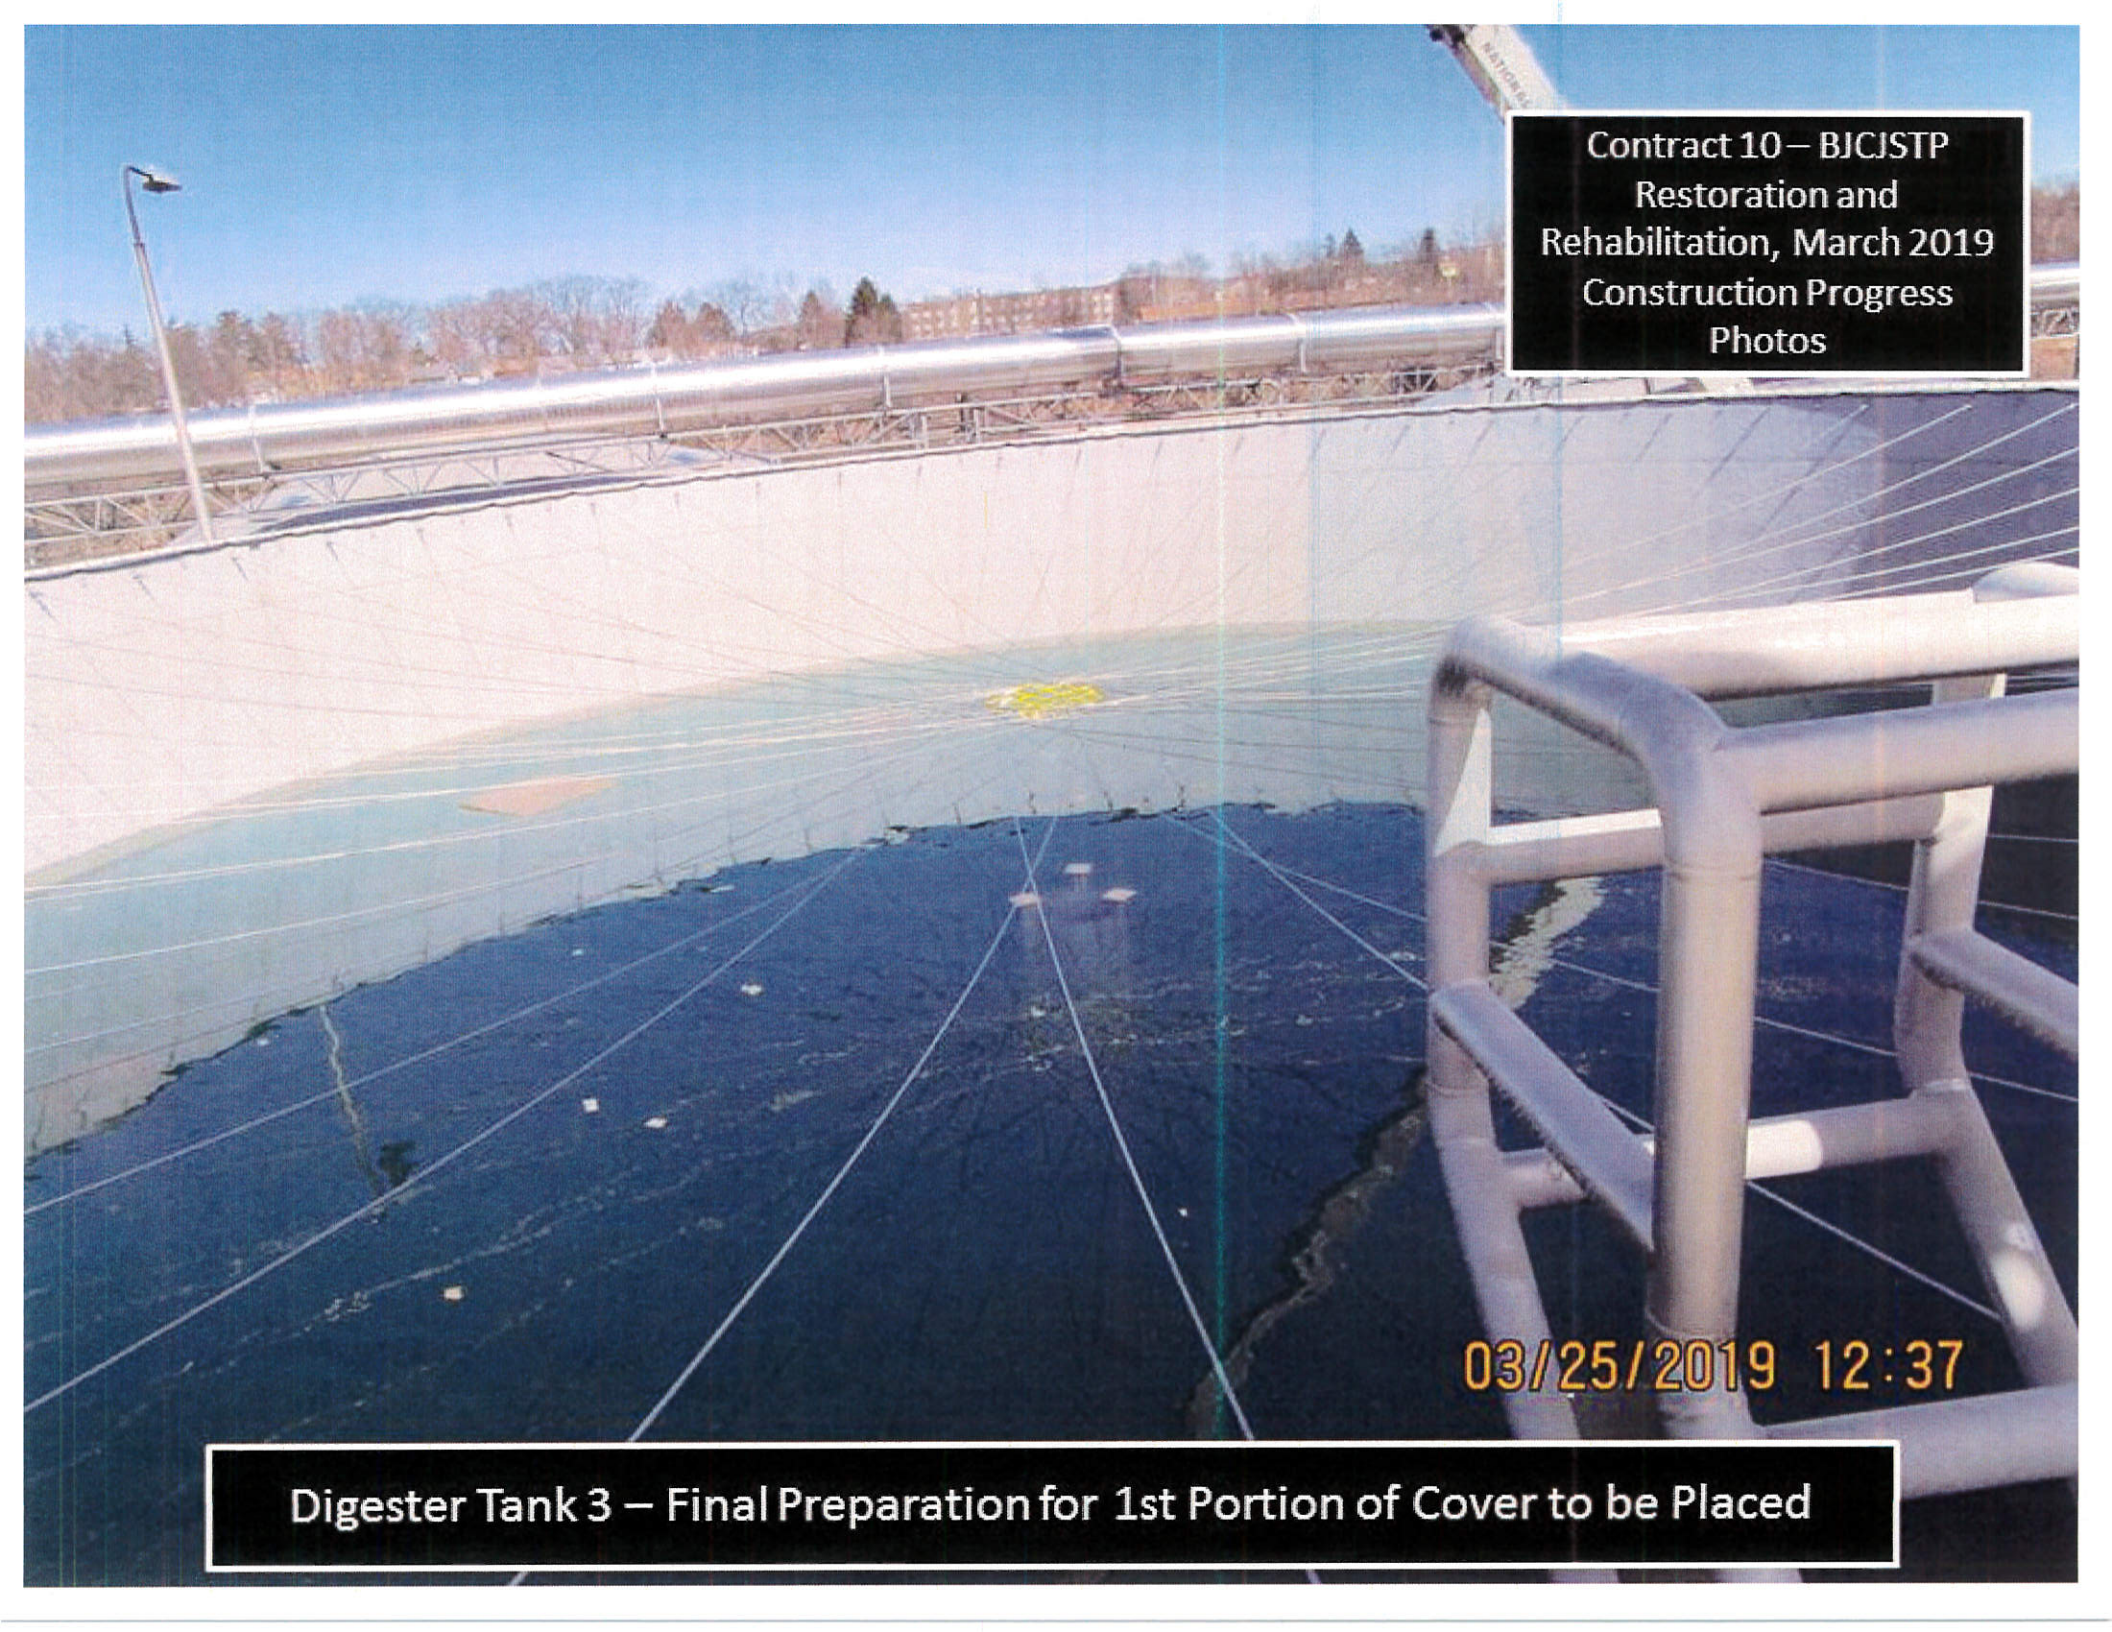
Digester Tank 3 – Final Preparation for 1st Portion of Cover to be Placed

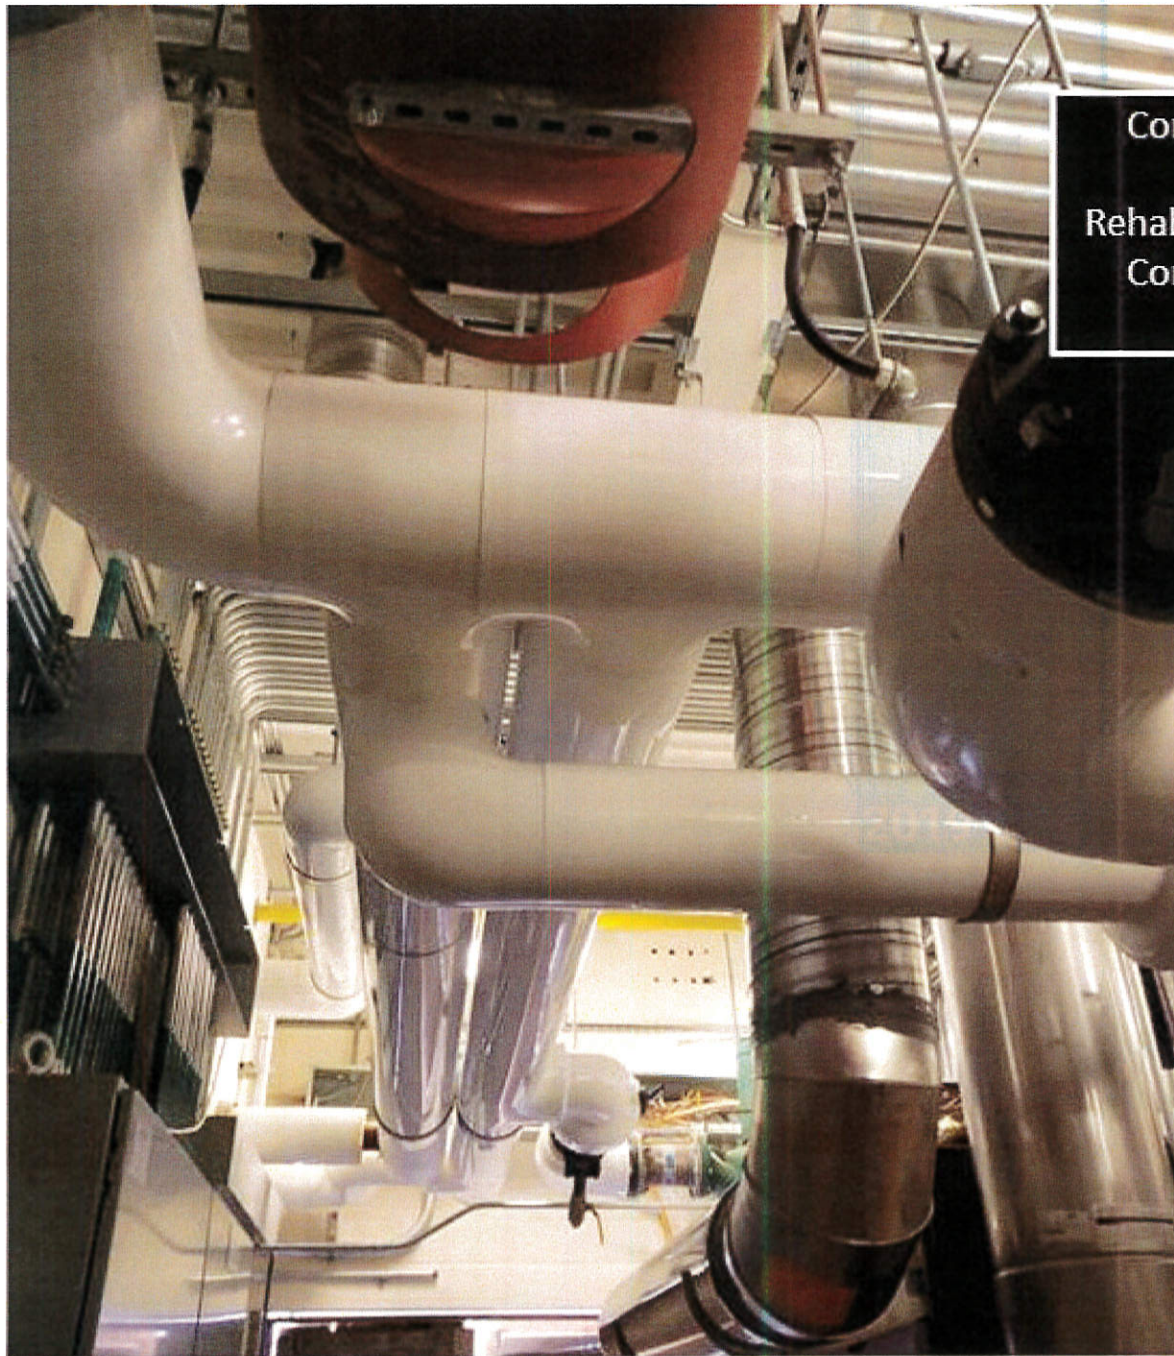
Digester Boiler Room – Completing Exhaust Vent

Status: The HVAC contractor is J&K Plumbing, as it is on the BAF Contract No. 7. J&K continues to install the boiler and associated piping in the Digester Control Building, and continued installing the HVAC equipment in the Solids Handling Building, sludge pumps station #1, and in the Digester Control Building. Because the heat exchanger for Digester #3 has never been put into service, and was installed before the 2011 flood, we are having J&K test the heat exchanger in advance of the need to start using the heat exchanger. They are also supporting the General Civil Contractor's schedule.

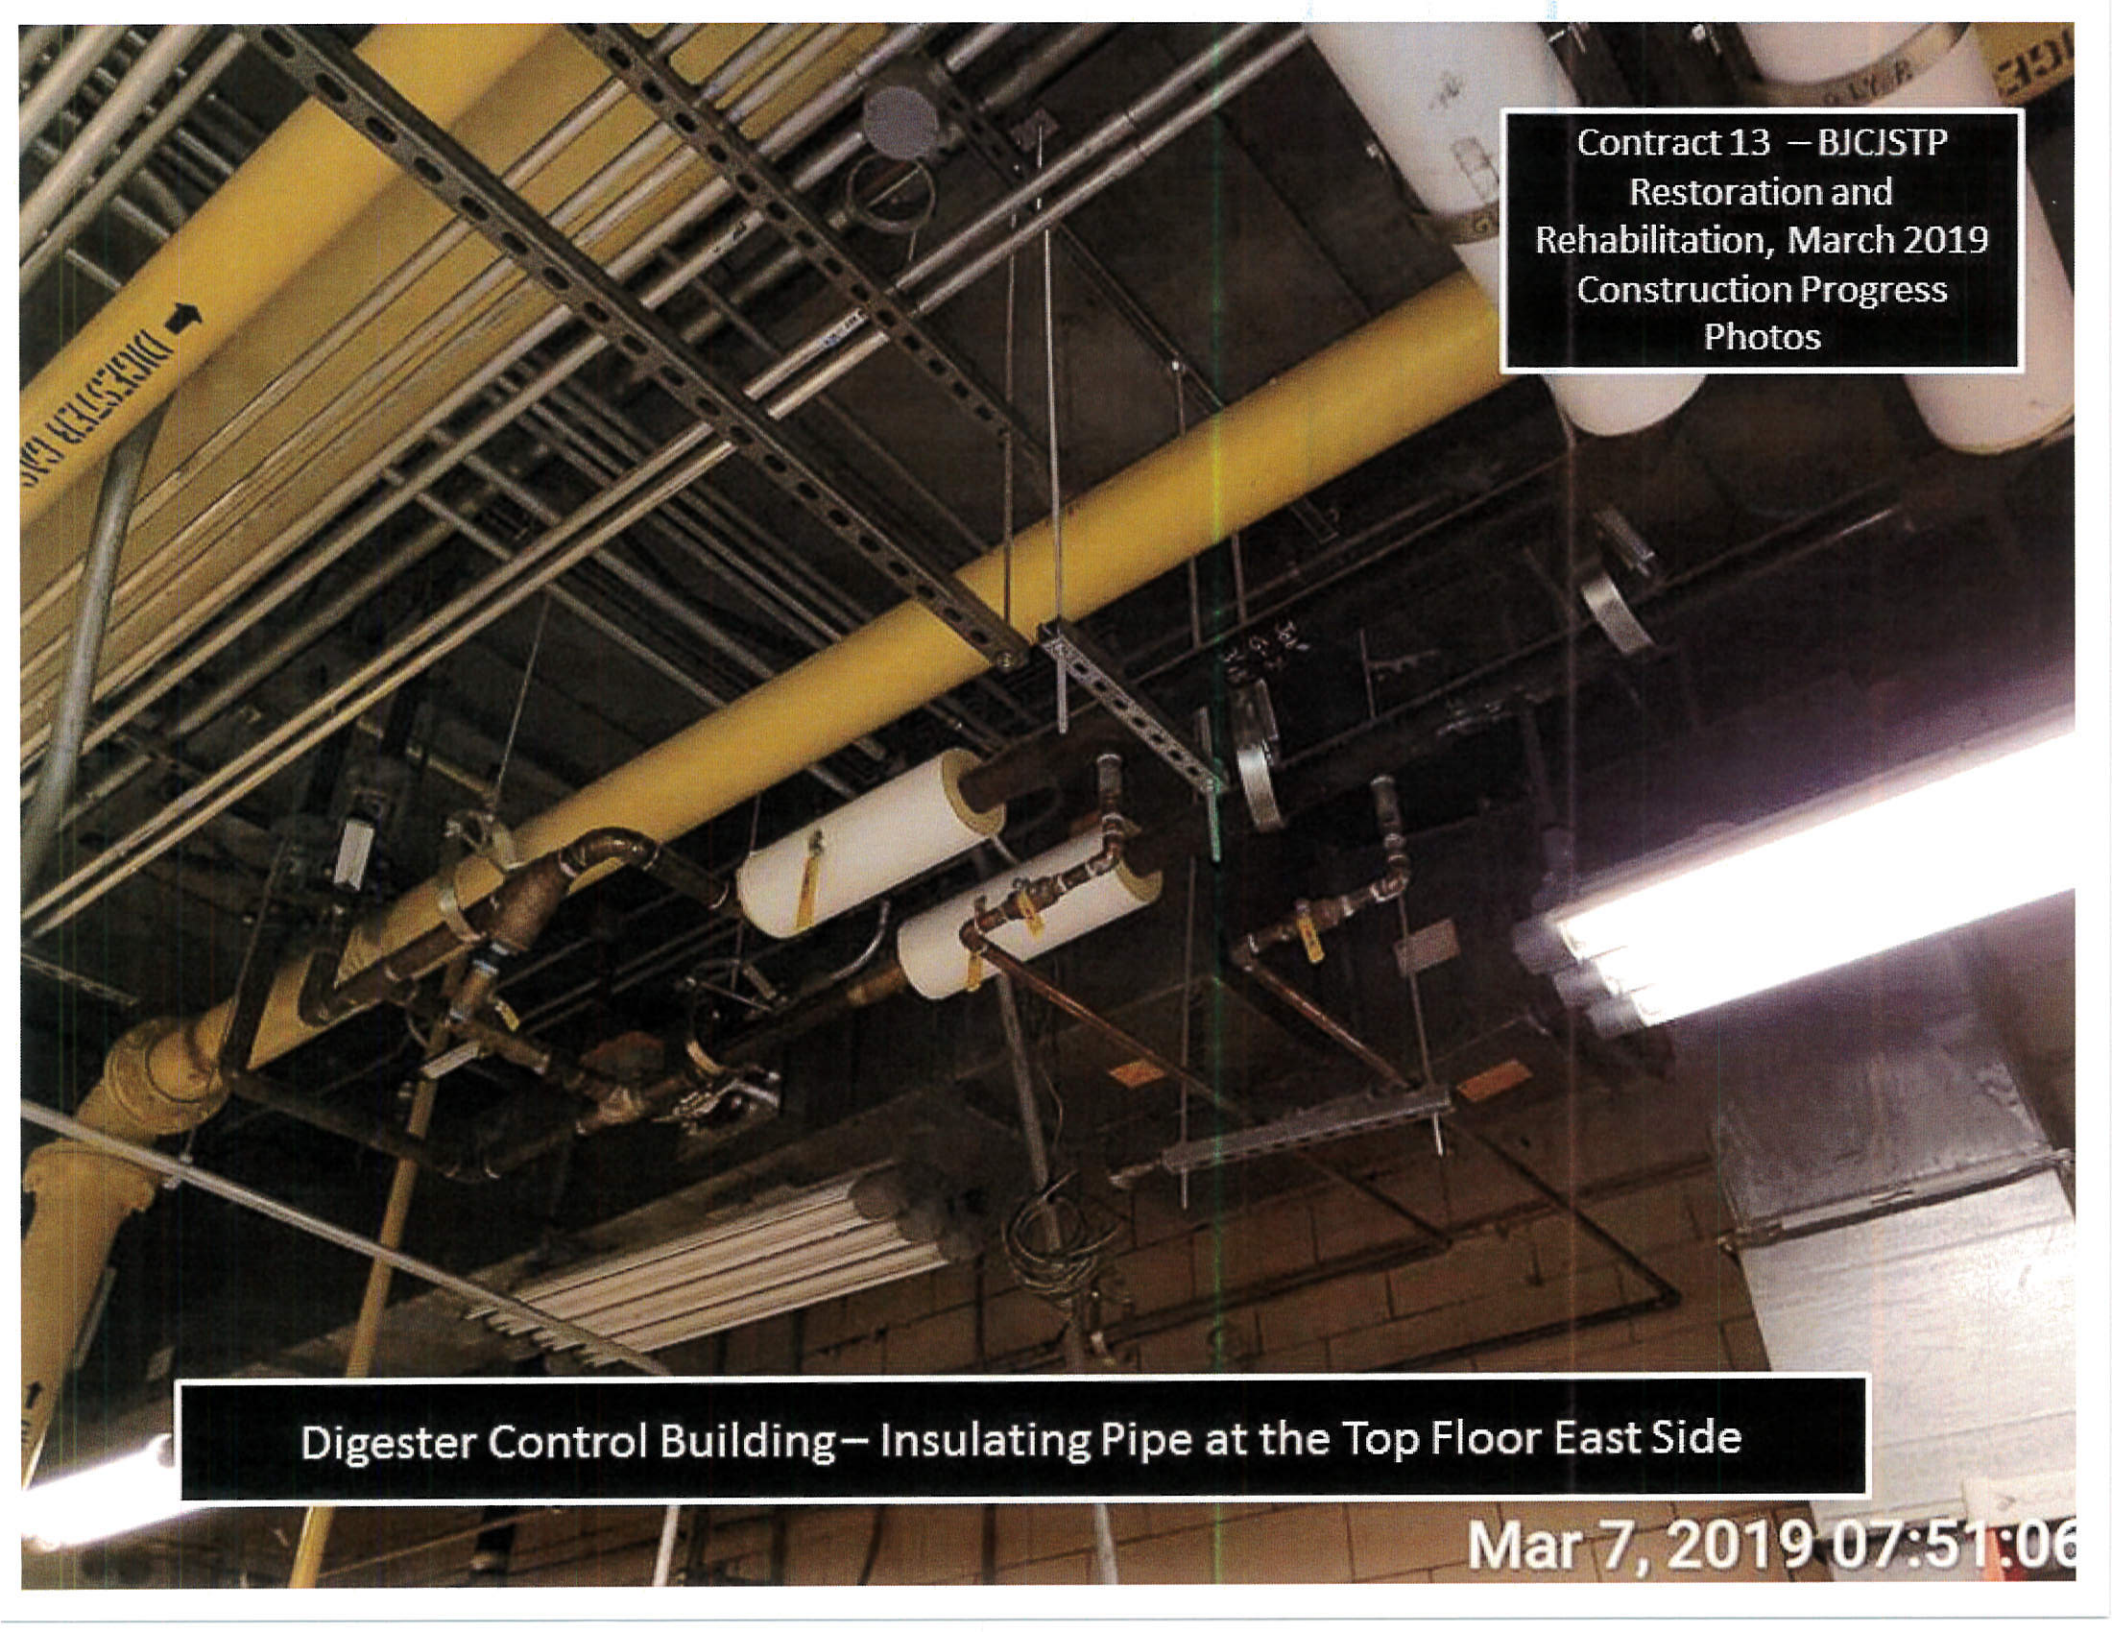
Digester Control Building – Insulating Pipe at the Top Floor East Side
