## June 2018 Monthly Report

### BJCJSTP Rehabilitation and Restoration Project

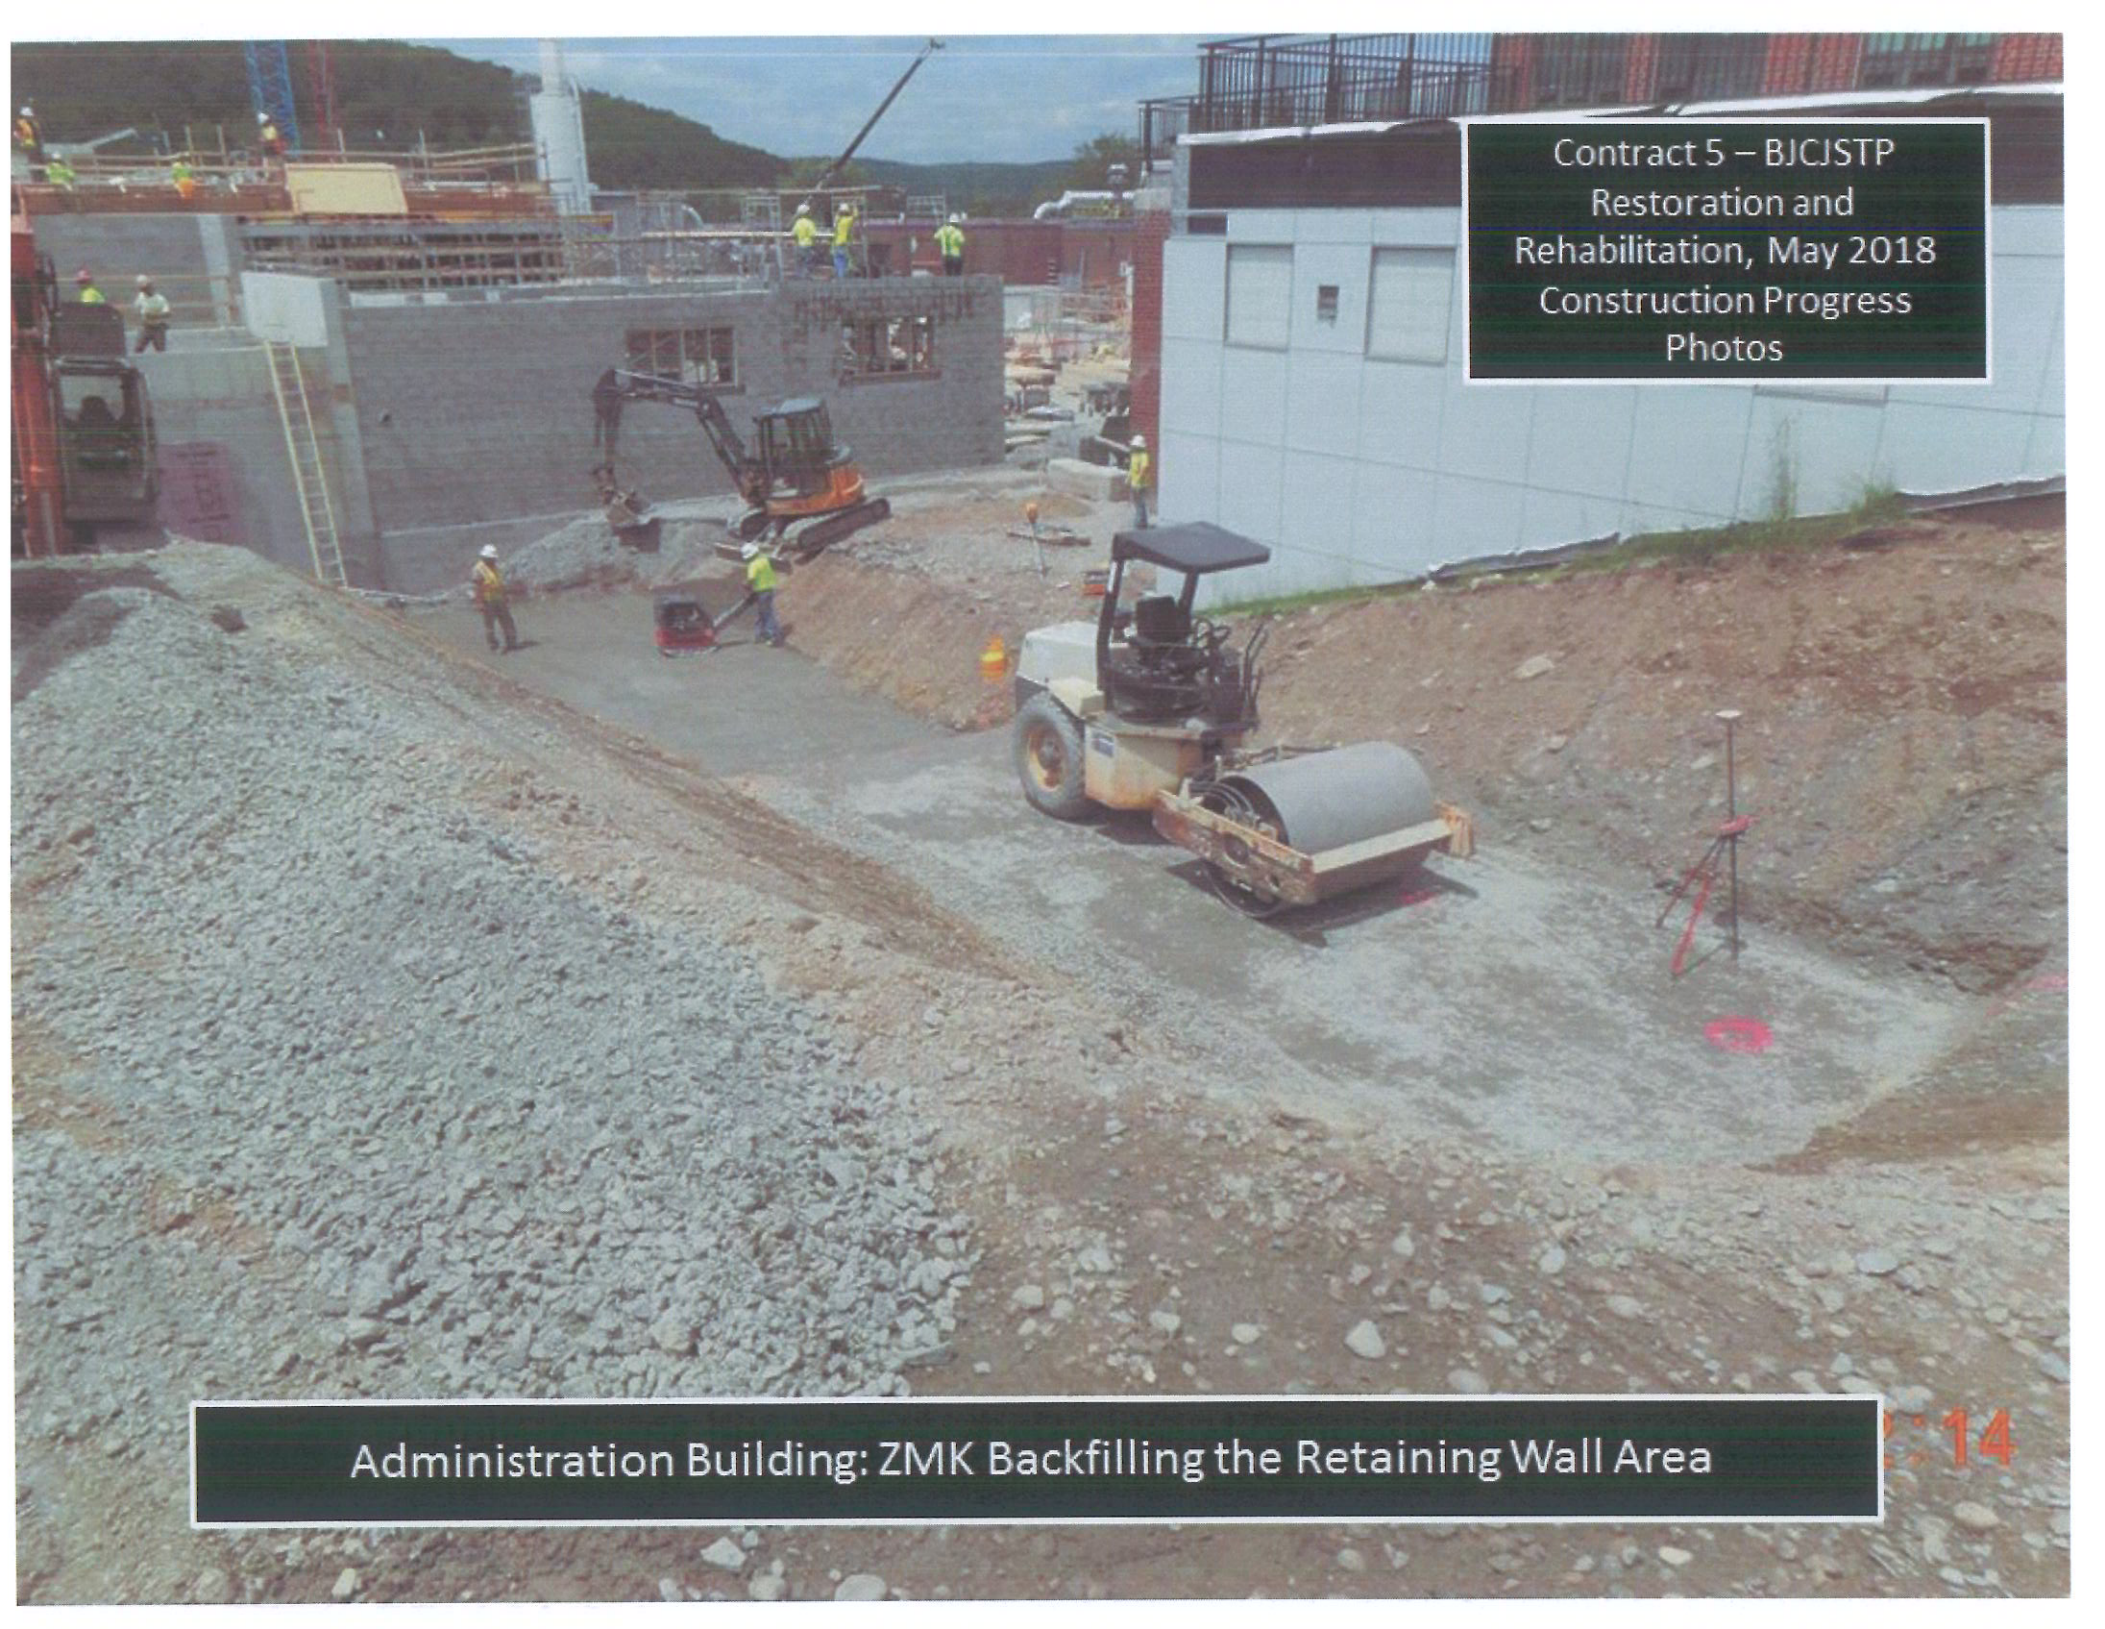
Contract 5 – BJCSTP  
Restoration and  
Rehabilitation, May 2018  
Construction Progress  
Photos

A wide-angle photograph of a construction site. In the foreground, a yellow and black roller is compacting a layer of grey gravel. To the left, a large pile of grey gravel is visible. In the middle ground, an orange excavator is working on a concrete structure. Several workers in yellow safety vests and hard hats are scattered across the site. In the background, a large building with a grey facade and a red brick structure are visible. The sky is overcast.

Administration Building: ZMK Backfilling the Retaining Wall Area

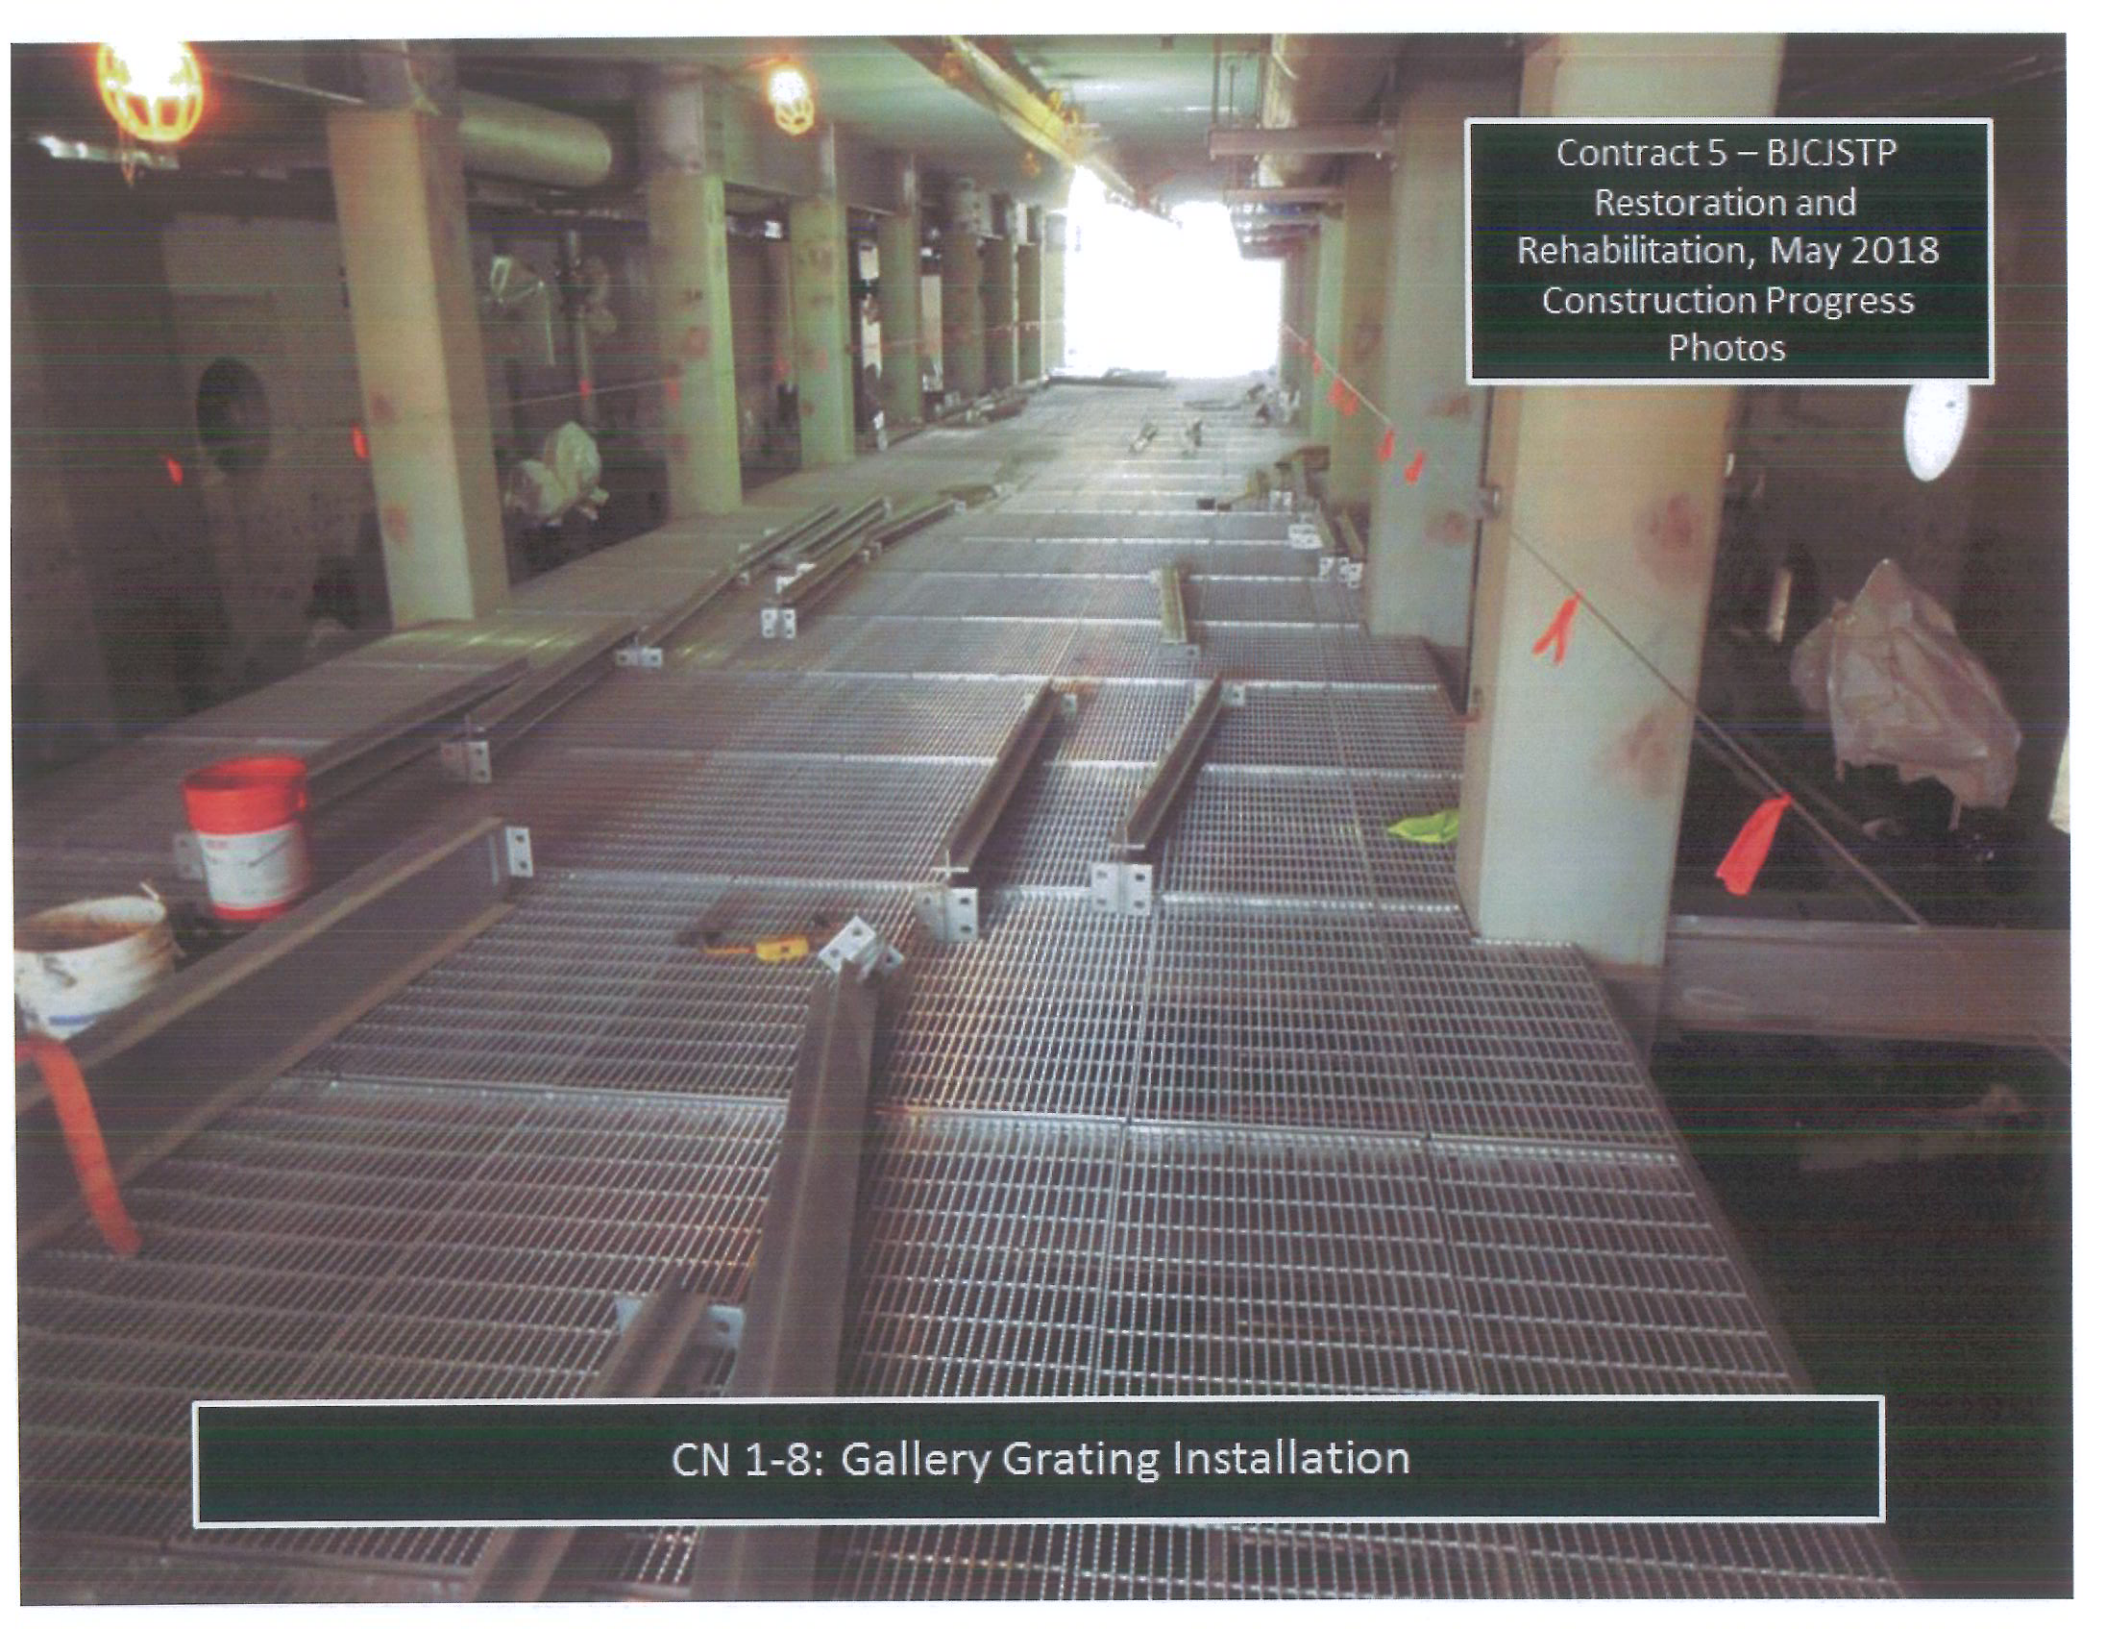
Contract 5 – BJCJSTP  
Restoration and  
Rehabilitation, May 2018  
Construction Progress  
Photos

CN 1-8: Gallery Grating Installation

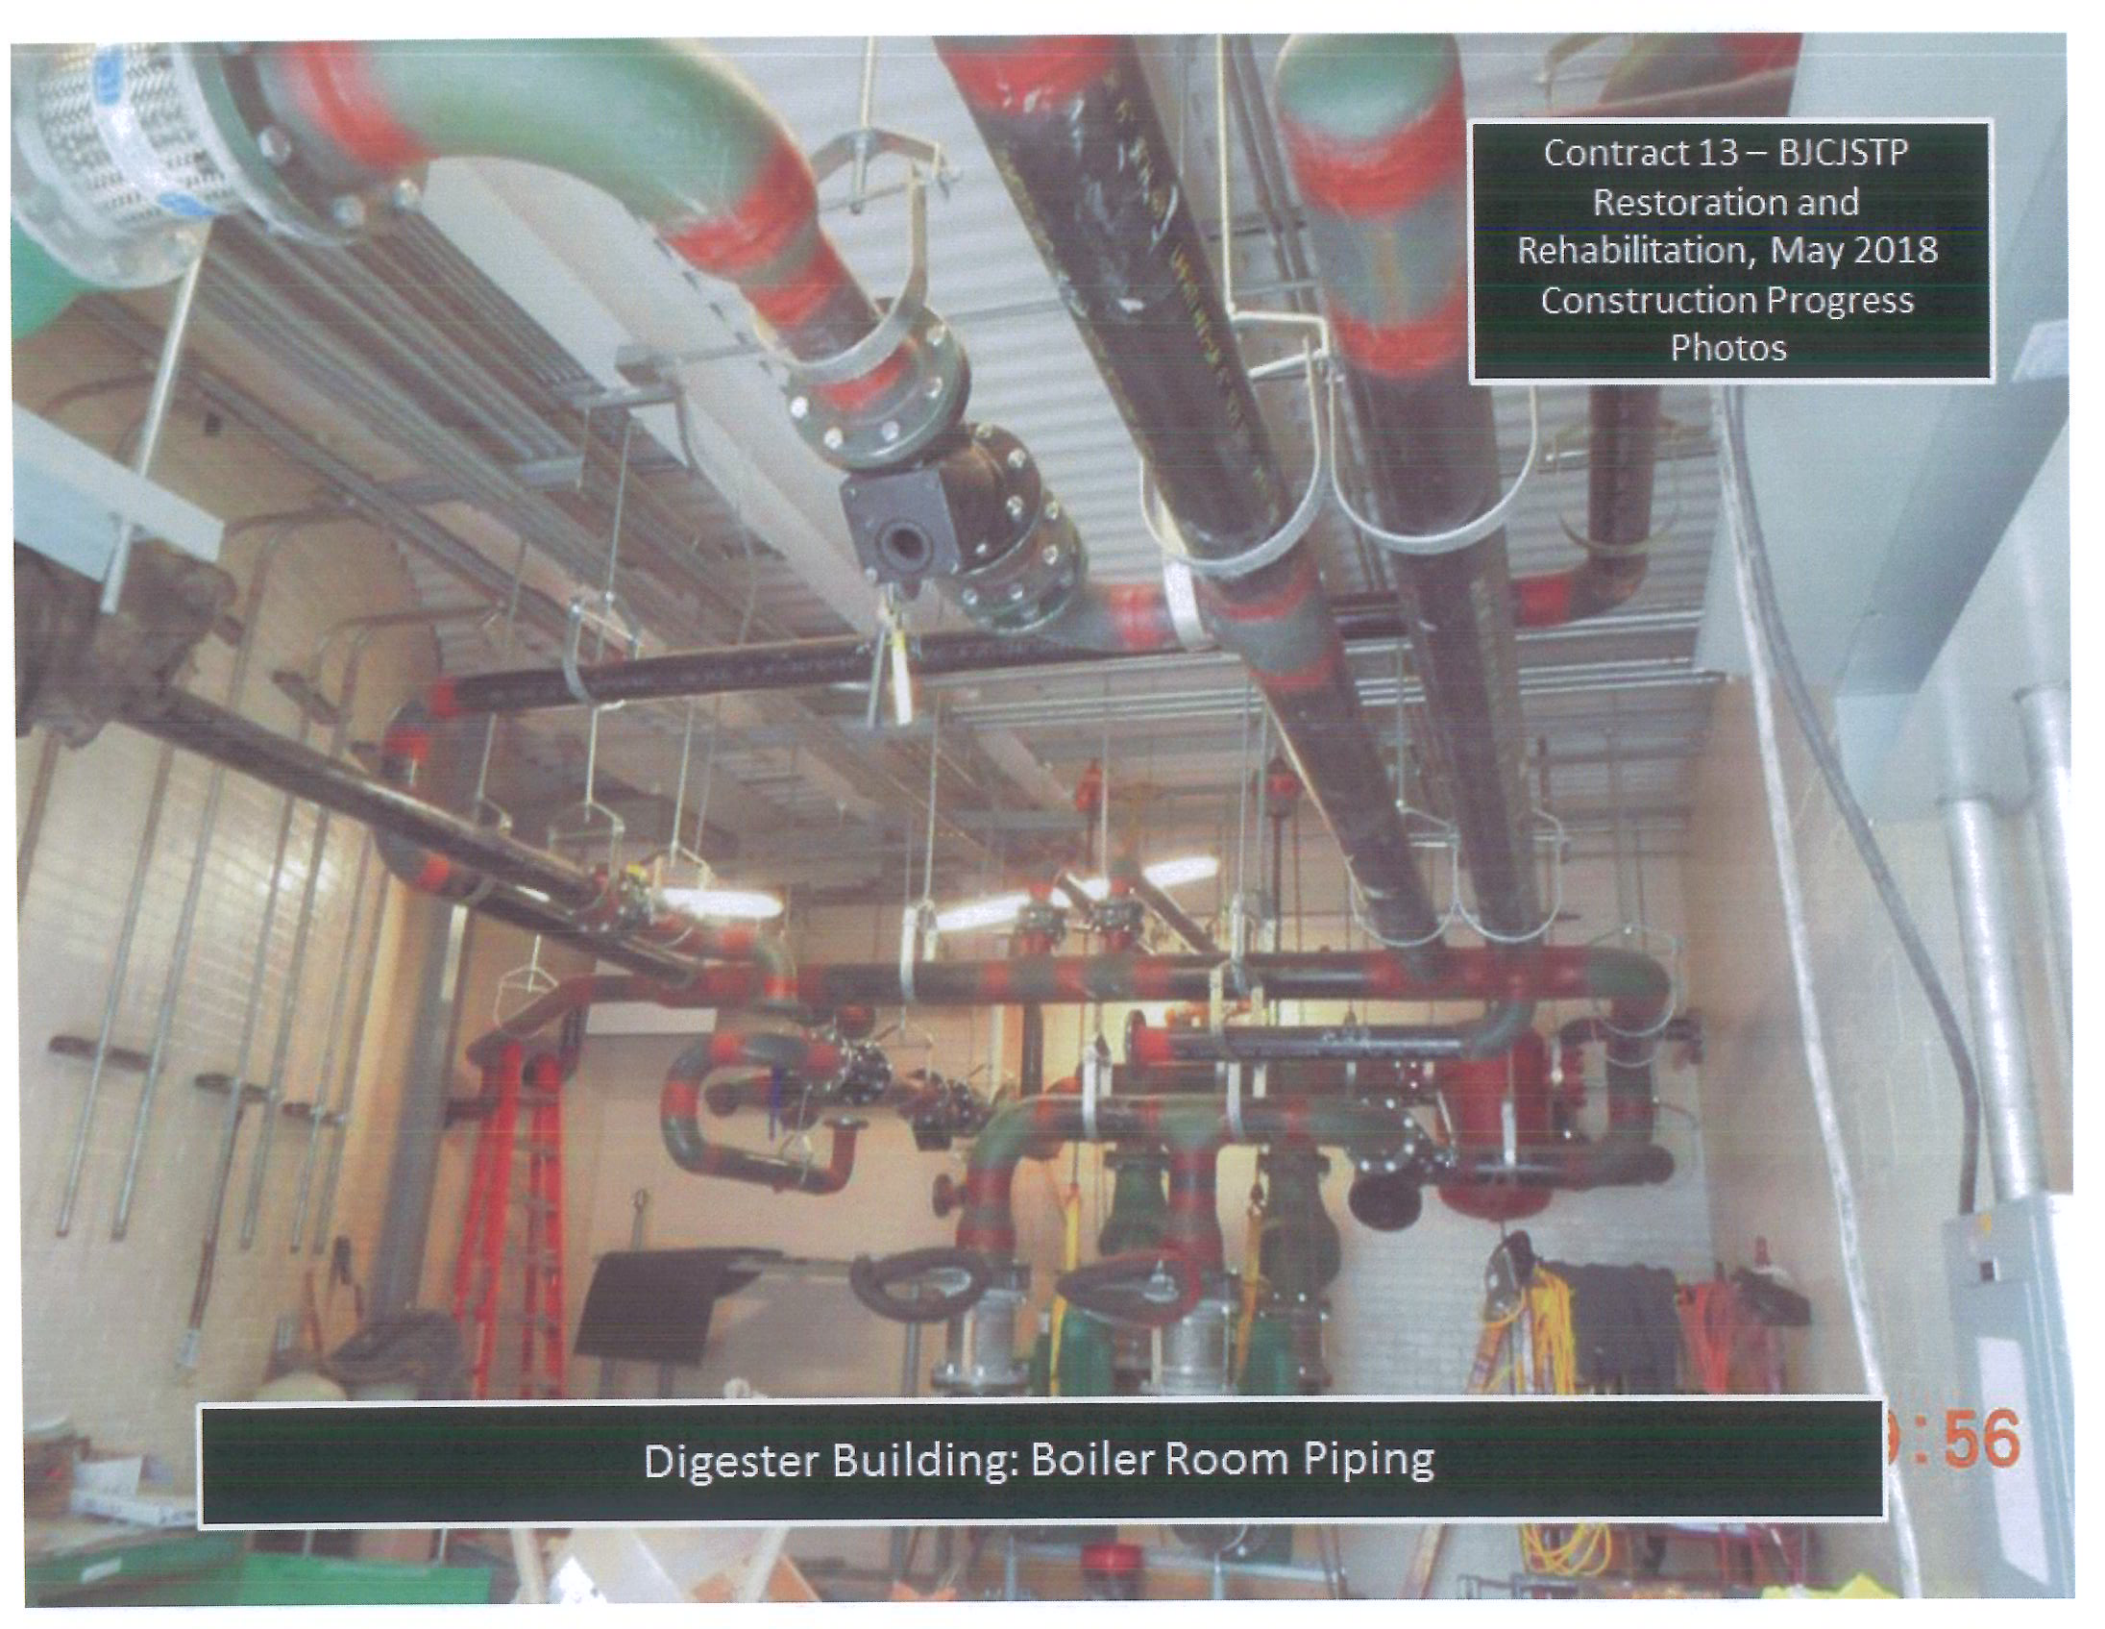
Contract 13 – BJCJSTP  
Restoration and  
Rehabilitation, May 2018  
Construction Progress  
Photos

Digester Building: Boiler Room Piping

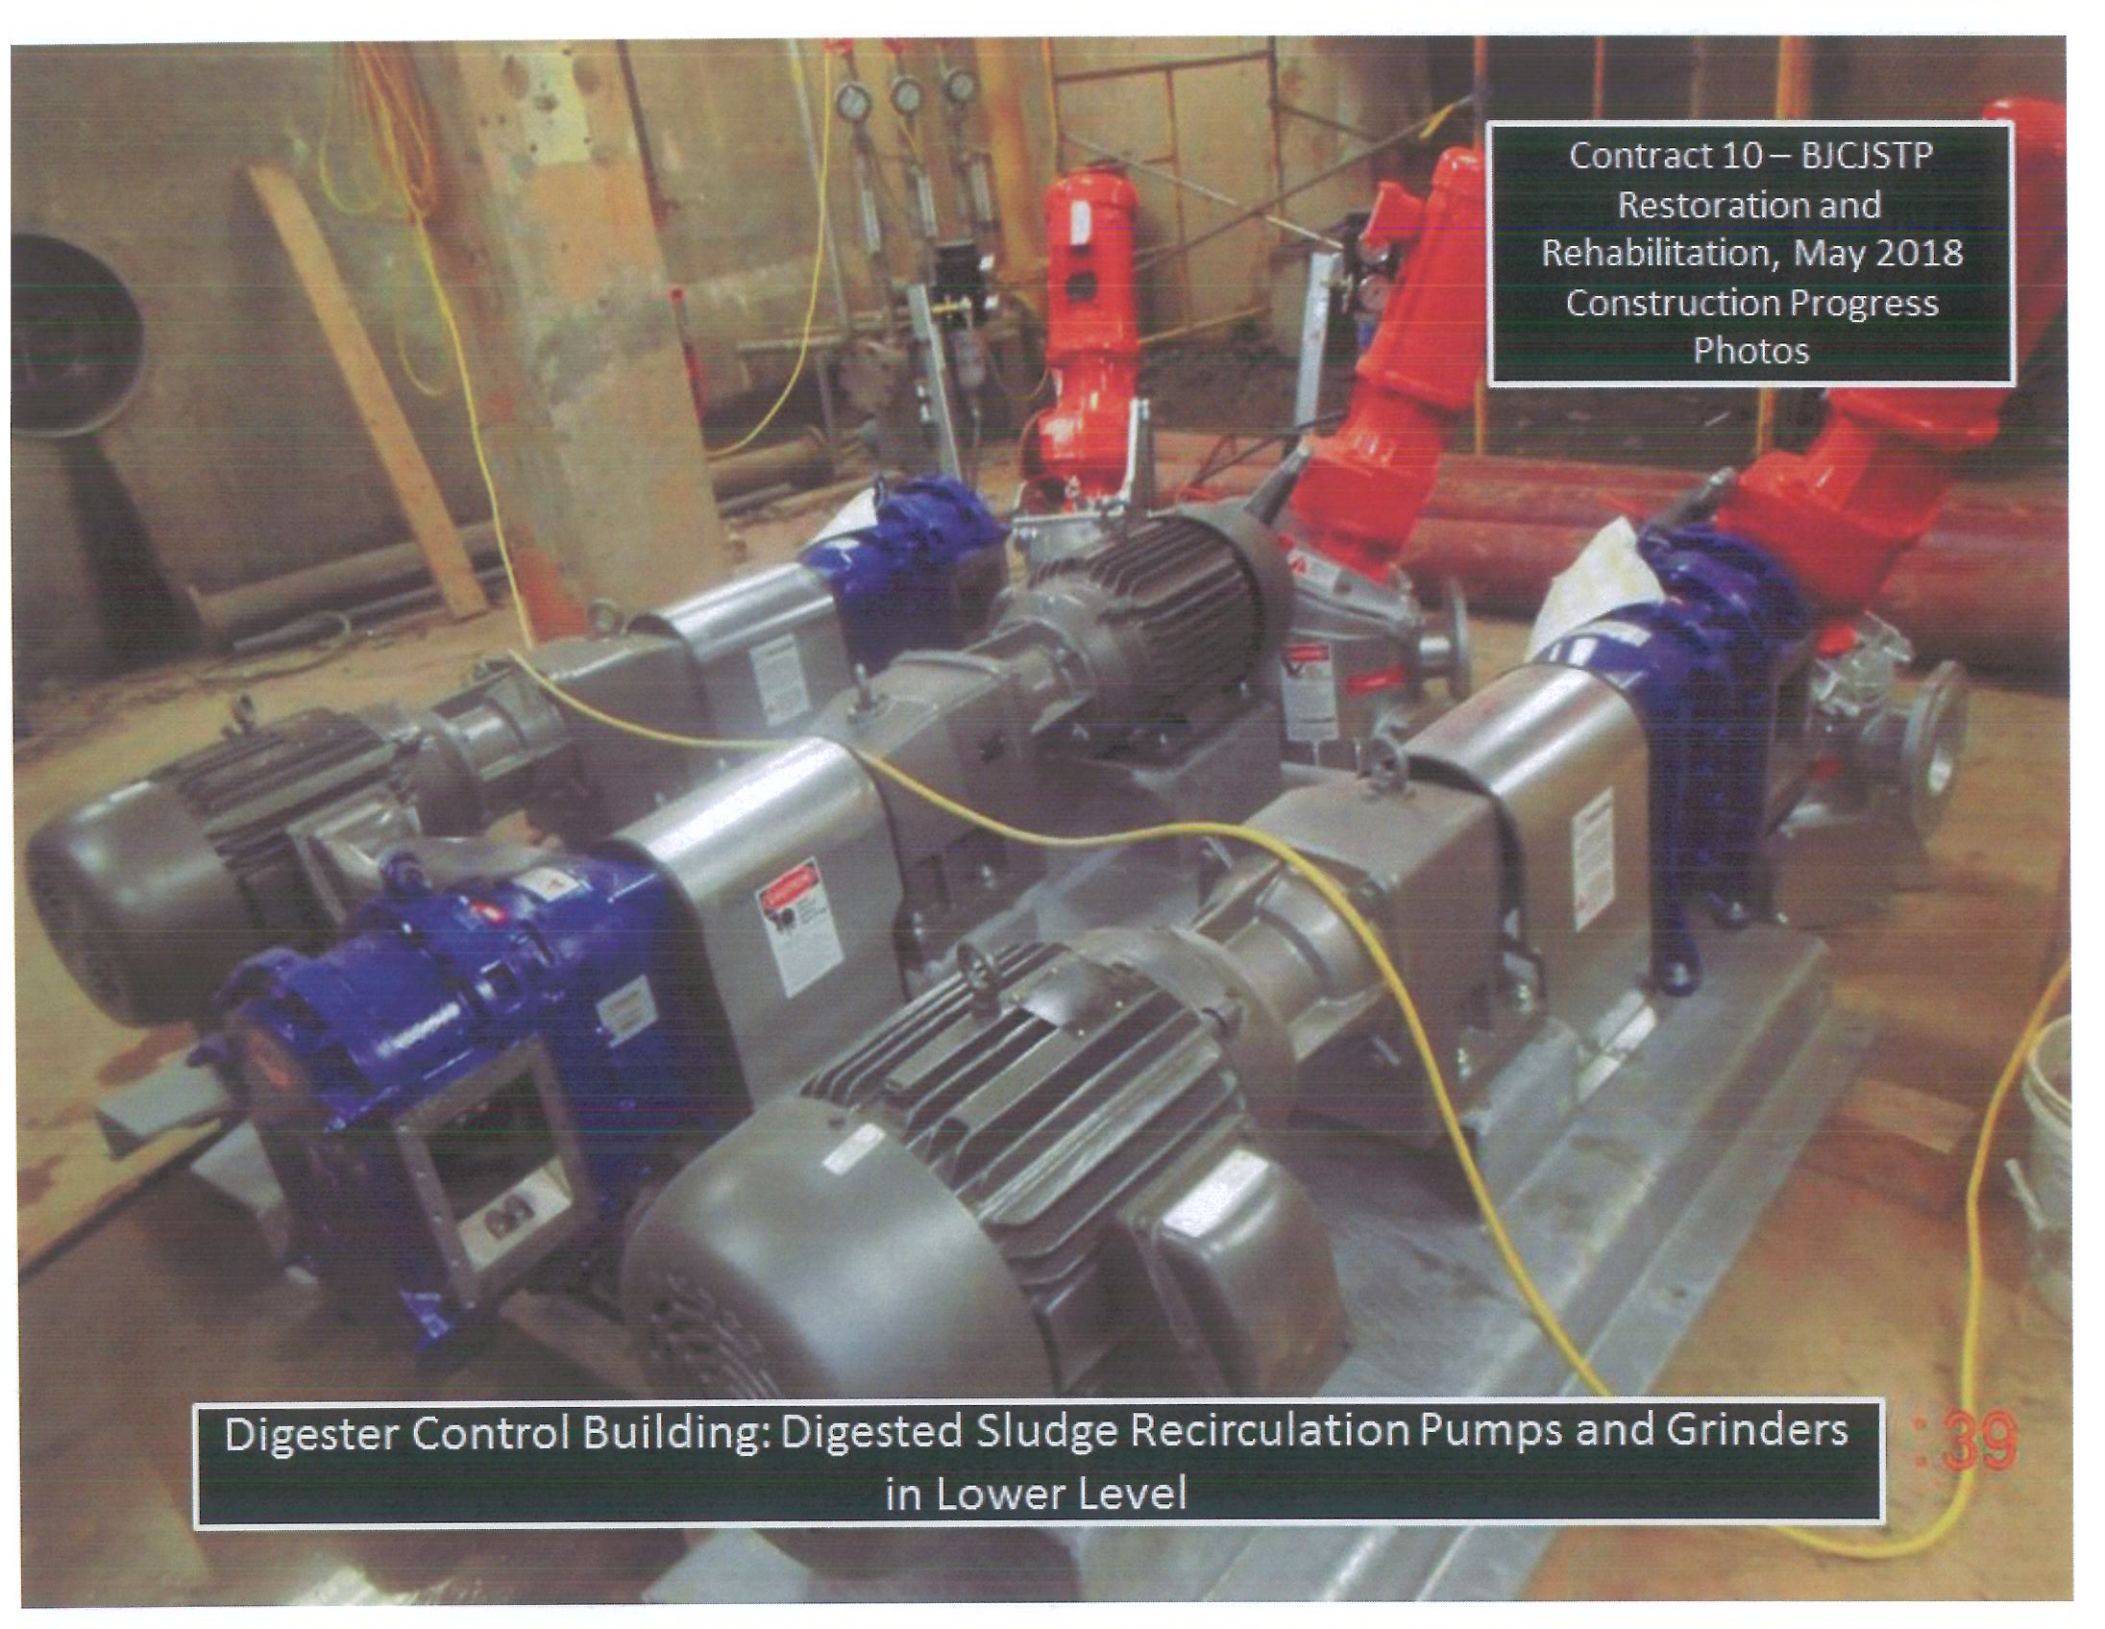
Contract 10 – BJCJSTP  
Restoration and  
Rehabilitation, May 2018  
Construction Progress  
Photos

Digester Control Building: Digested Sludge Recirculation Pumps and Grinders  
in Lower Level

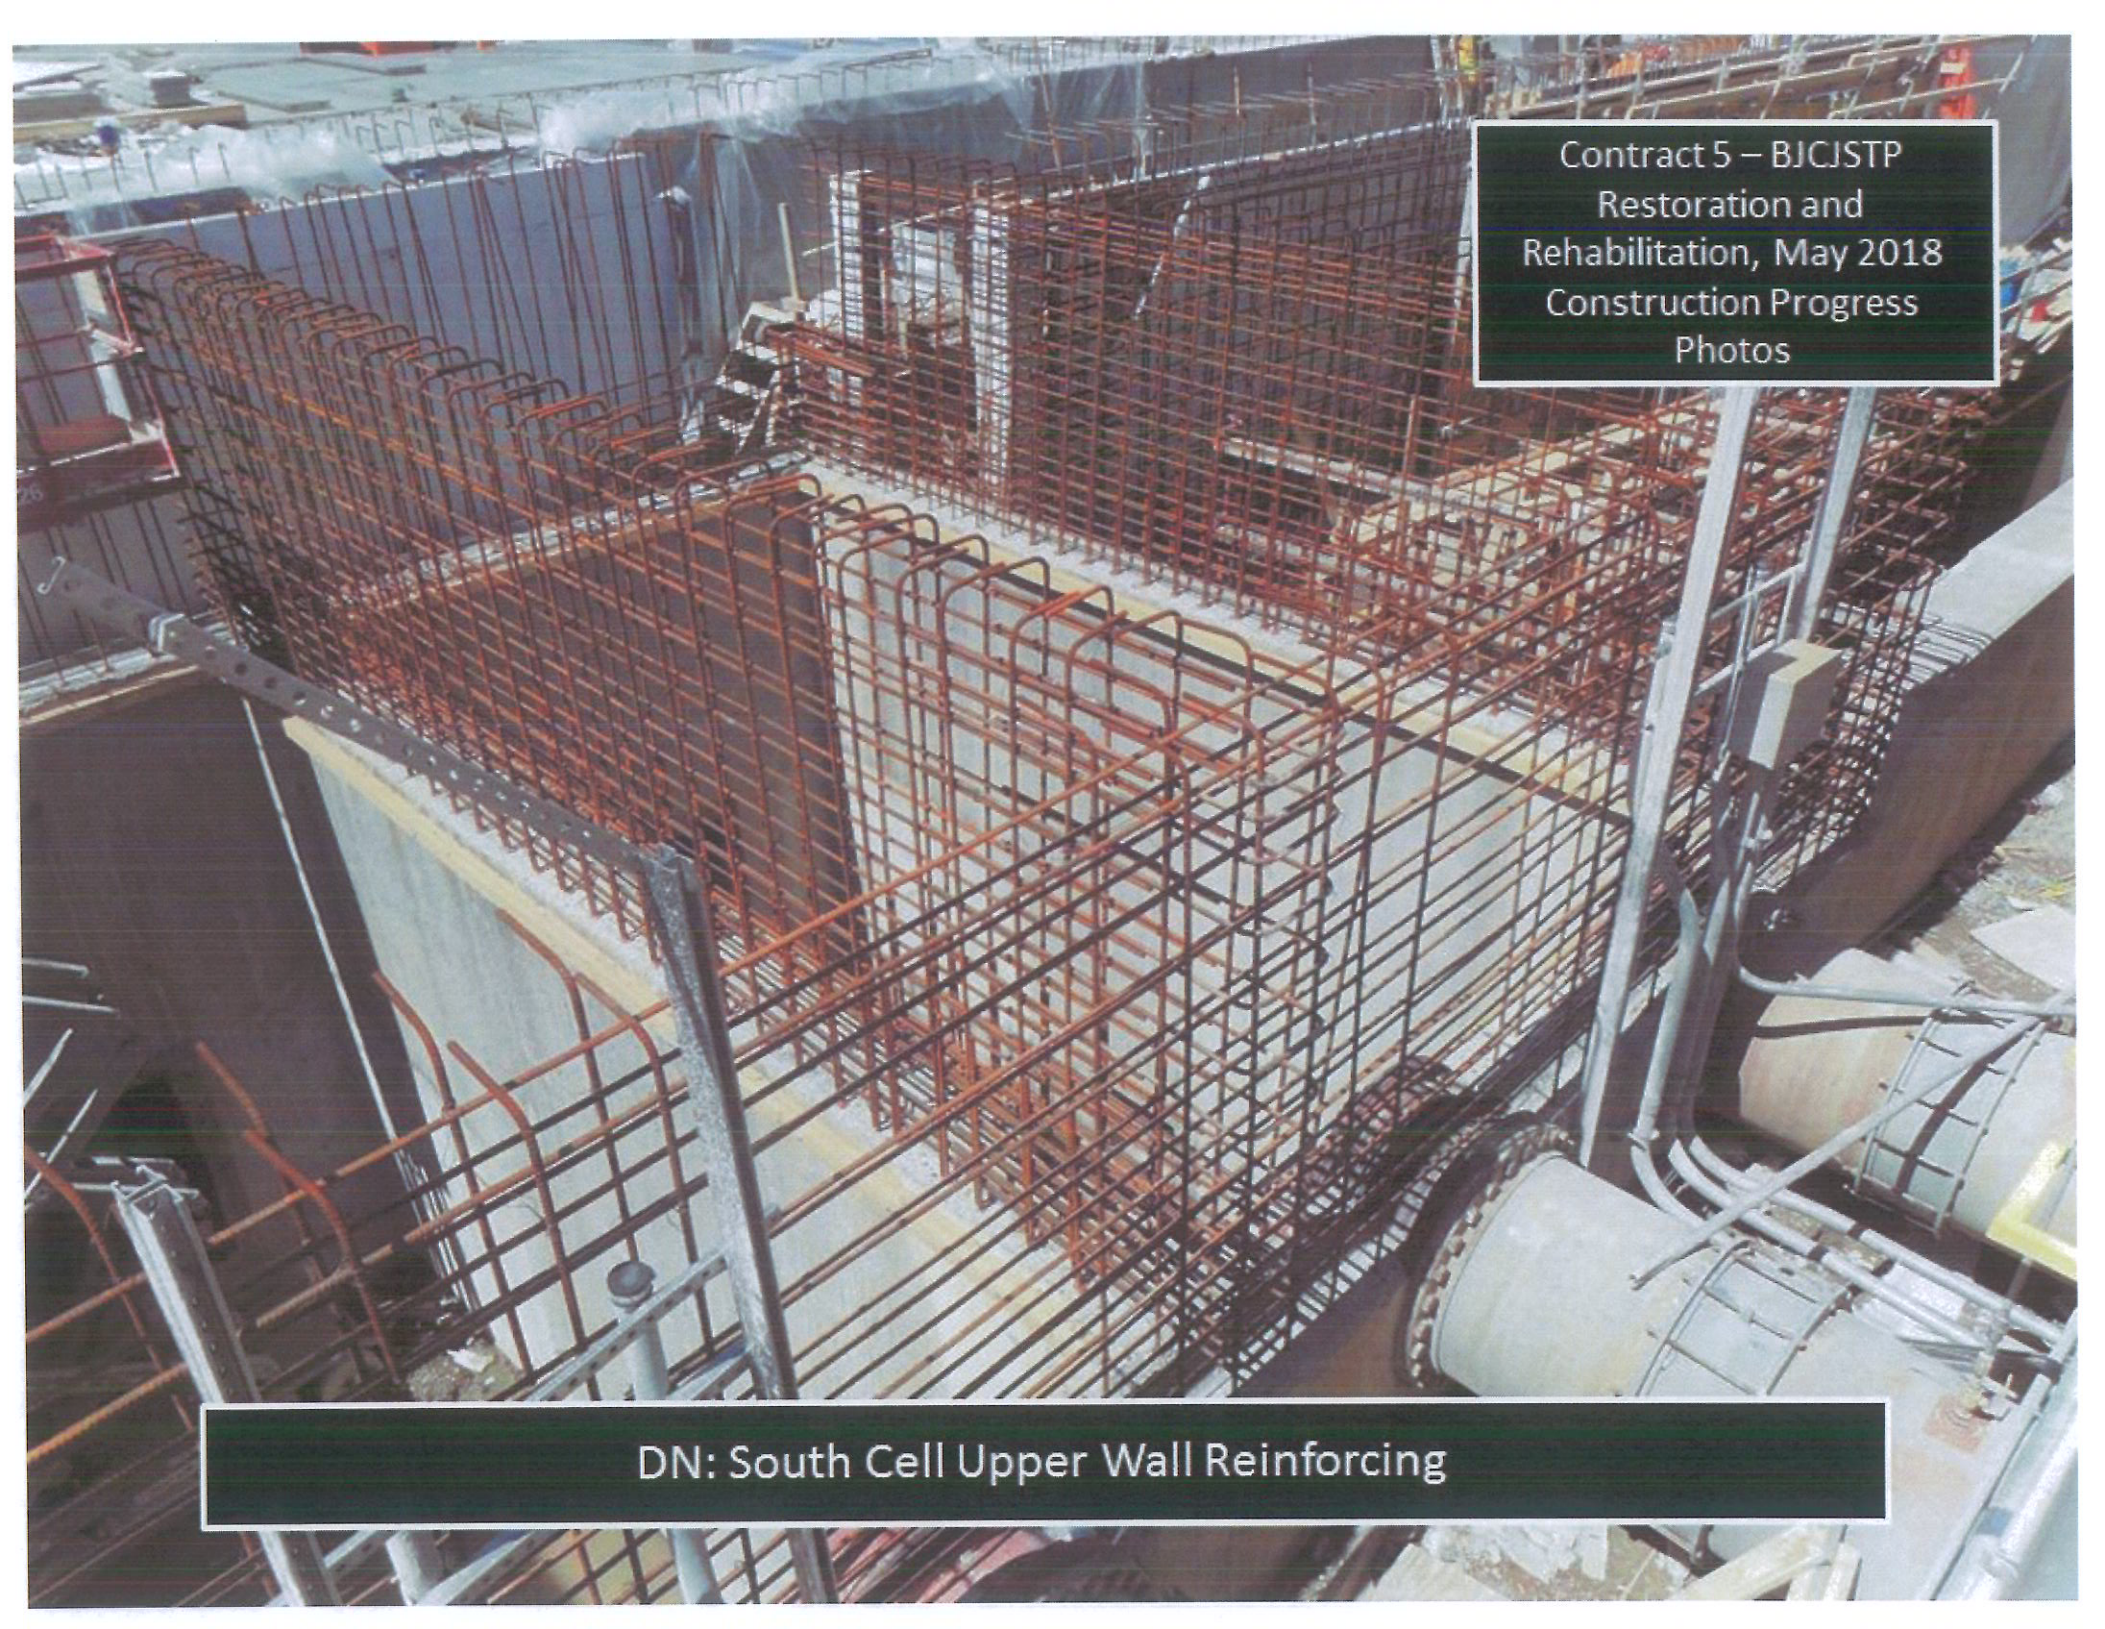
Contract 5 – BJCISTP  
Restoration and  
Rehabilitation, May 2018  
Construction Progress  
Photos

DN: South Cell Upper Wall Reinforcing

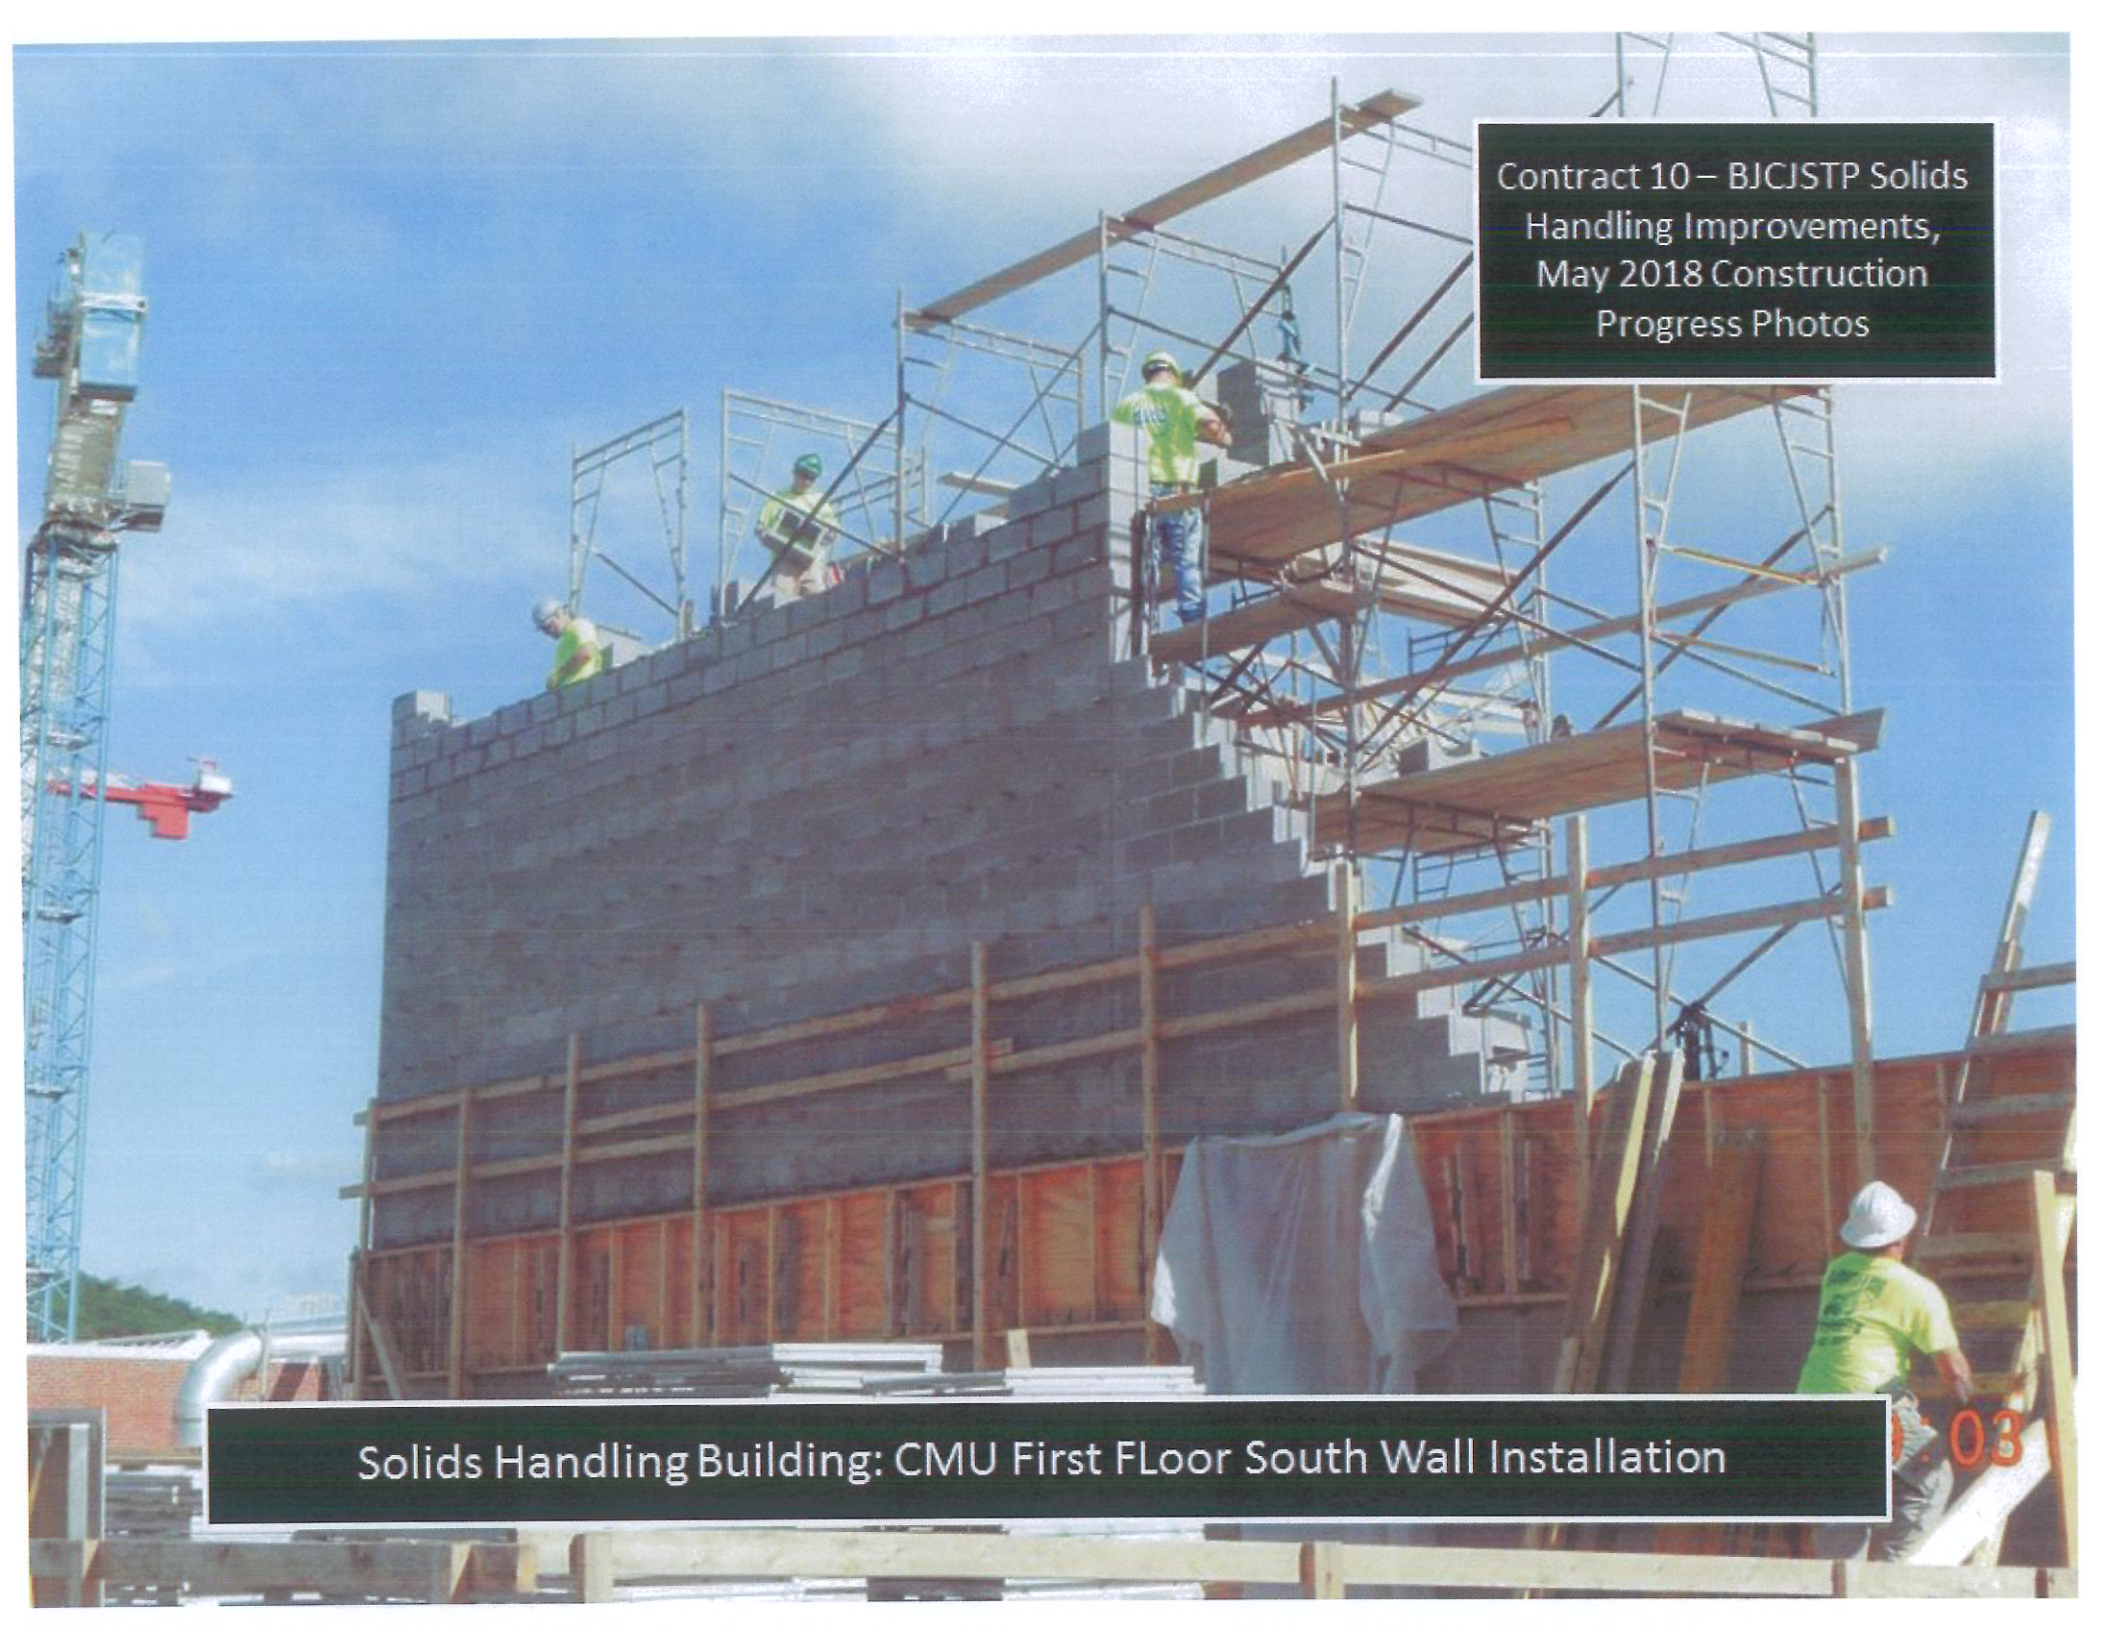
Contract 10 – BJCJSTP Solids  
Handling Improvements,  
May 2018 Construction  
Progress Photos

A large-scale construction project is underway under a clear blue sky. The central focus is a multi-story building's exterior wall, which is being constructed using dark grey concrete masonry units (CMU). The wall is partially completed, with several levels of scaffolding and wooden formwork in place. Three construction workers, wearing bright yellow-green safety vests and hard hats, are visible on the scaffolding, actively engaged in the installation process. To the left, a tall blue tower crane stands against the sky. In the foreground, a worker in a white hard hat and yellow-green vest is seen from behind, working on a wooden structure. The overall scene depicts a busy and organized construction site.

Solids Handling Building: CMU First Floor South Wall Installation
