## June 2018 Monthly Report

### BJCJSTP Rehabilitation and Restoration Project

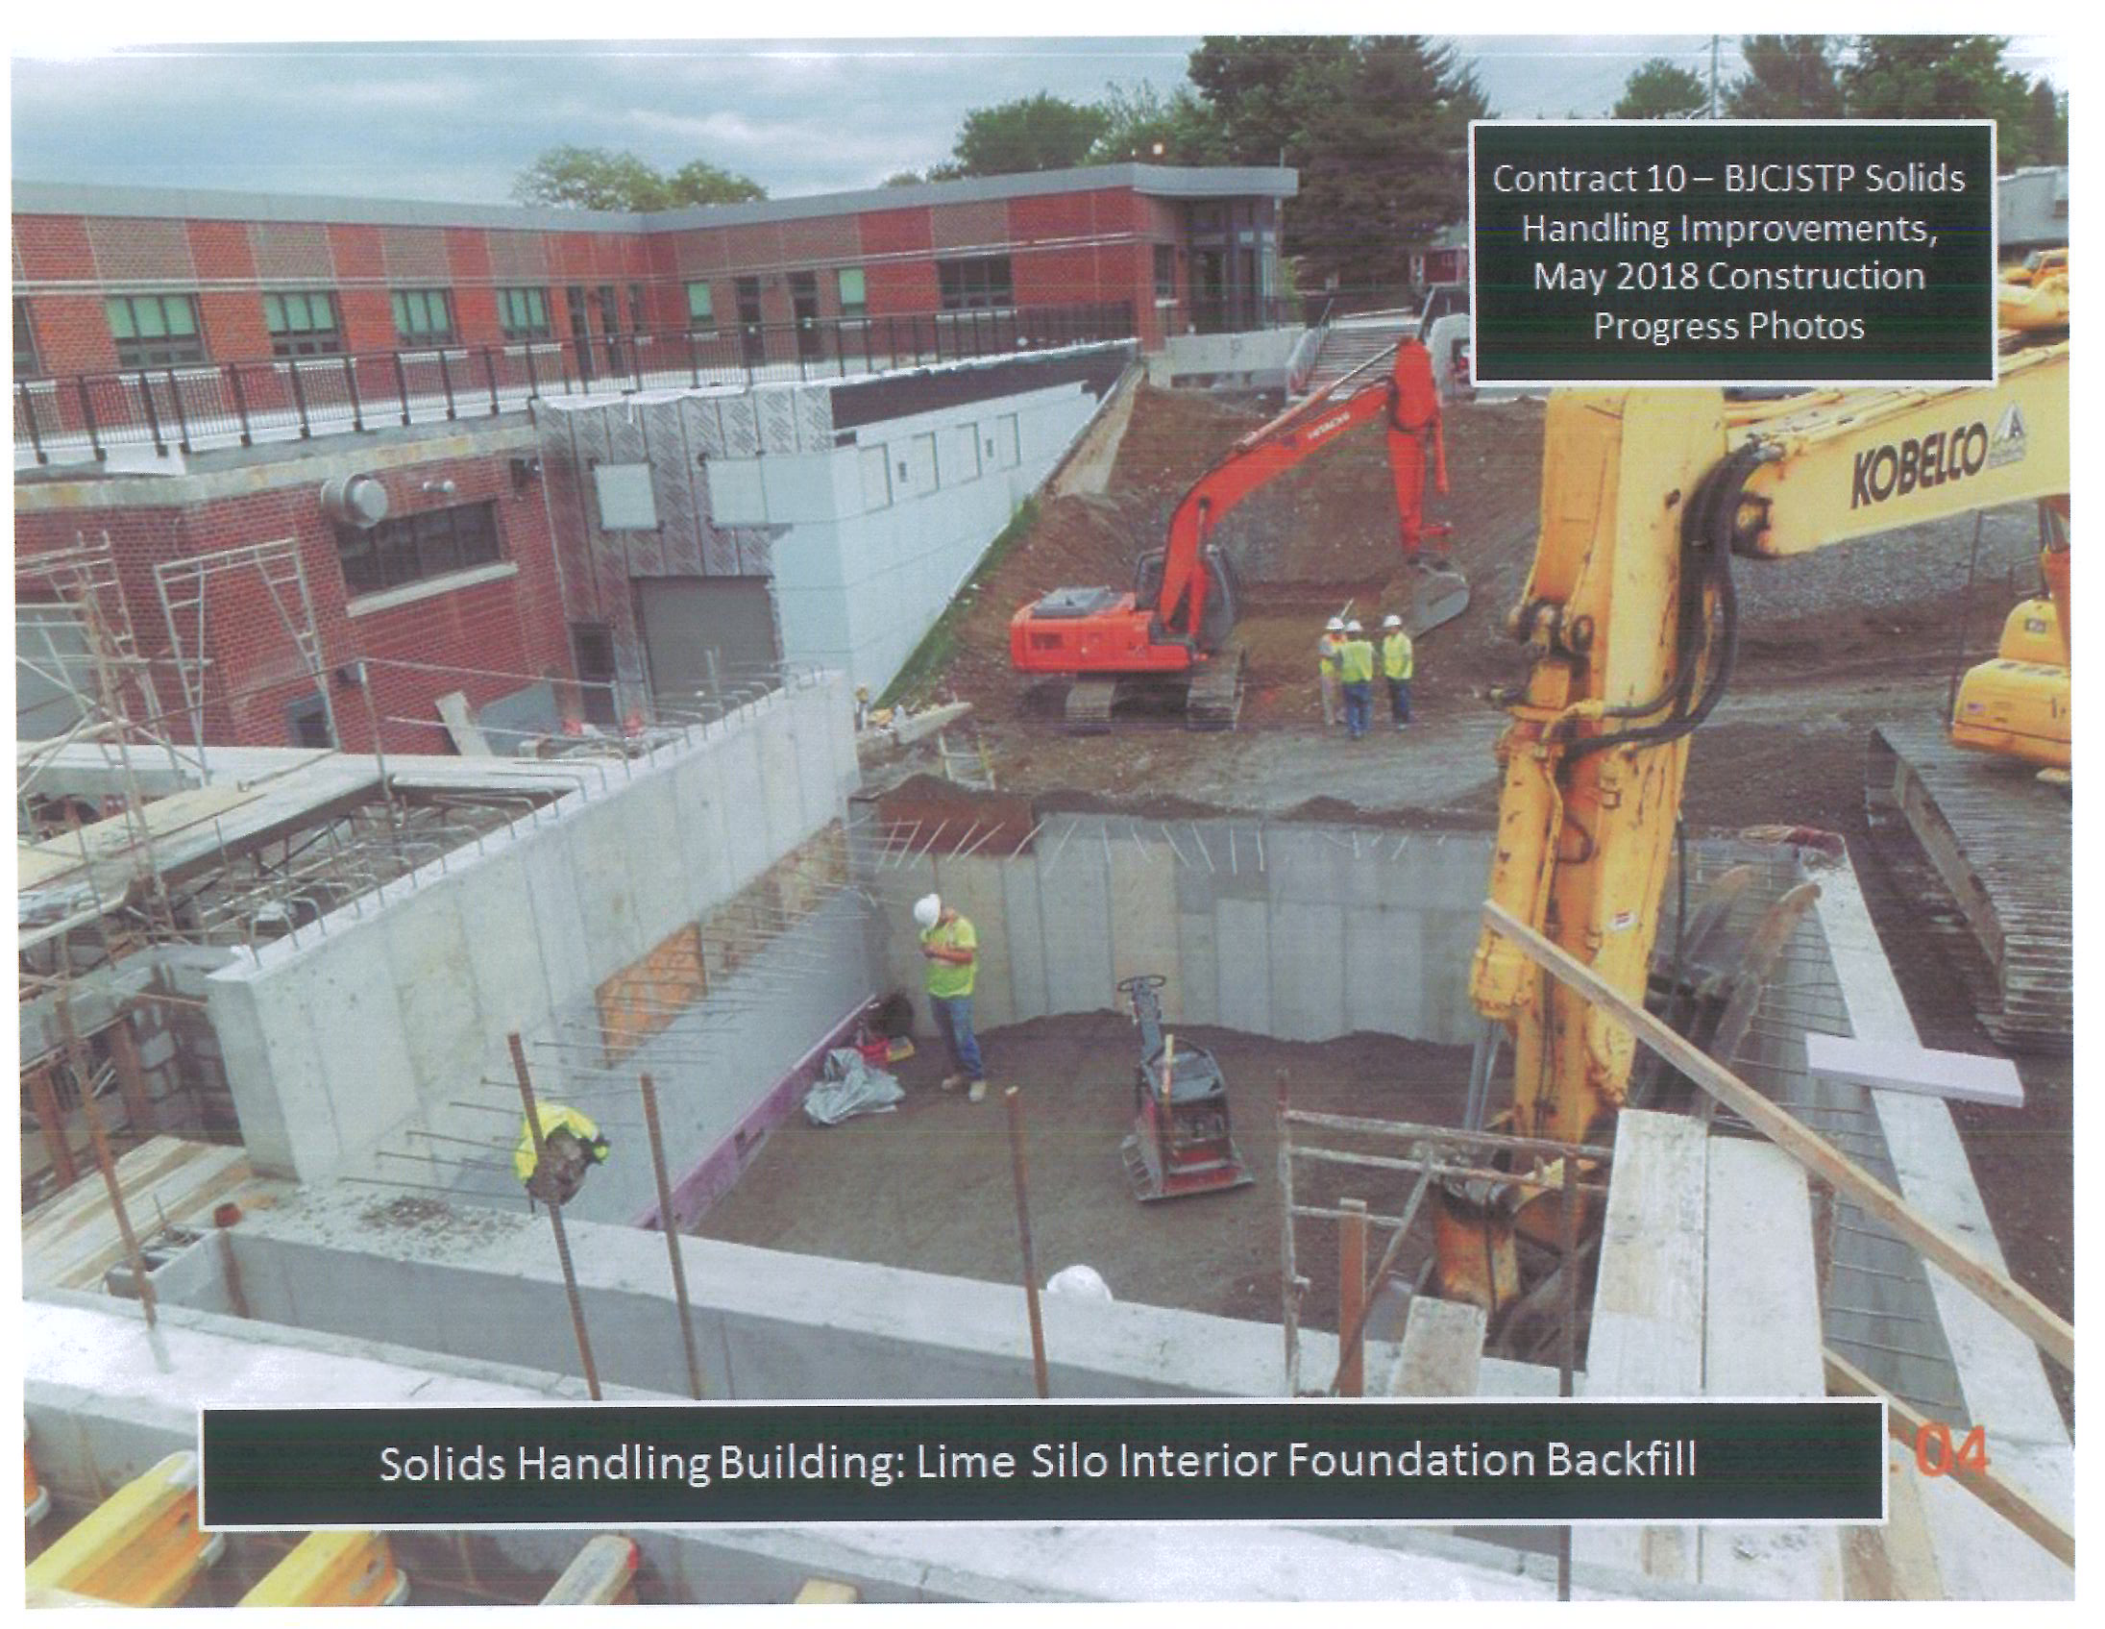
Contract 10 – BJCJSTP Solids  
Handling Improvements,  
May 2018 Construction  
Progress Photos

Solids Handling Building: Lime Silo Interior Foundation Backfill
