## March 2018 Monthly Report

### BJCJSTP Rehabilitation and Restoration Project

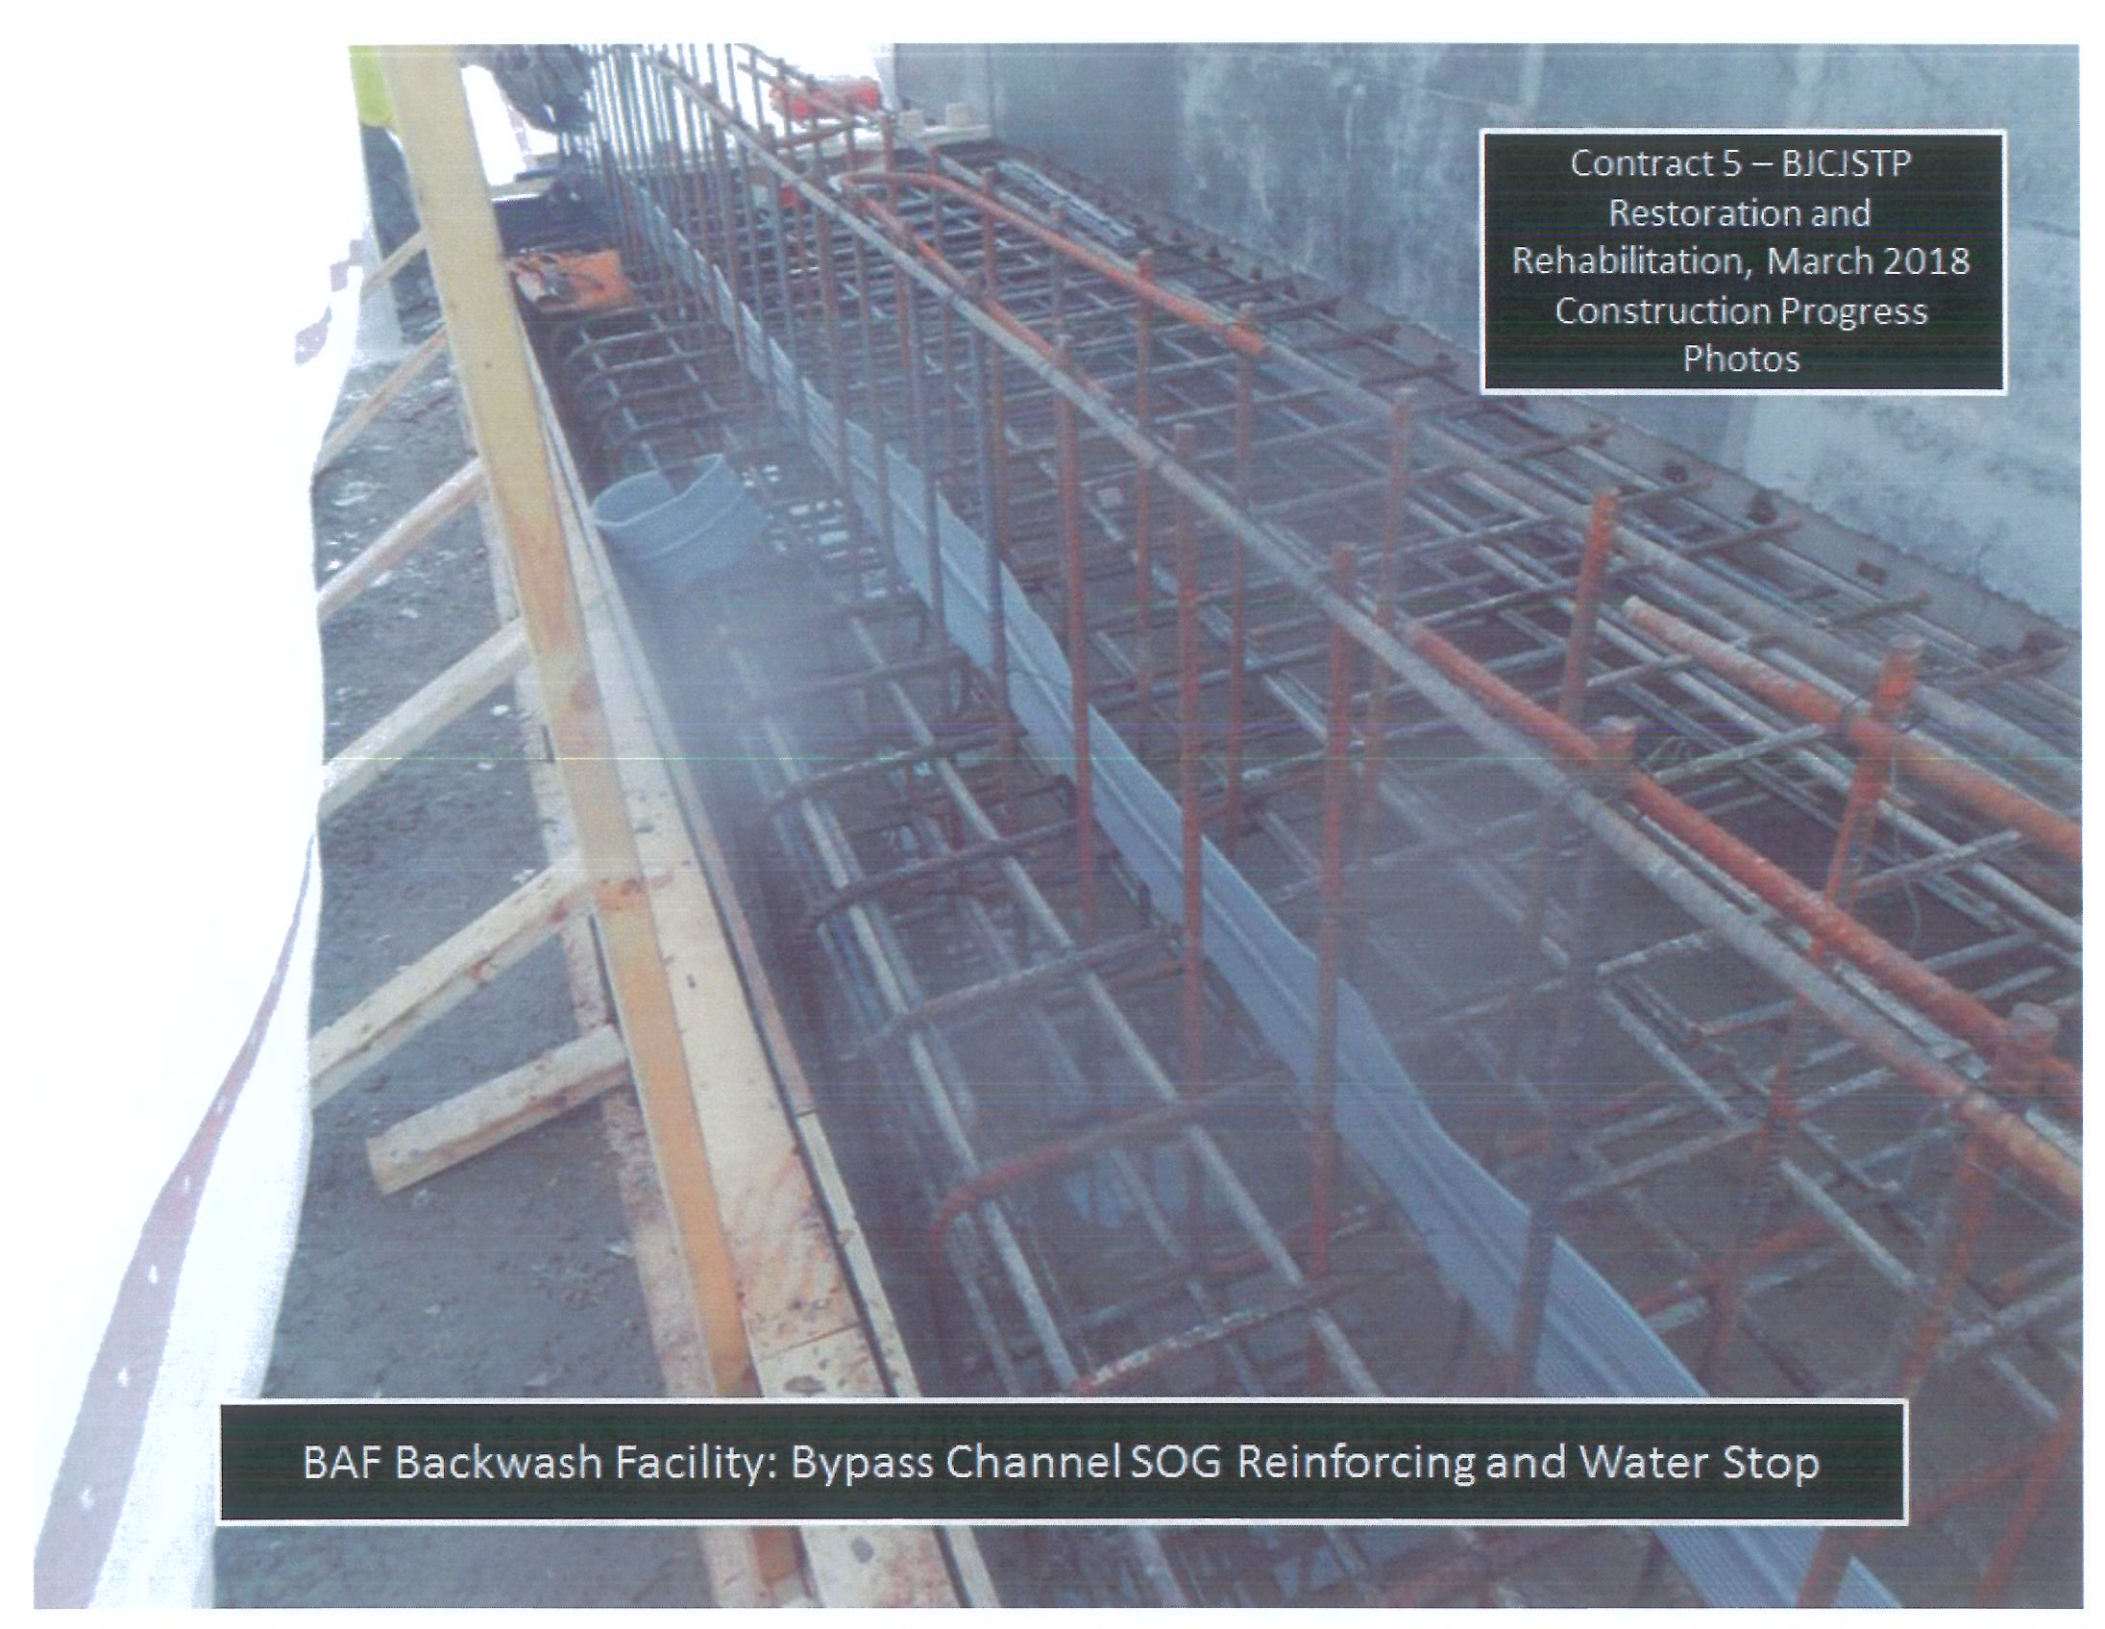
BAF Backwash Facility: Bypass Channel SOG Reinforcing and Water Stop

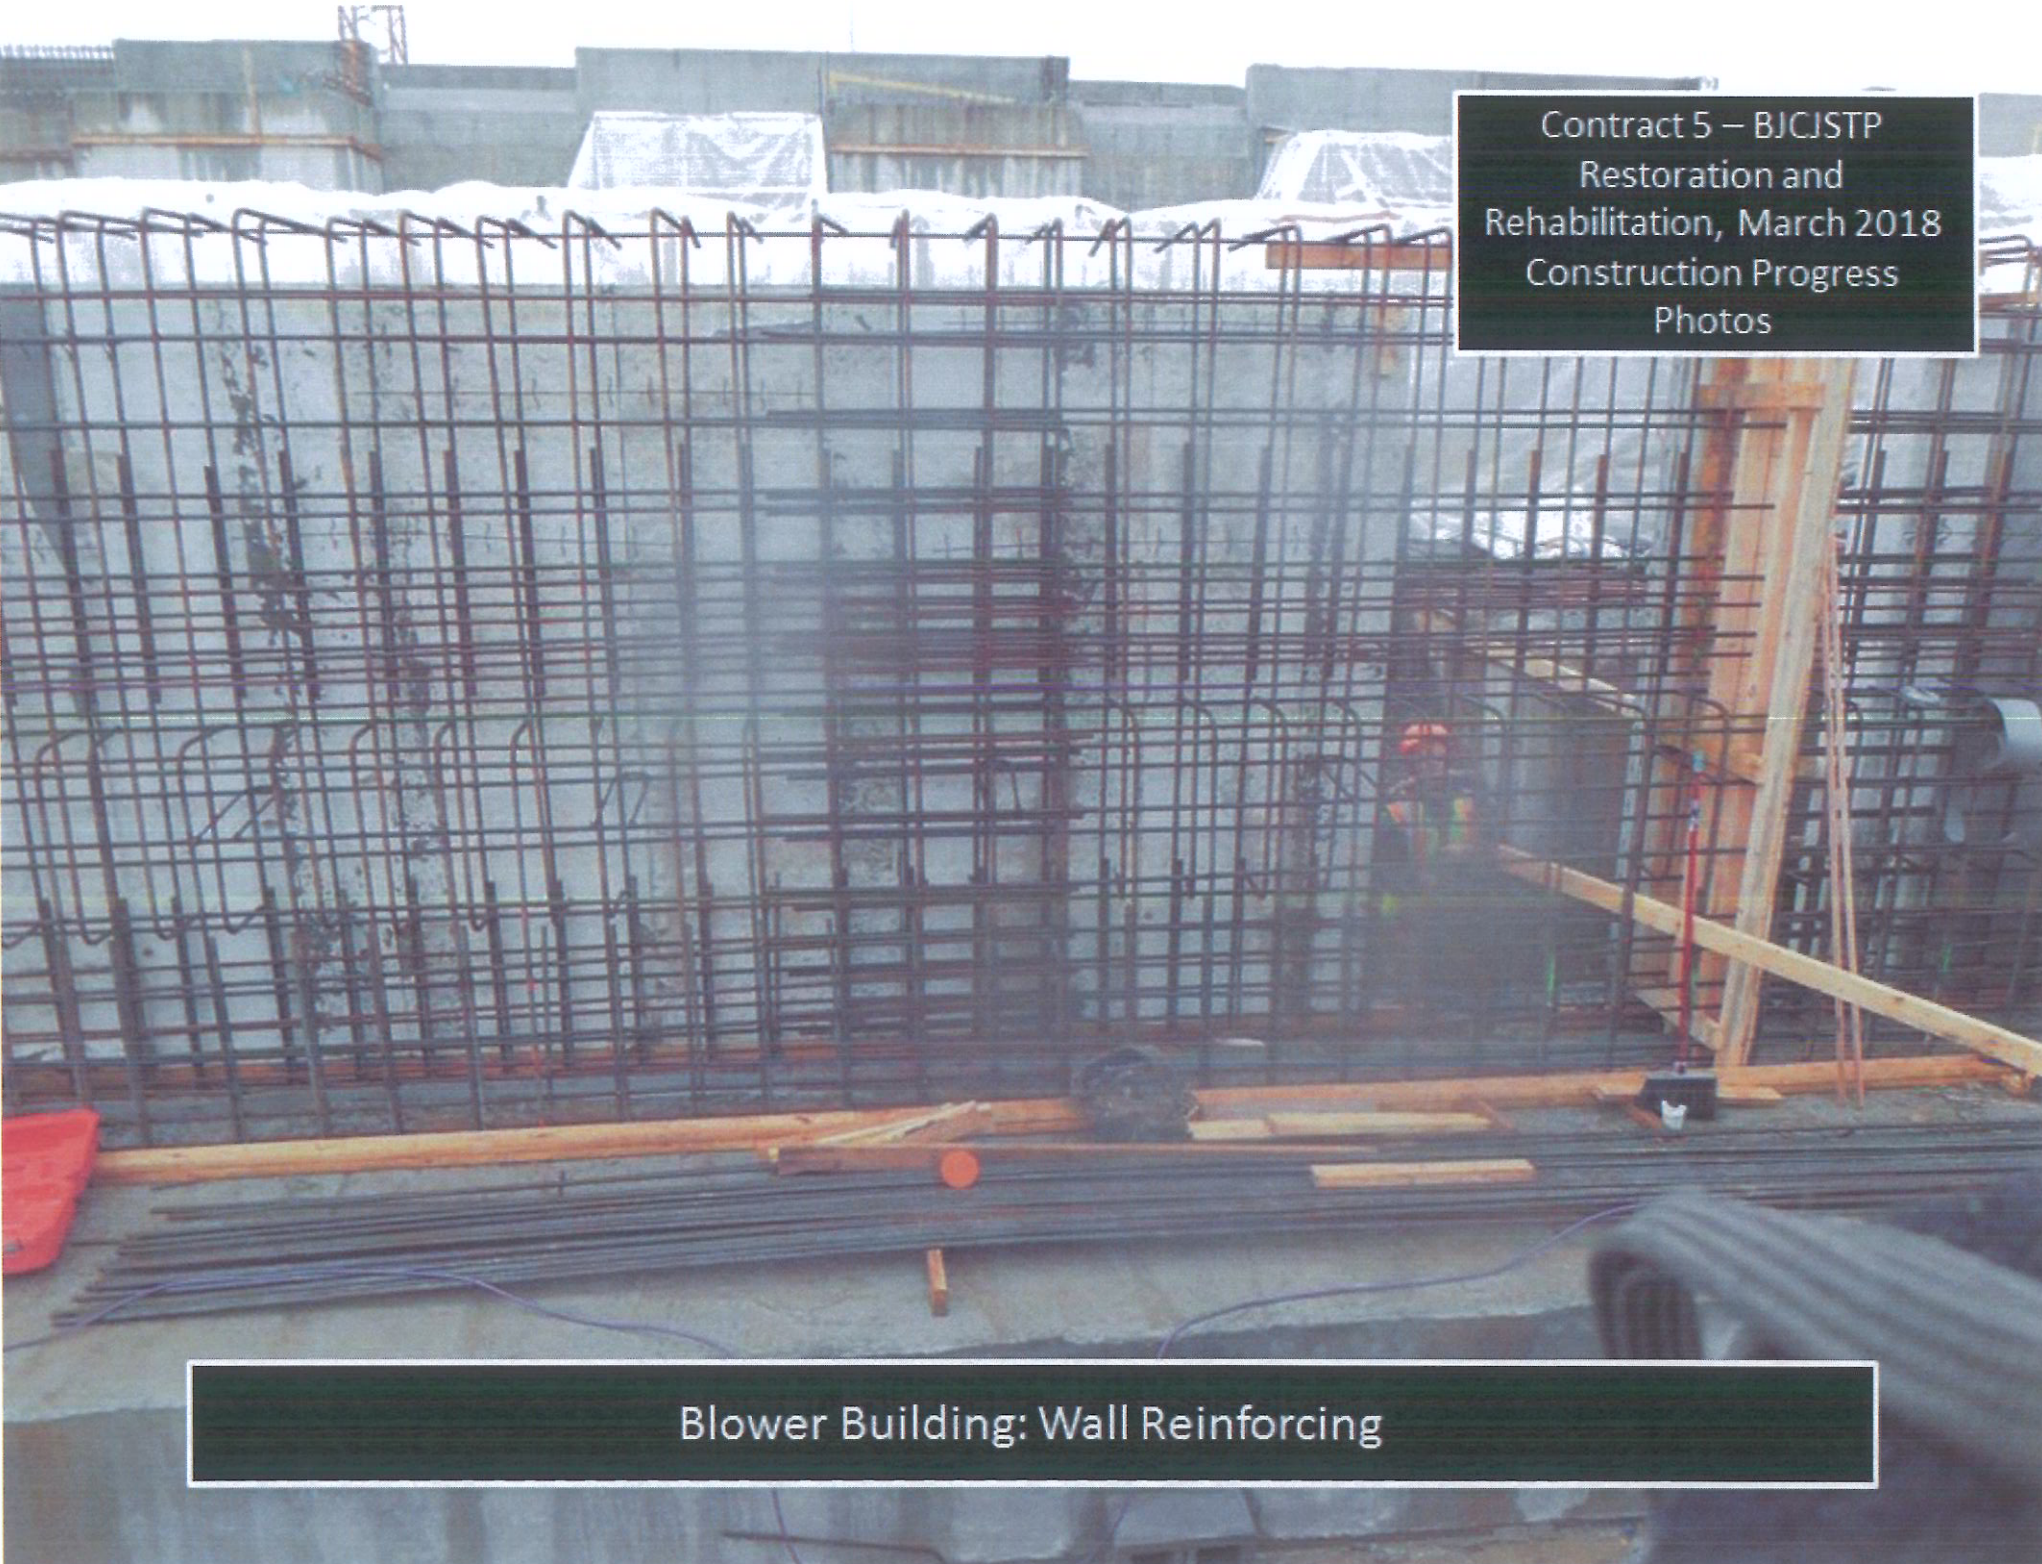
Blower Building: Wall Reinforcing

Completion of the slab for the Blower Building is essential for achieving flood protection for the plant. This work was delayed due to conditions at the site in January. Concrete work for the perimeter walls below the slab for the building was completed this month. Concrete work for the interior beams and slab will be completed in the middle of April.

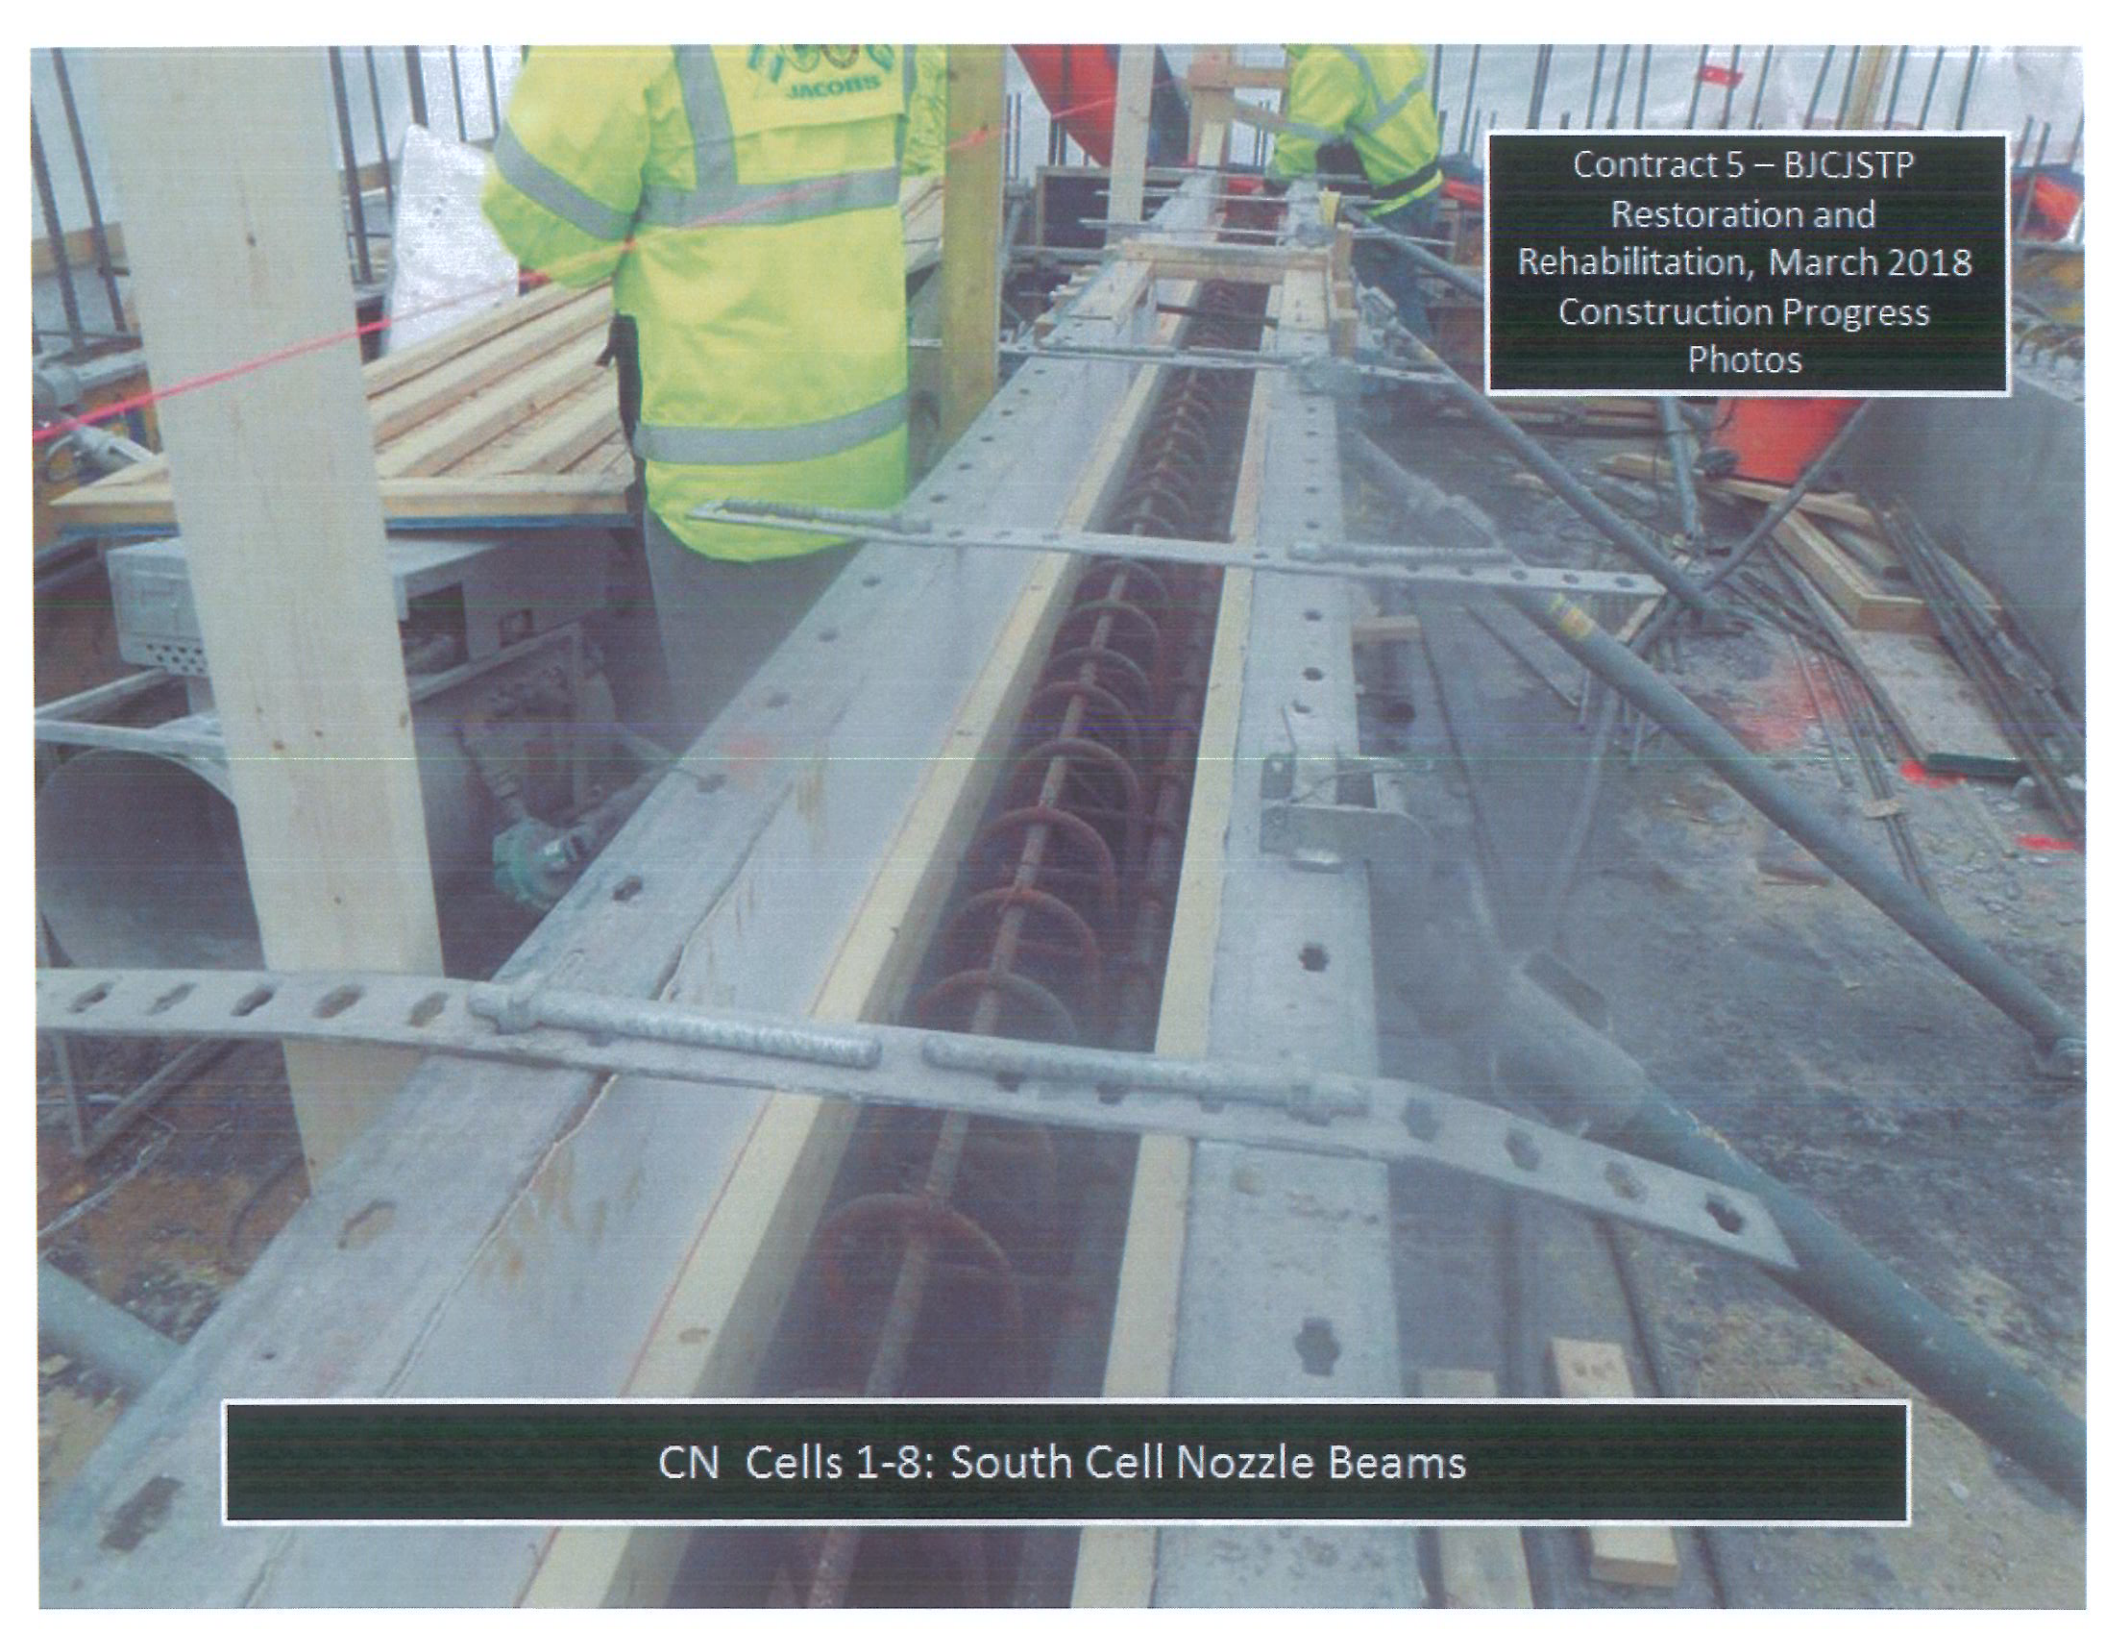
CN Cells 1-8: South Cell Nozzle Beams

Work on CN Cells 1-8 is being advanced, but the half walls on the north side of the gallery that were expected to be completed in March are still not done. CN Cells 9-14 walls are also being advanced. The concrete walls forming flood protection around the outside of the U.V. building is complete. The west wall of DN Cells is expected to be completed by the end of March. The remaining portion of the work for flood protection to elevation 838 will be at CN Cells 9-14. The cap beams and walls on the west side of CN 9-14 may be completed as early as the middle of April.

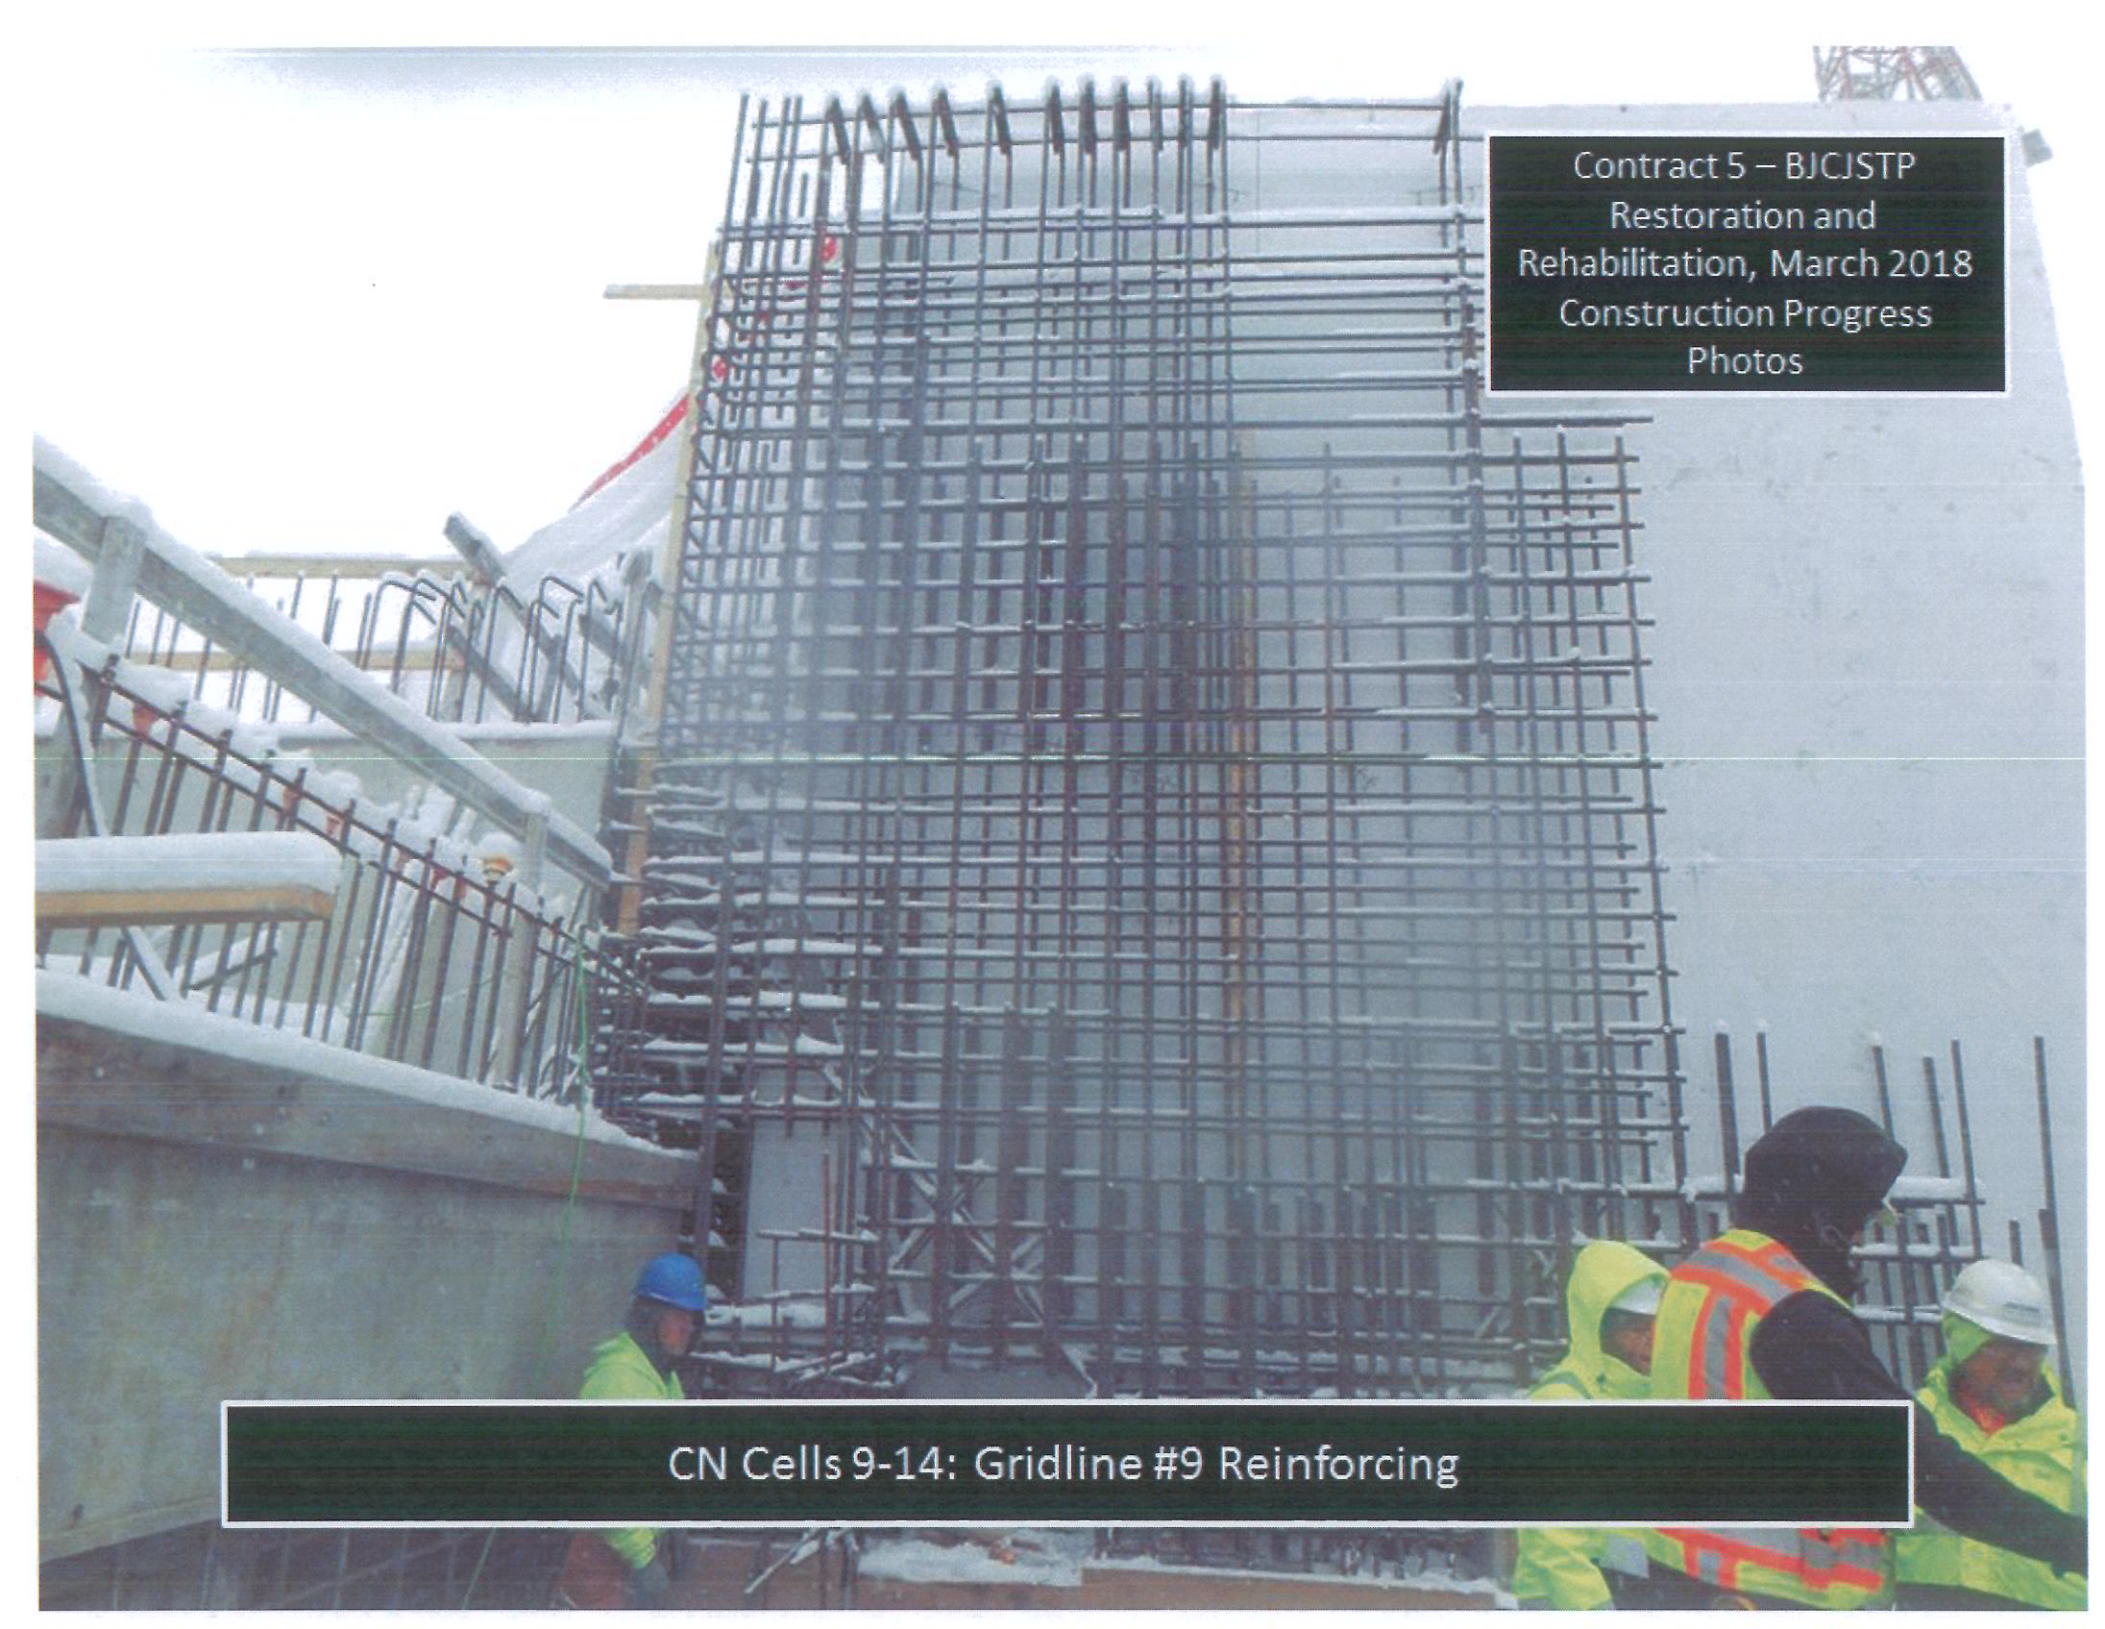
CN Cells 9-14: Gridline #9 Reinforcing

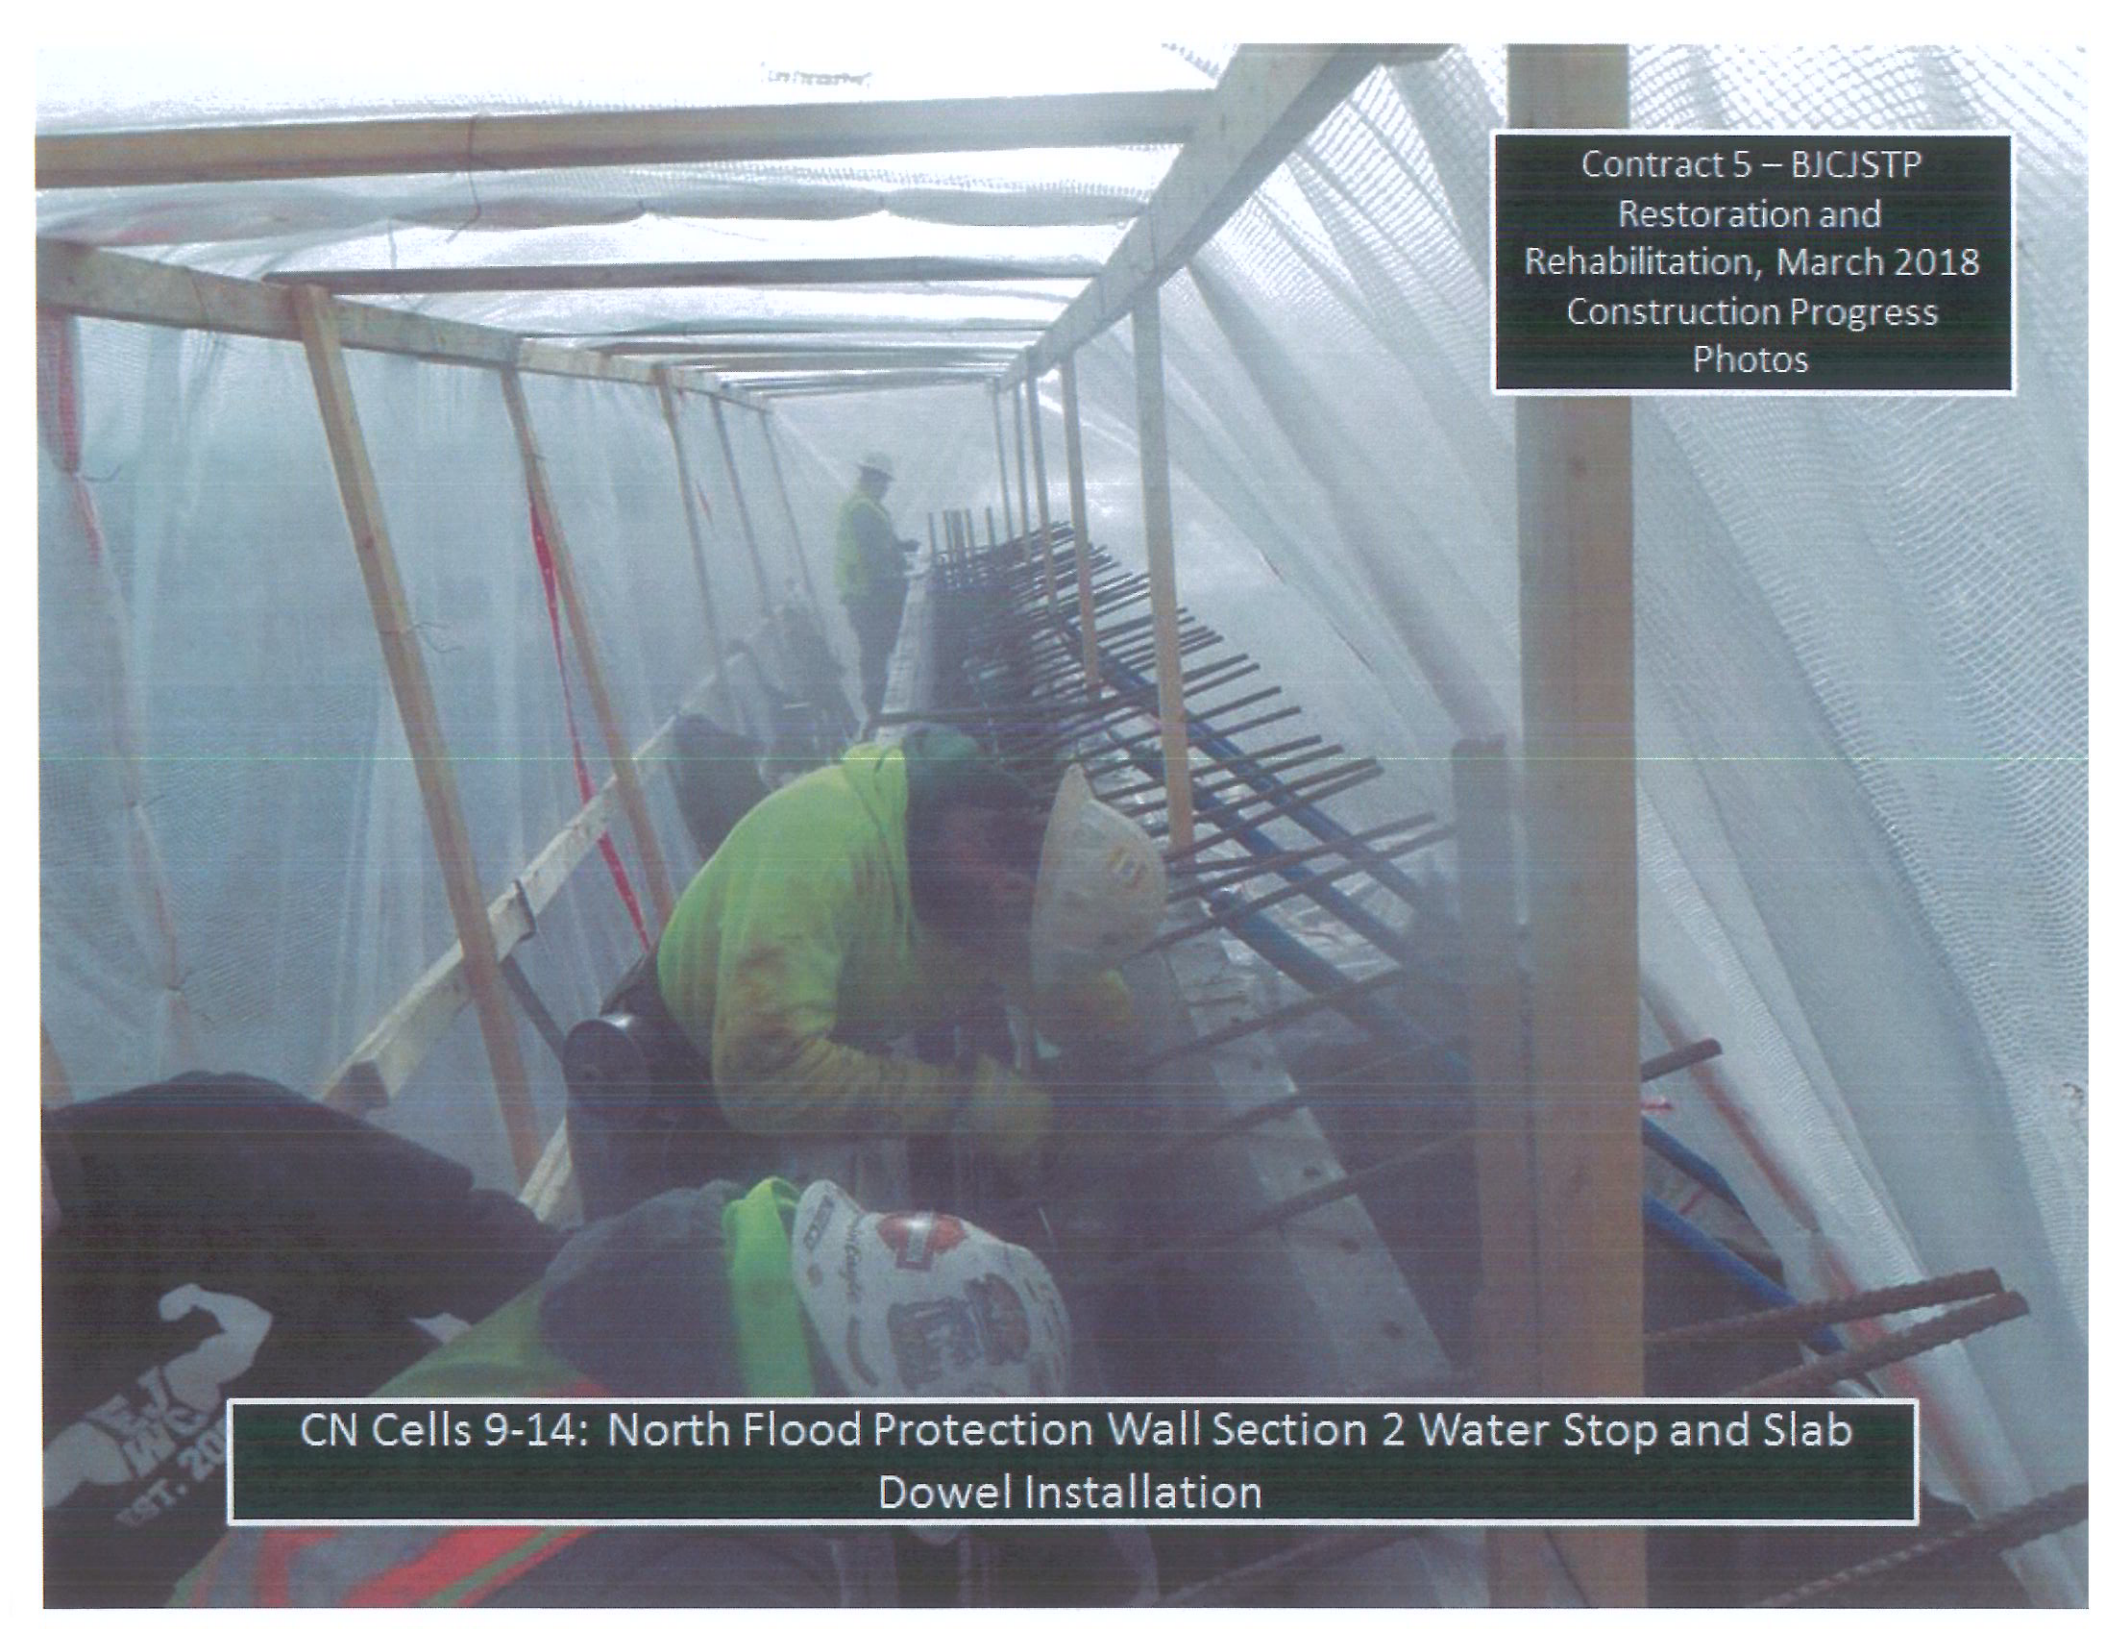
CN Cells 9-14: North Flood Protection Wall Section 2 Water Stop and Slab  
Dowel Installation

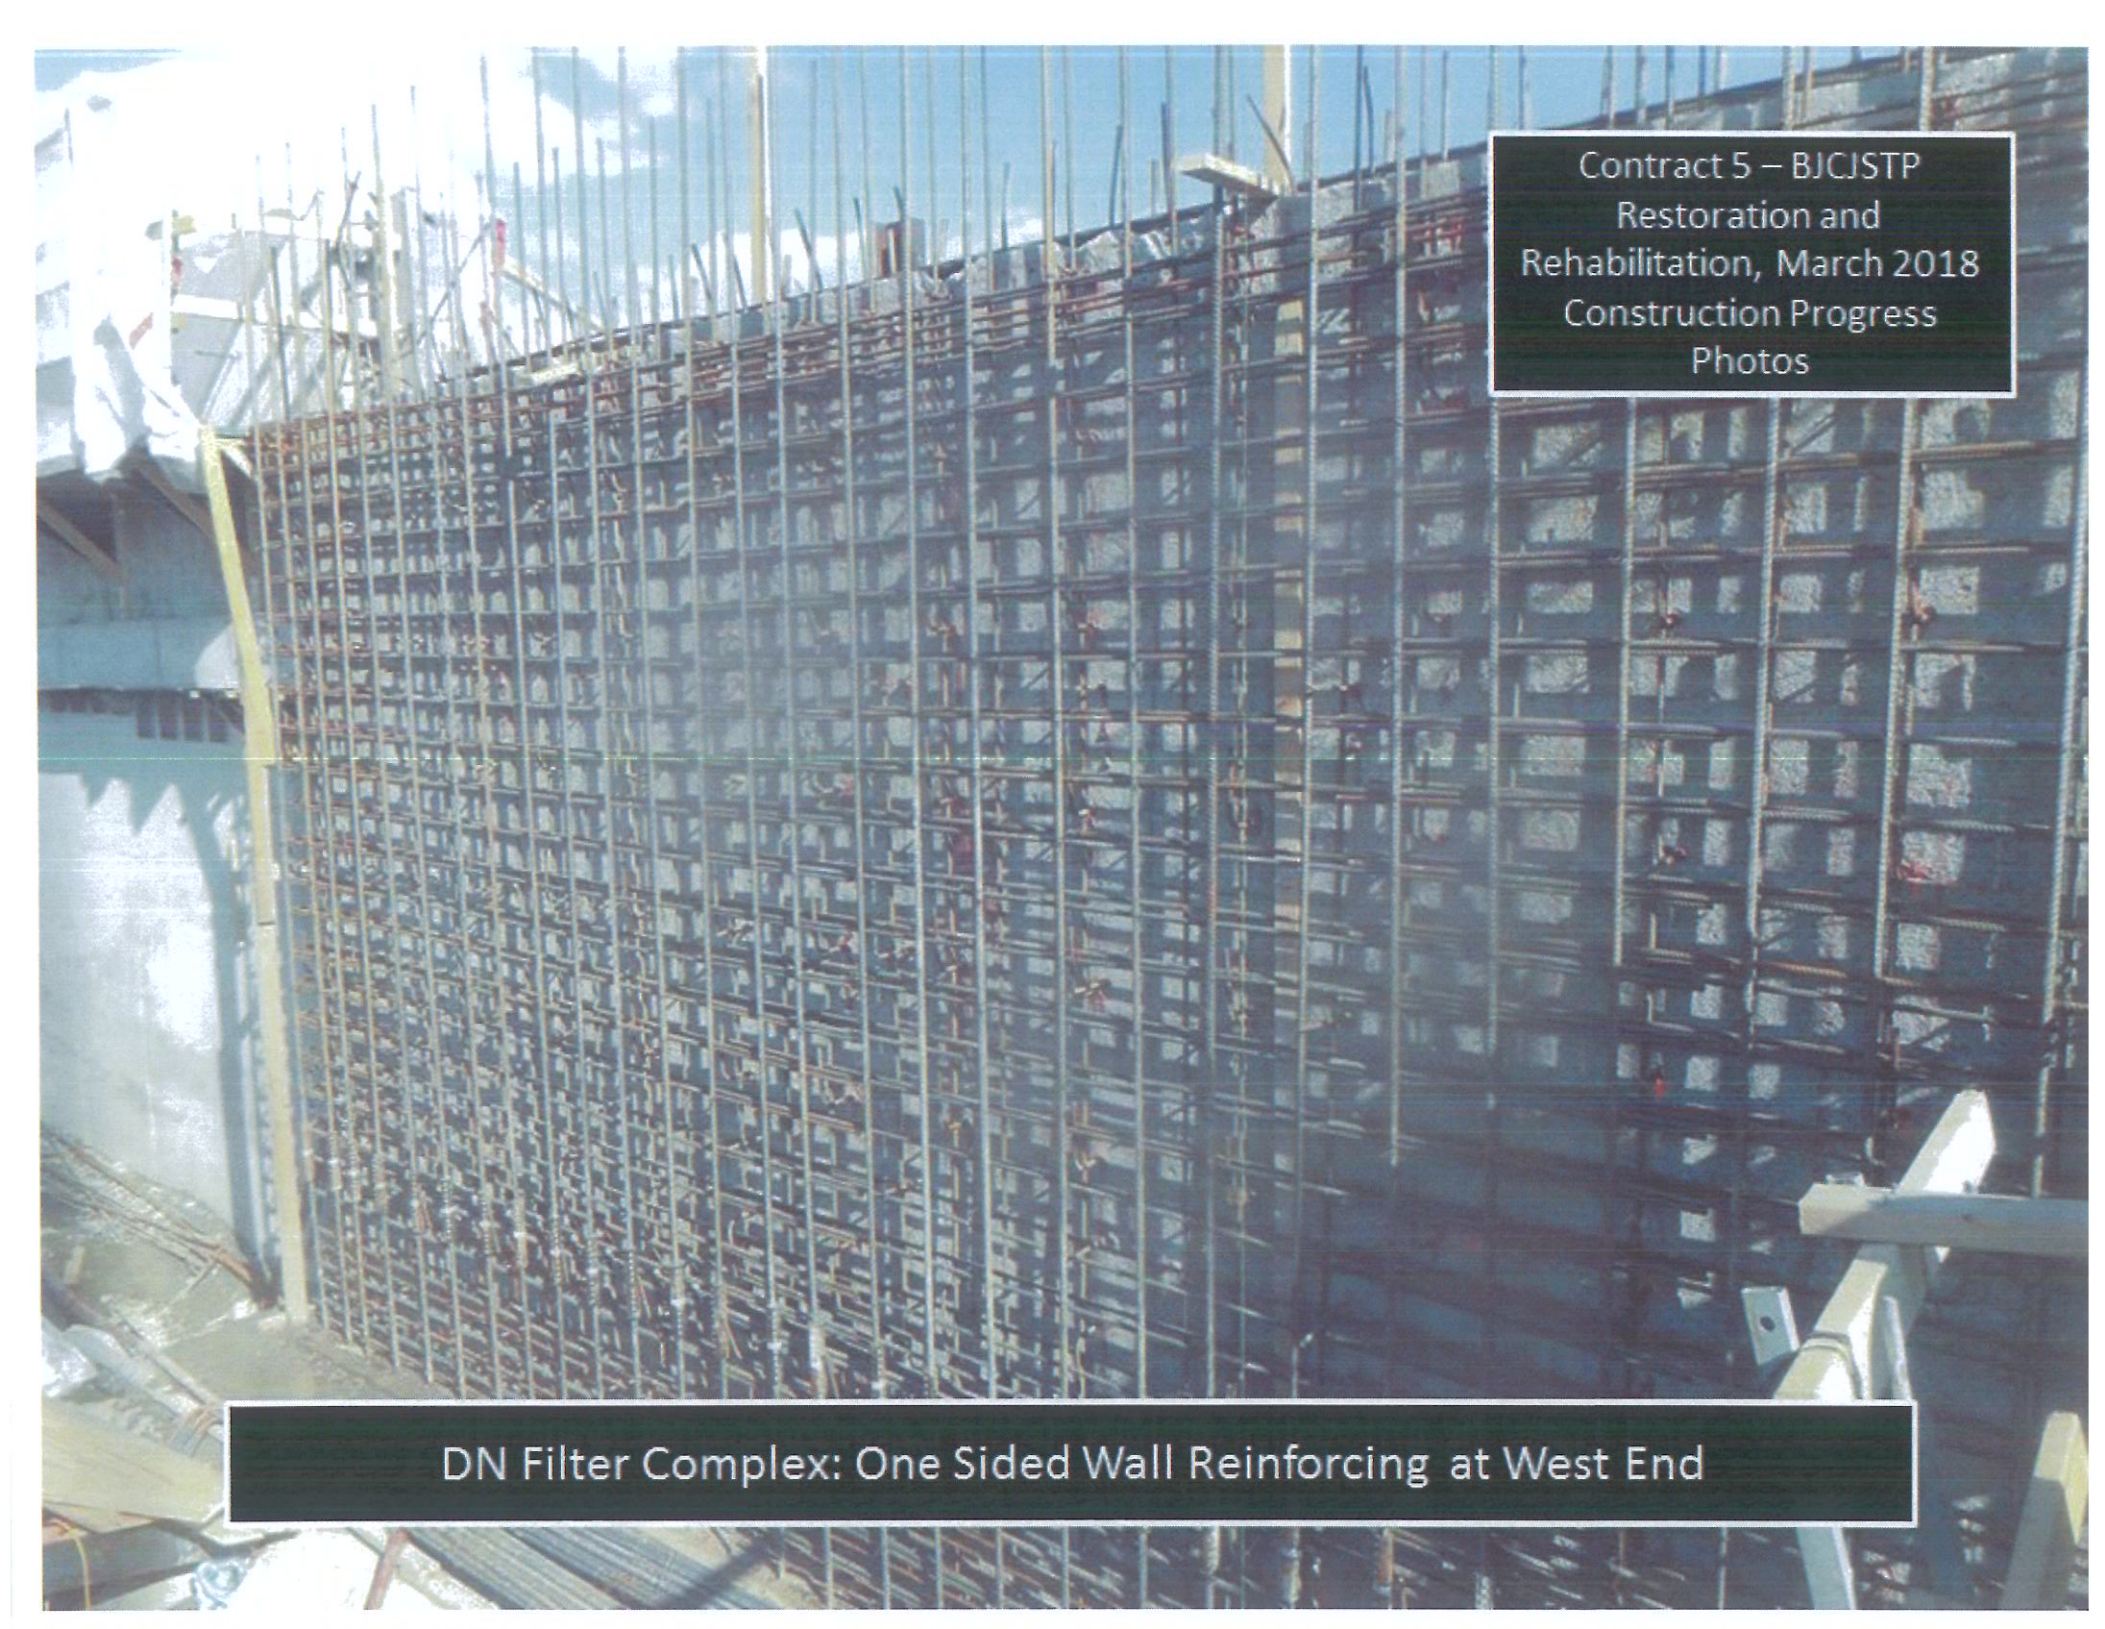
DN Filter Complex: One Sided Wall Reinforcing at West End
