## March 2018 Monthly Report

### BJCJSTP Rehabilitation and Restoration Project

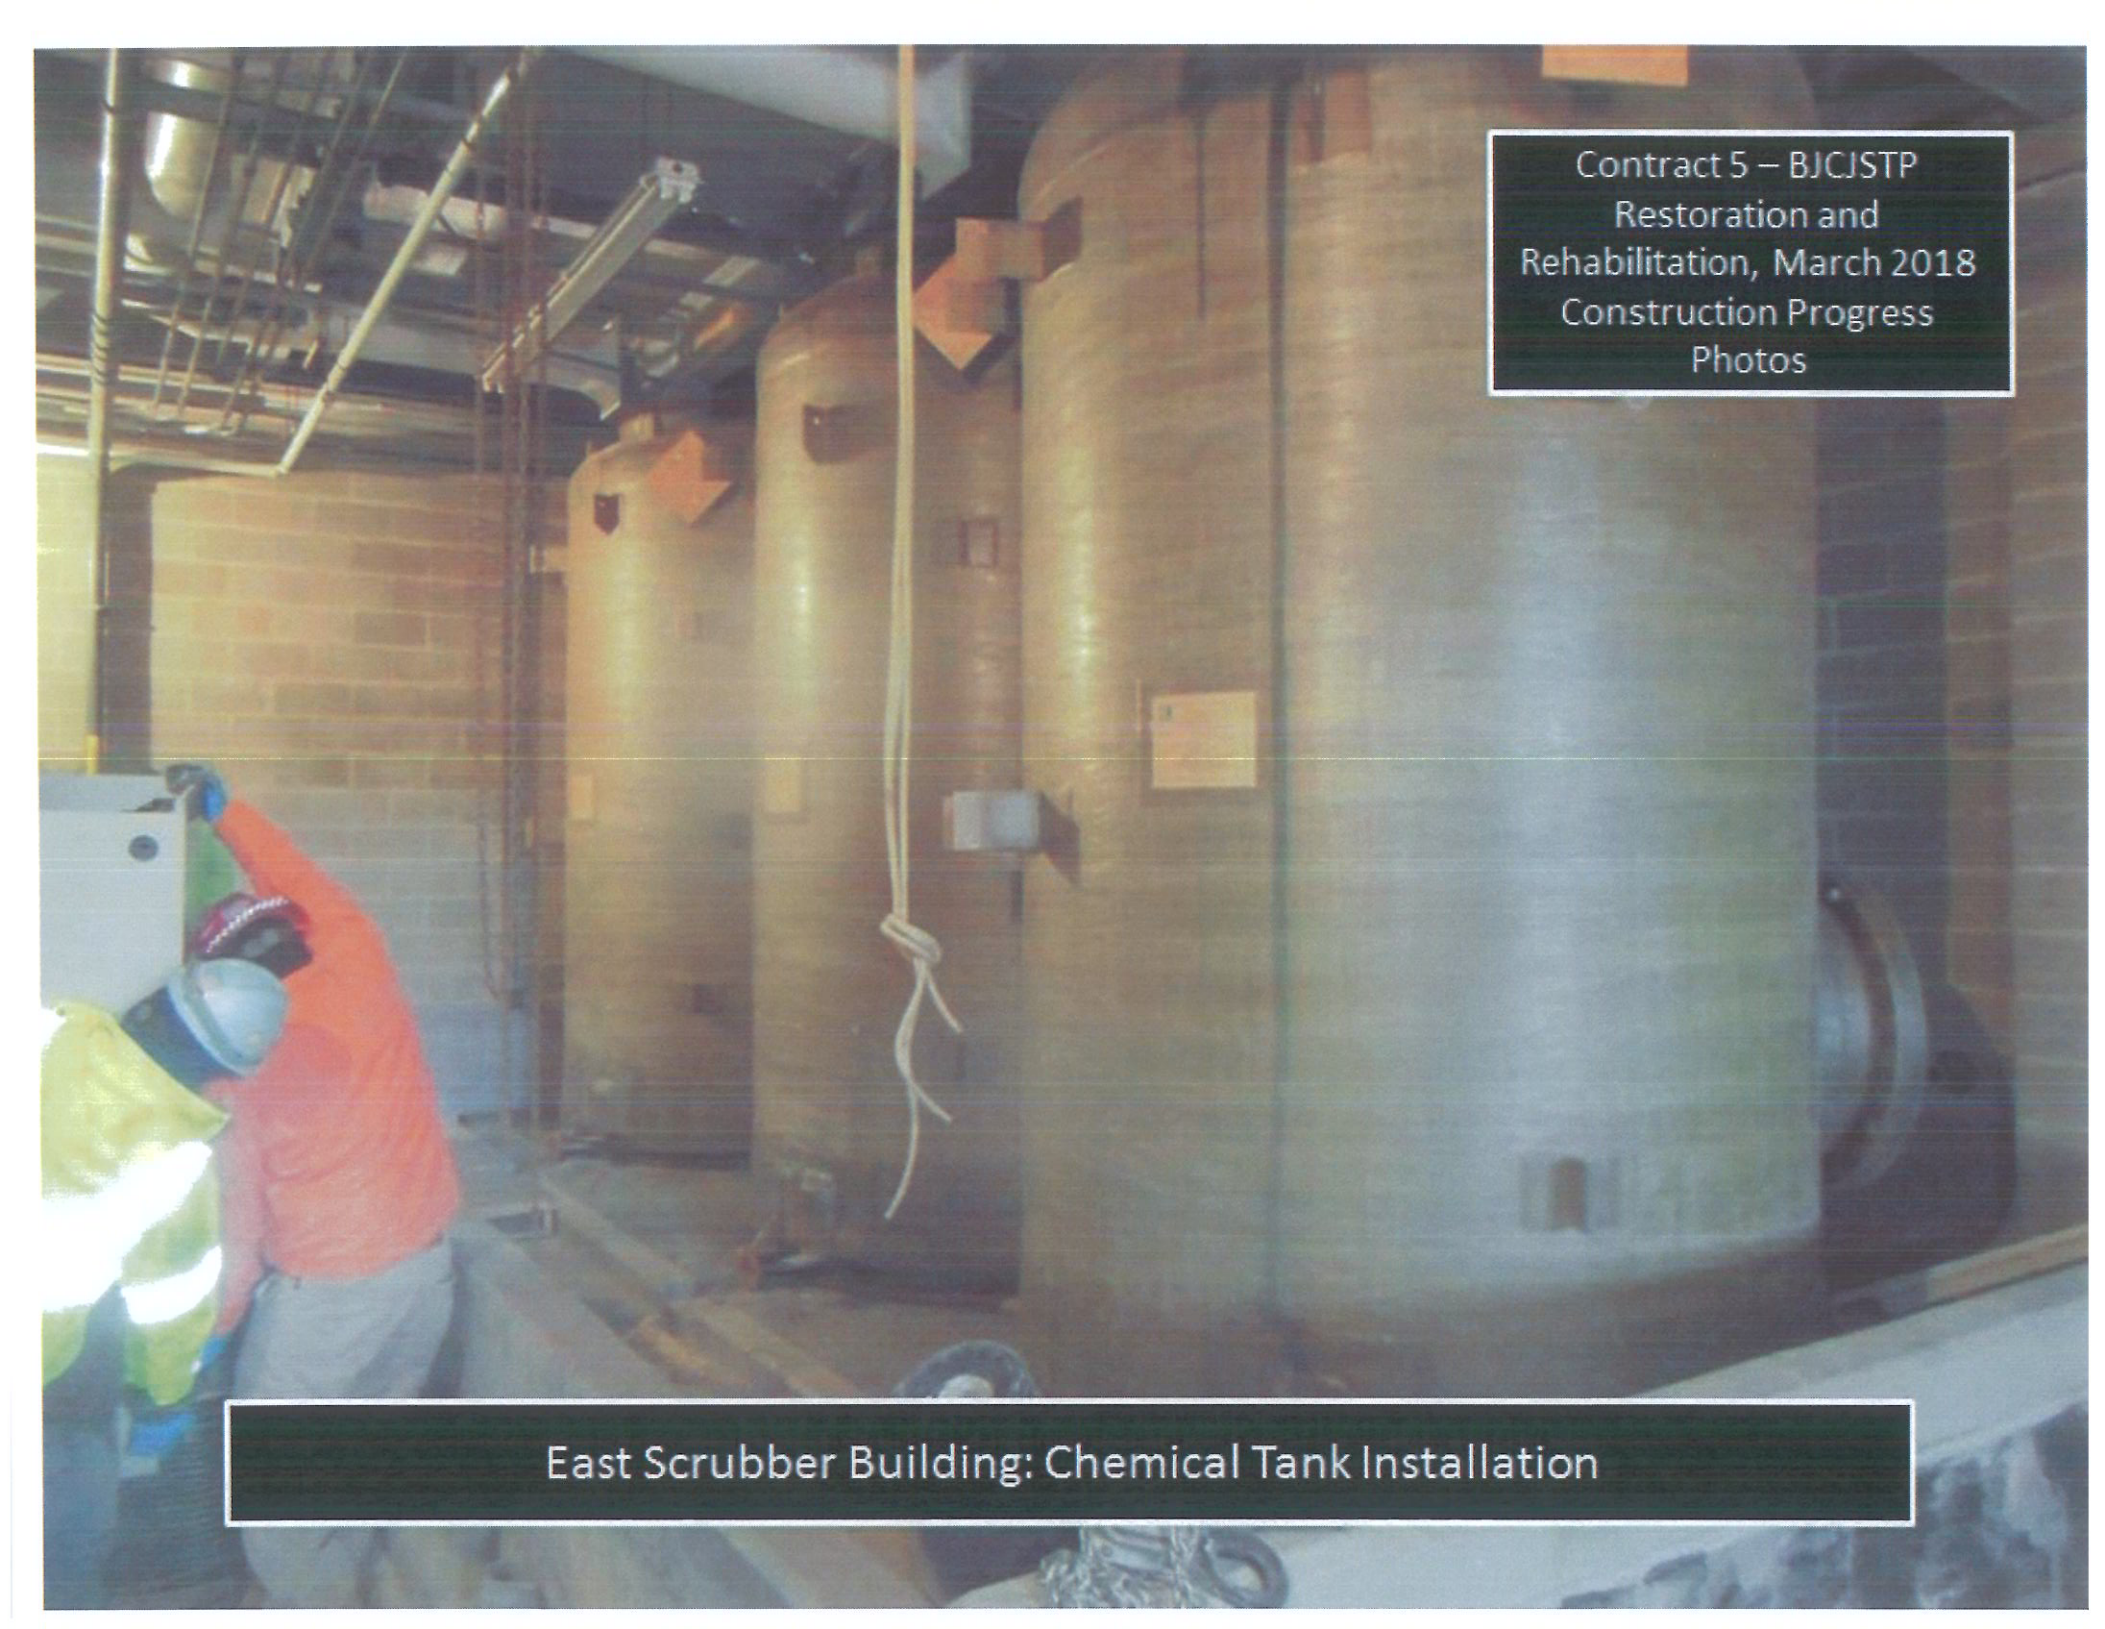
East Scrubber Building: Chemical Tank Installation

Construction of the new Chemical Building is well underway. The coatings for the concrete walls are complete. The tanks and equipment are set, and the electricians and HVAC crews are proceeding with their work in the building.

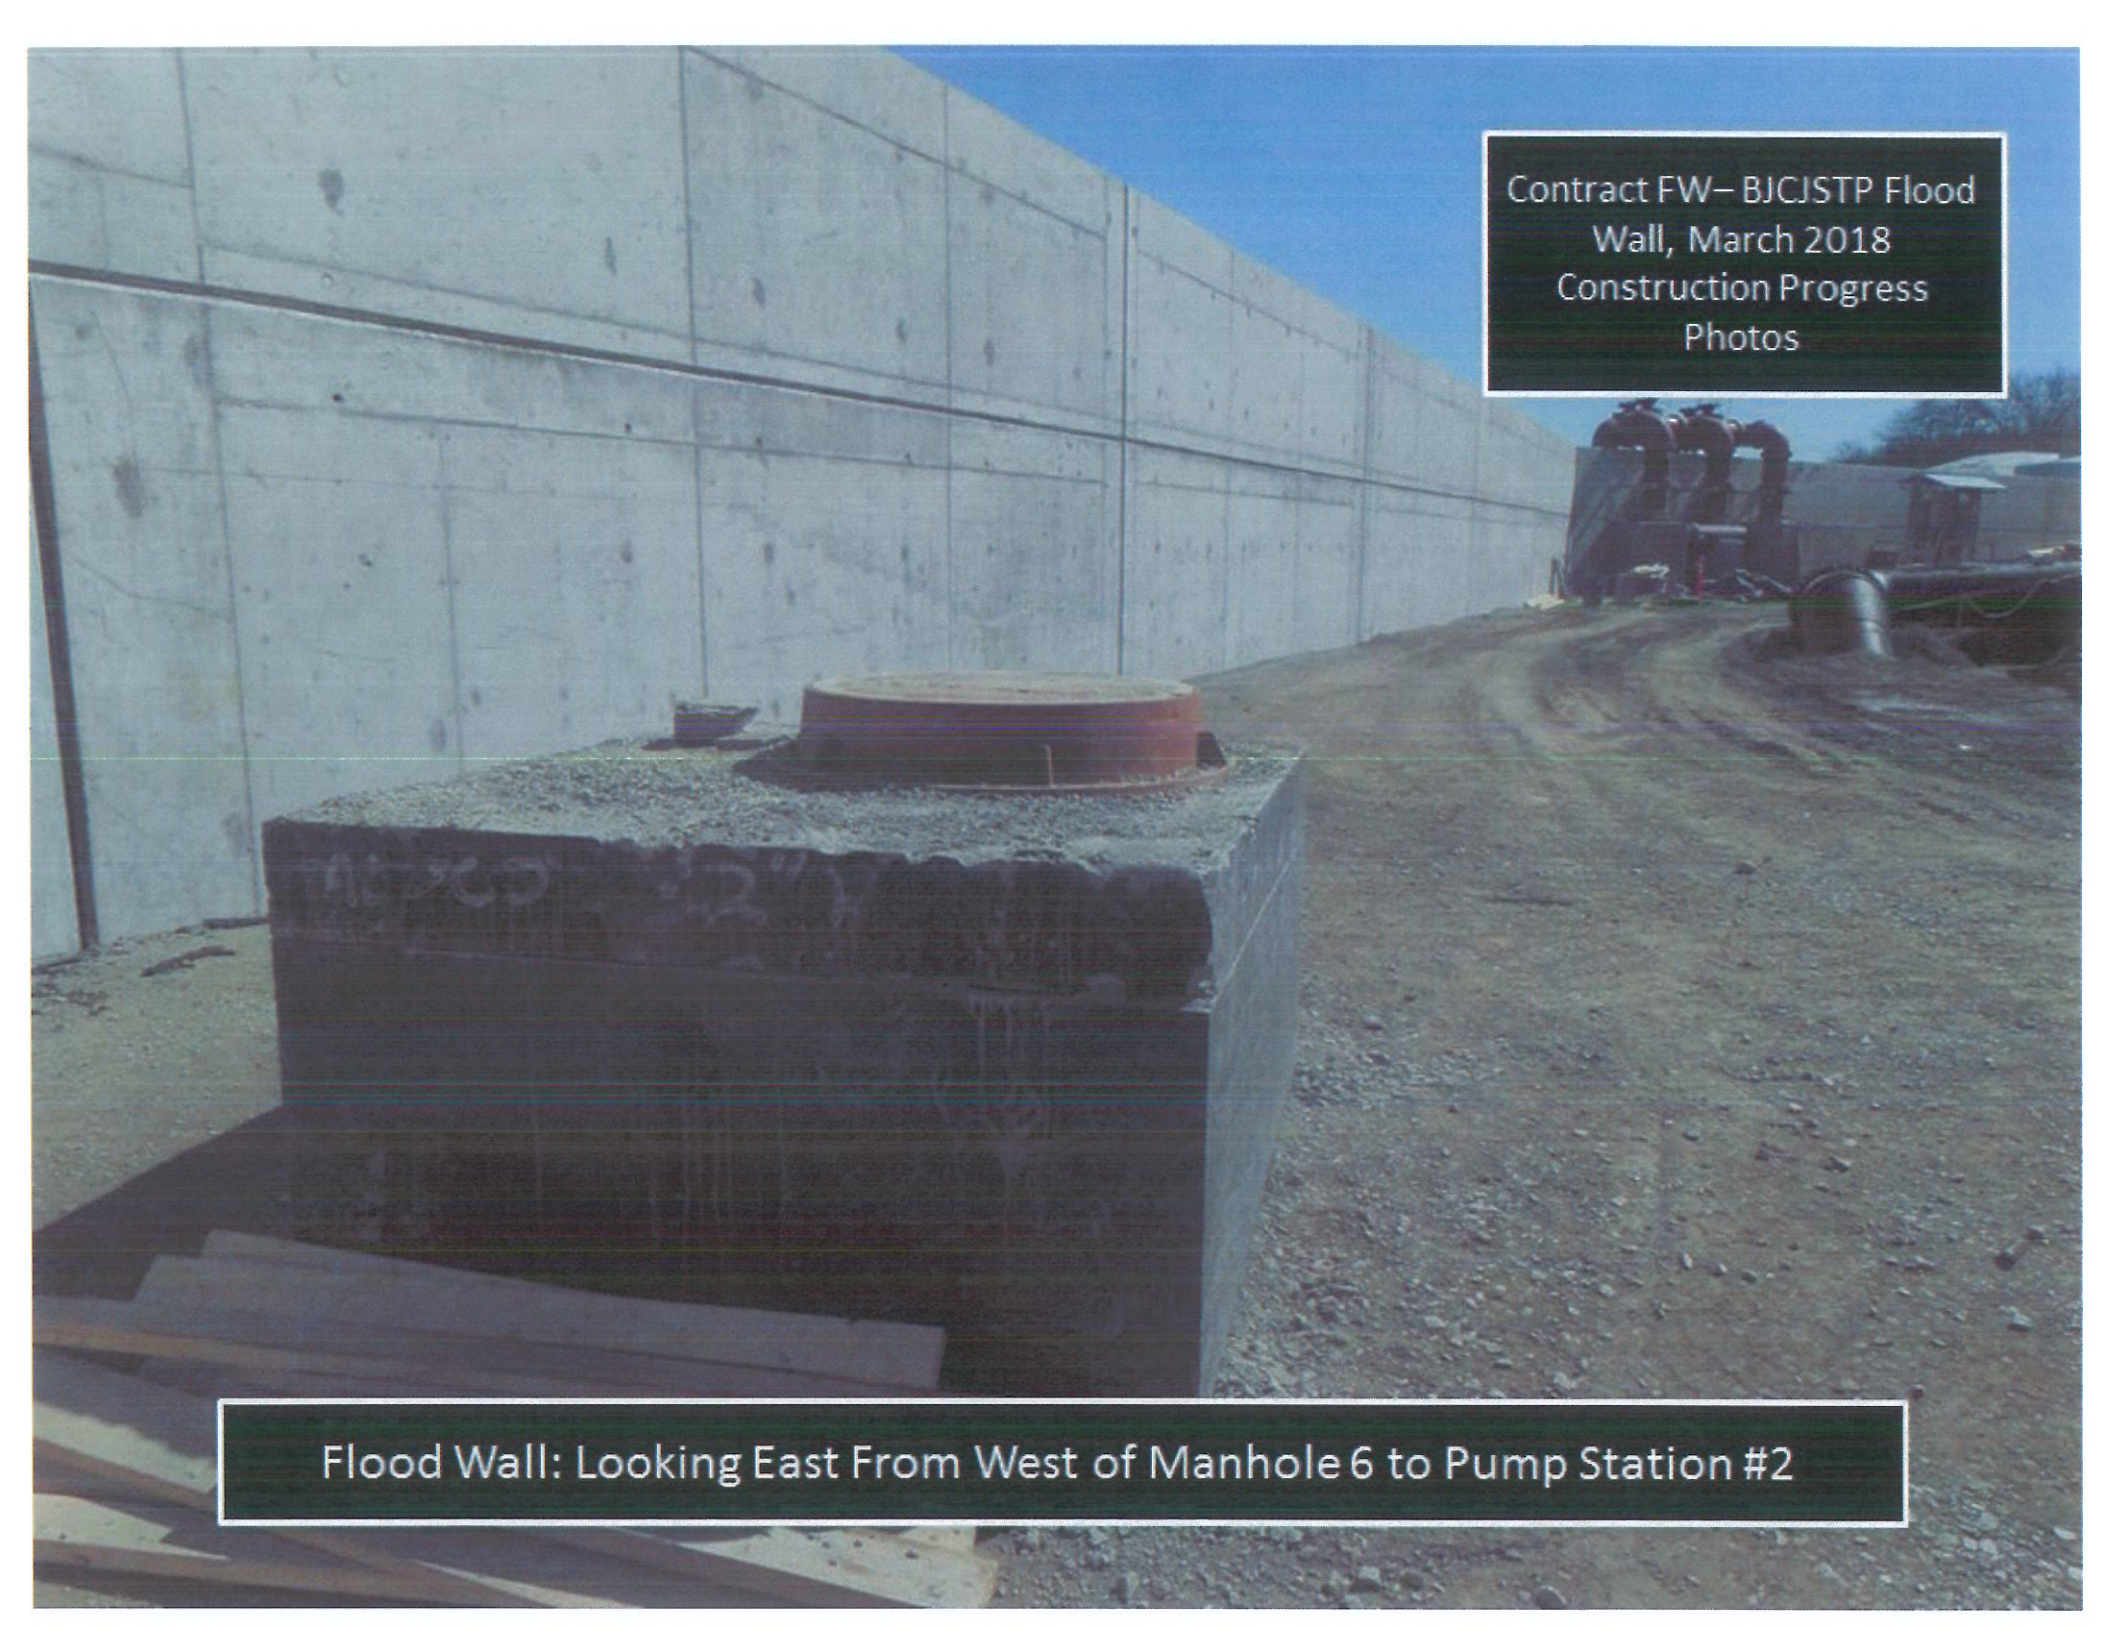
Flood Wall: Looking East From West of Manhole 6 to Pump Station #2

**Status:** The concrete floodwall under Streeter's contract has been completed. The concrete work for Pump Stations No. 1 and 2 are complete. The contractor has continued installing the pump and pipework for the two pump stations. The concrete base has been completed and the precast concrete riser pieces are installed on the new MH #3. Streeter is now able to install the 54" overflow and also install the Binghamton University Line. On February 26, 2018 we were informed that not only hadn't the valves not been shipped but that they hadn't been fabricated. Delivery of the two 54" gates for the Binghamton Line have been delayed by the manufacturer. They had not begun fabrication as they indicated in December. They are now in fabrication and we will send someone to visually inspect the gates in the factory to confirm the status of the gates. This situation is presently under investigation and the impacts have not been determined.

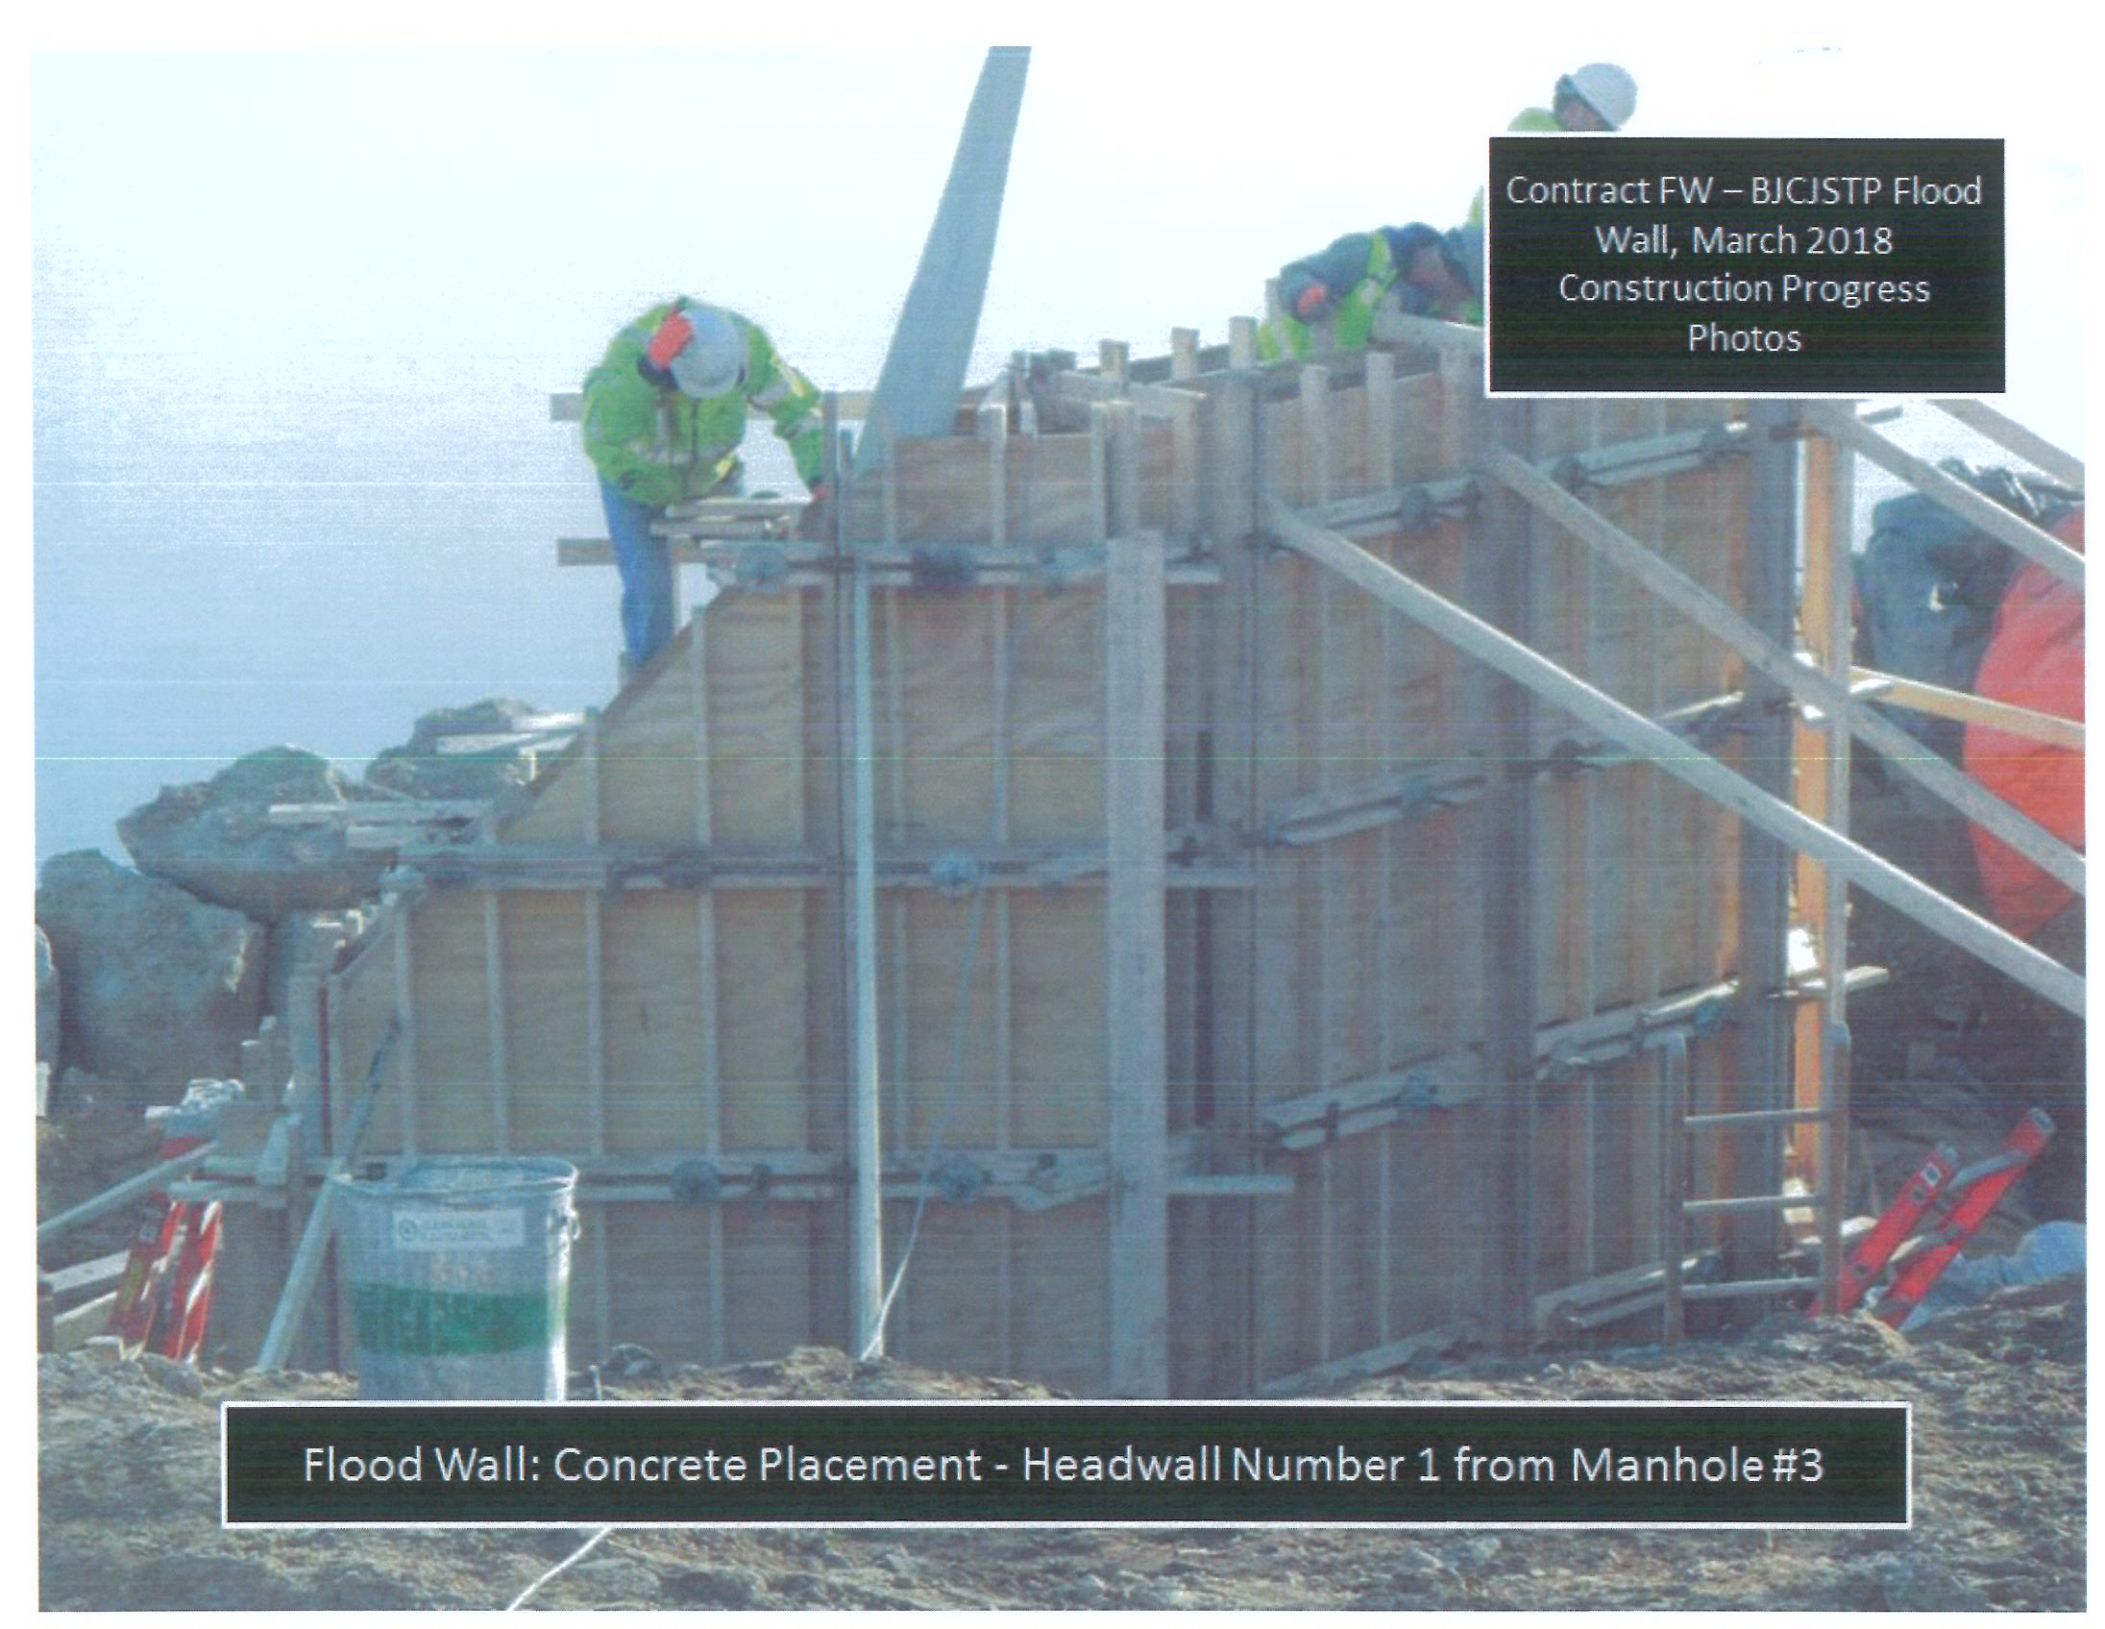
Flood Wall: Concrete Placement - Headwall Number 1 from Manhole #3

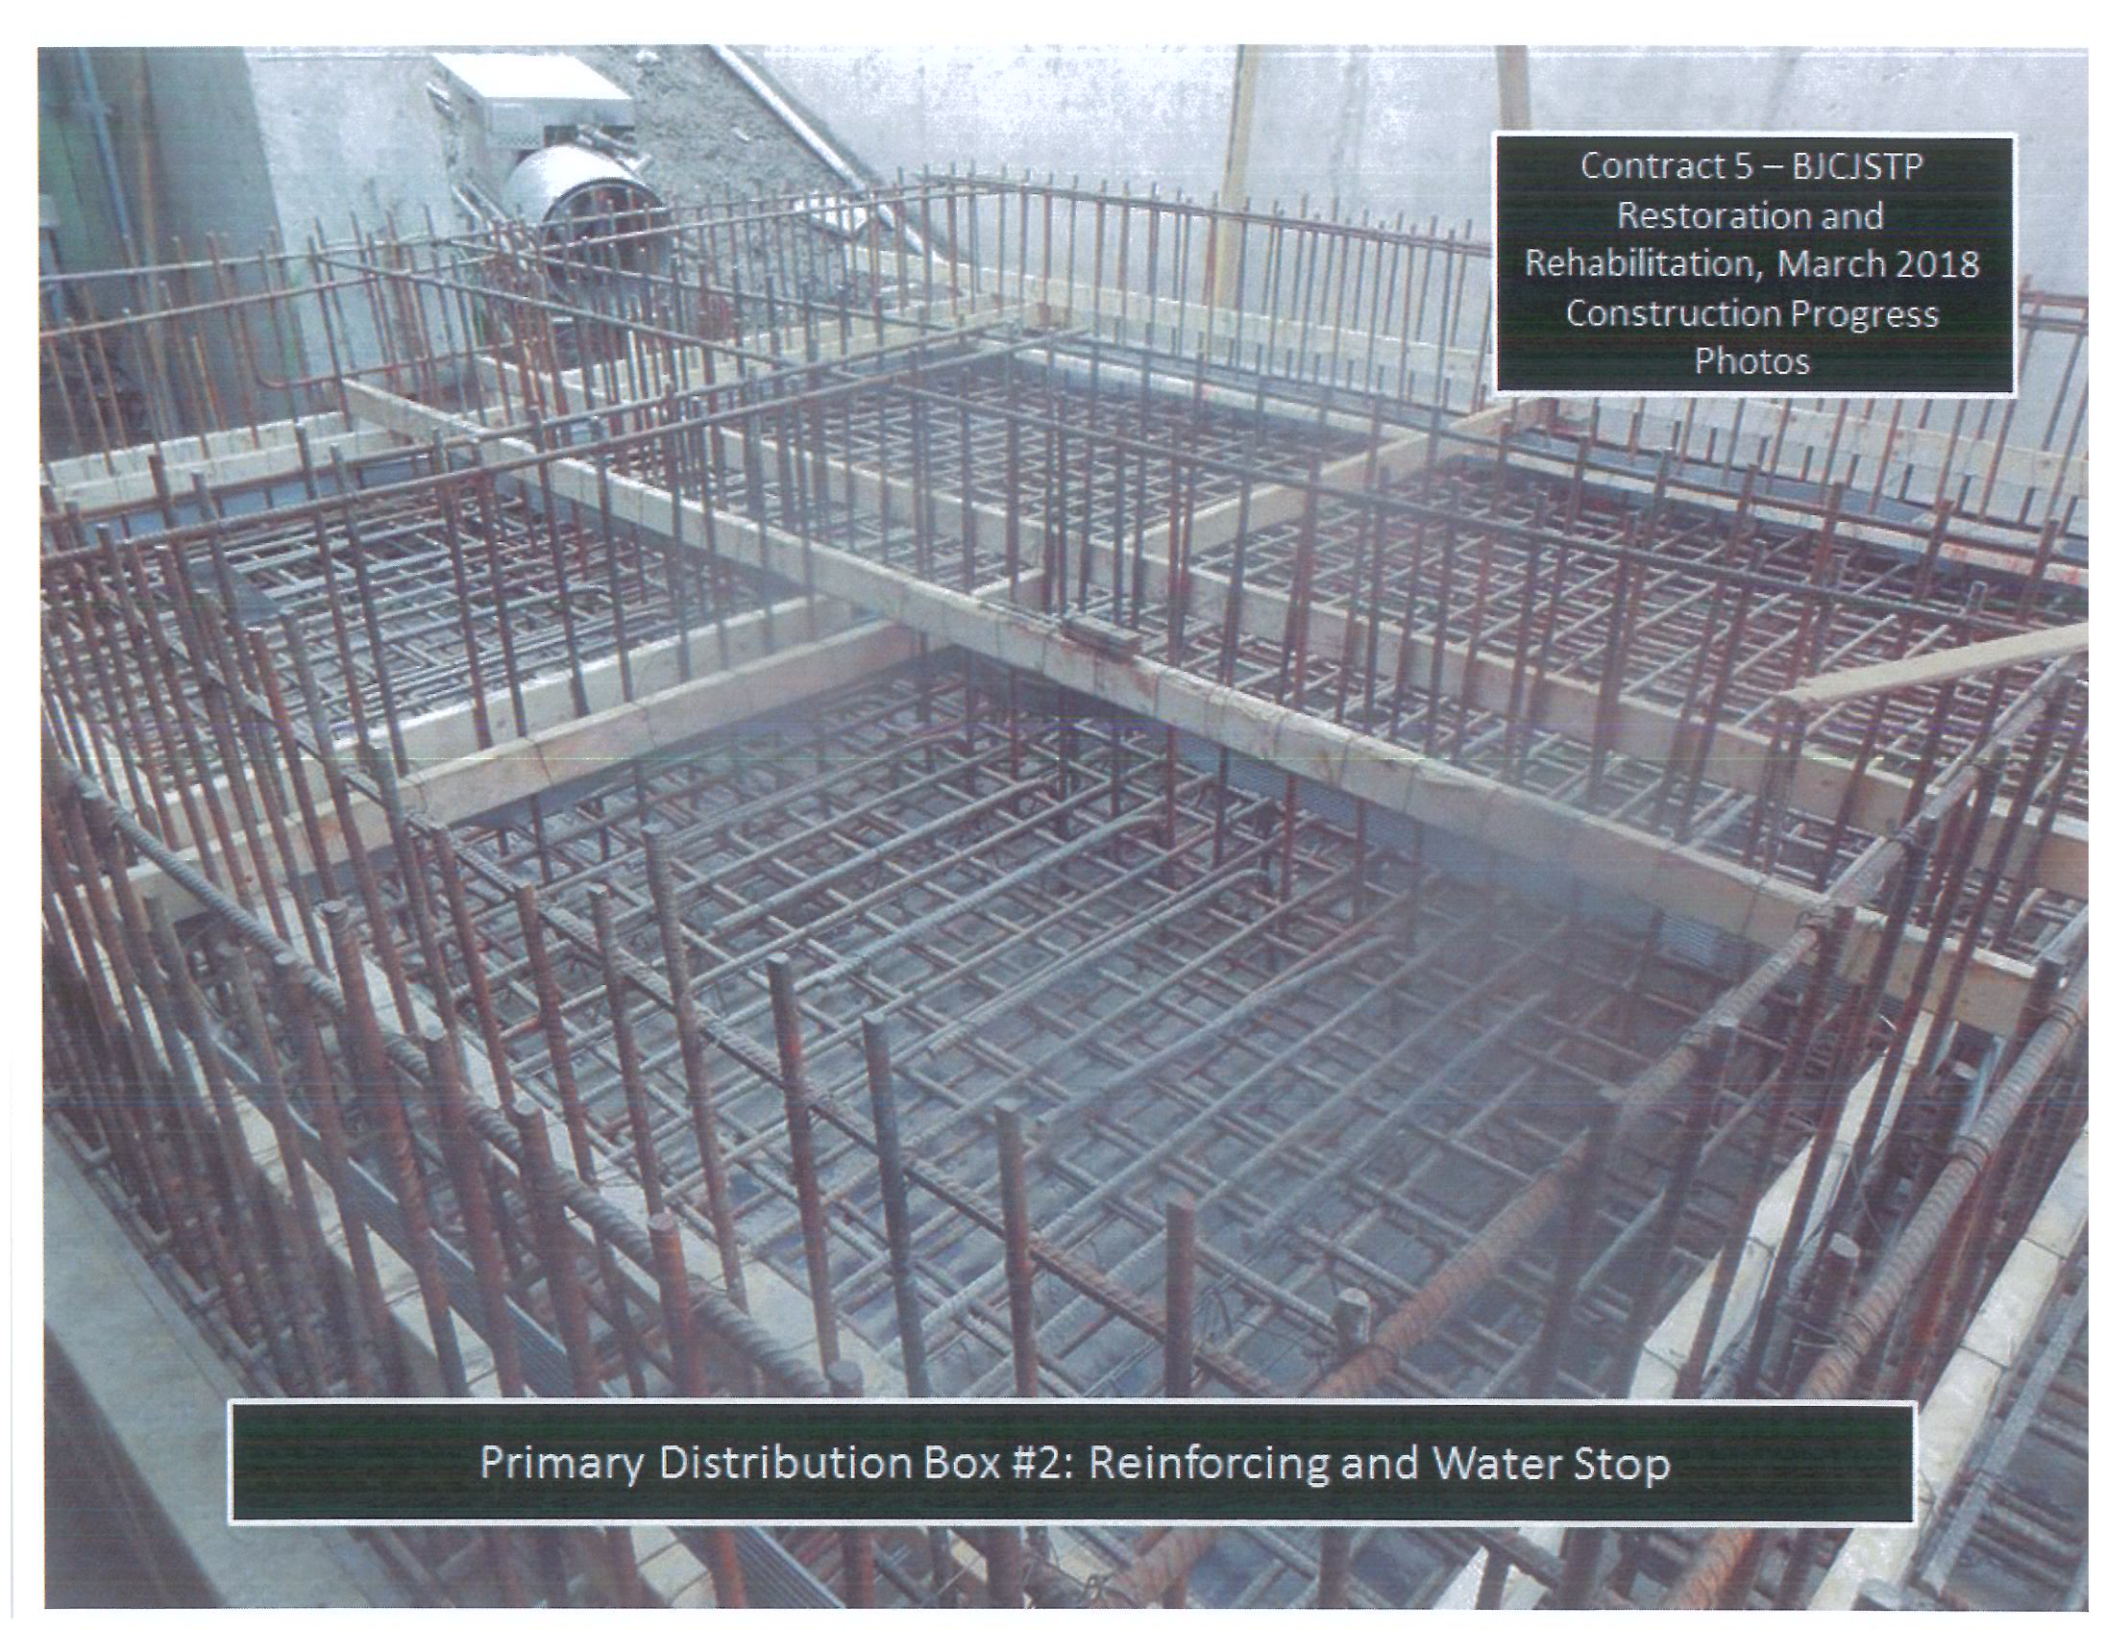
Primary Distribution Box #2: Reinforcing and Water Stop

A plan to correct the problems at the Distribution Box has been agreed to and PC is proceeding with dowel installation which will allow the box construction to proceed. The exterior wall dowels have been installed and the pull test is ready to perform. The exterior concrete walls for the distribution box should be completed by the middle to the end of April. PC has started doing pipe work in the corridor north of the Headworks and BAF Backwash Treatment Facility. They began installing the under drains for PST's 1-6.

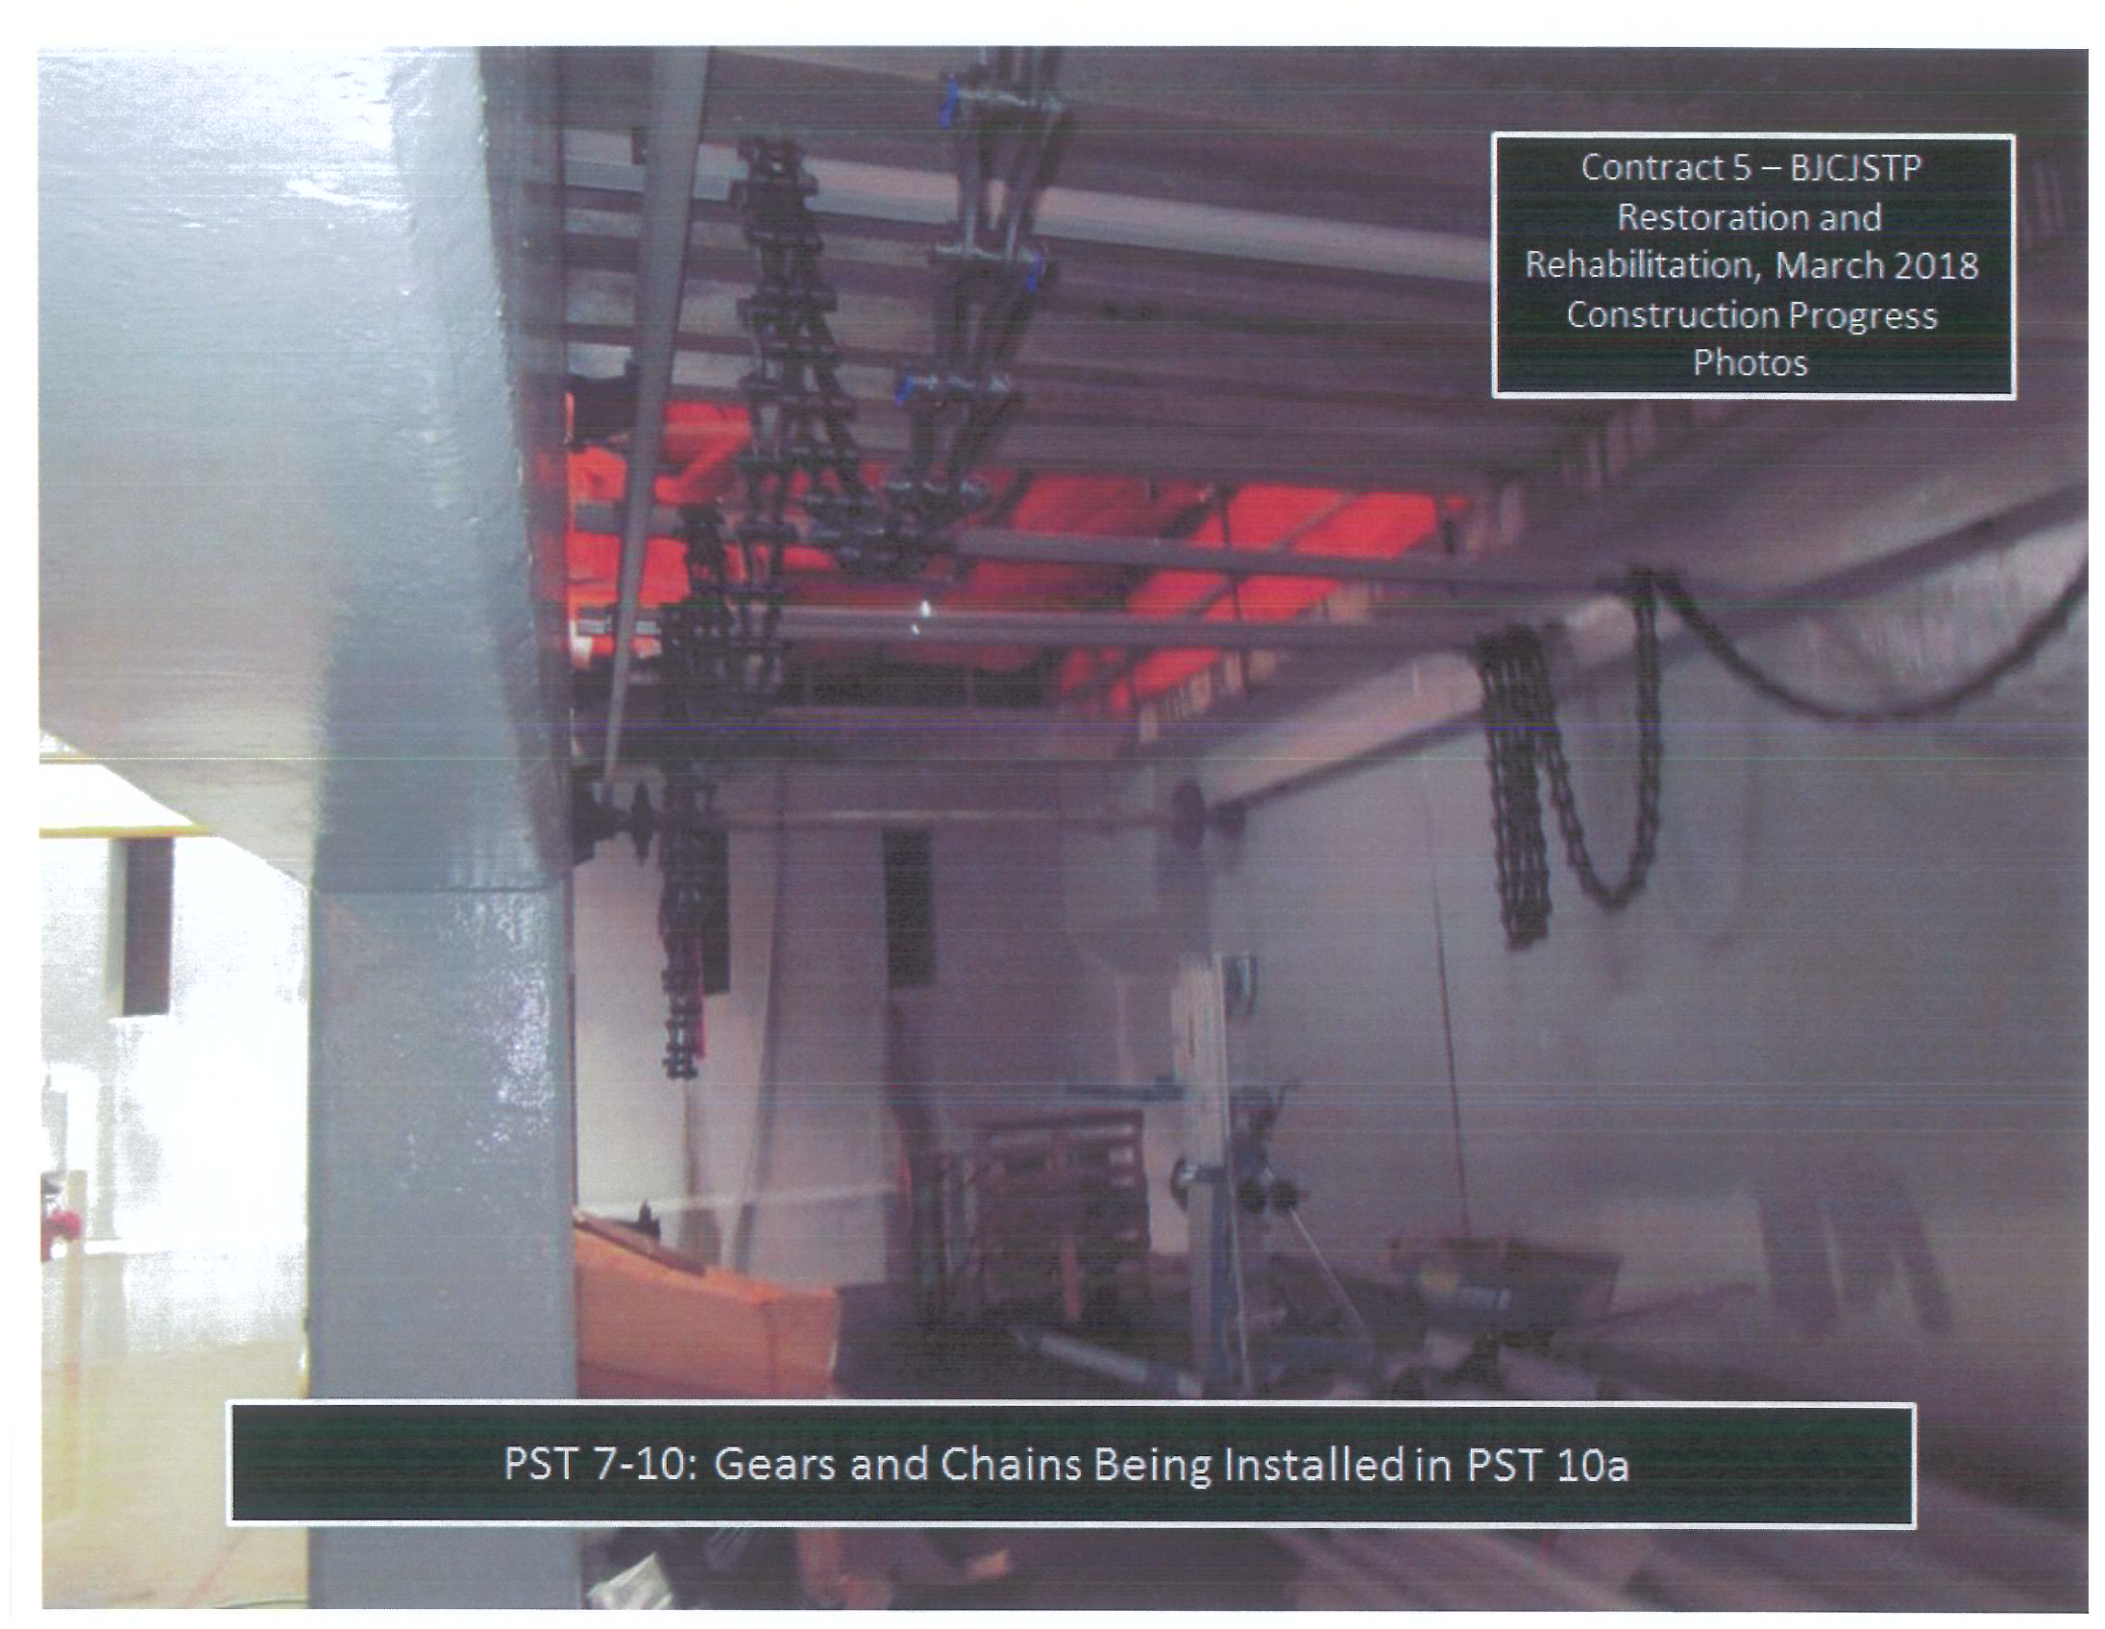
PST 7-10: Gears and Chains Being Installed in PST 10a

The reconstruction of Primary Setting Tanks 7-10 is progressing well. The concrete coating applications are complete and PC is continuing to install the effluent troughs and the chain flight equipment in PST's 7-10. The initial leakage test is complete with minor repairs implemented at joints.

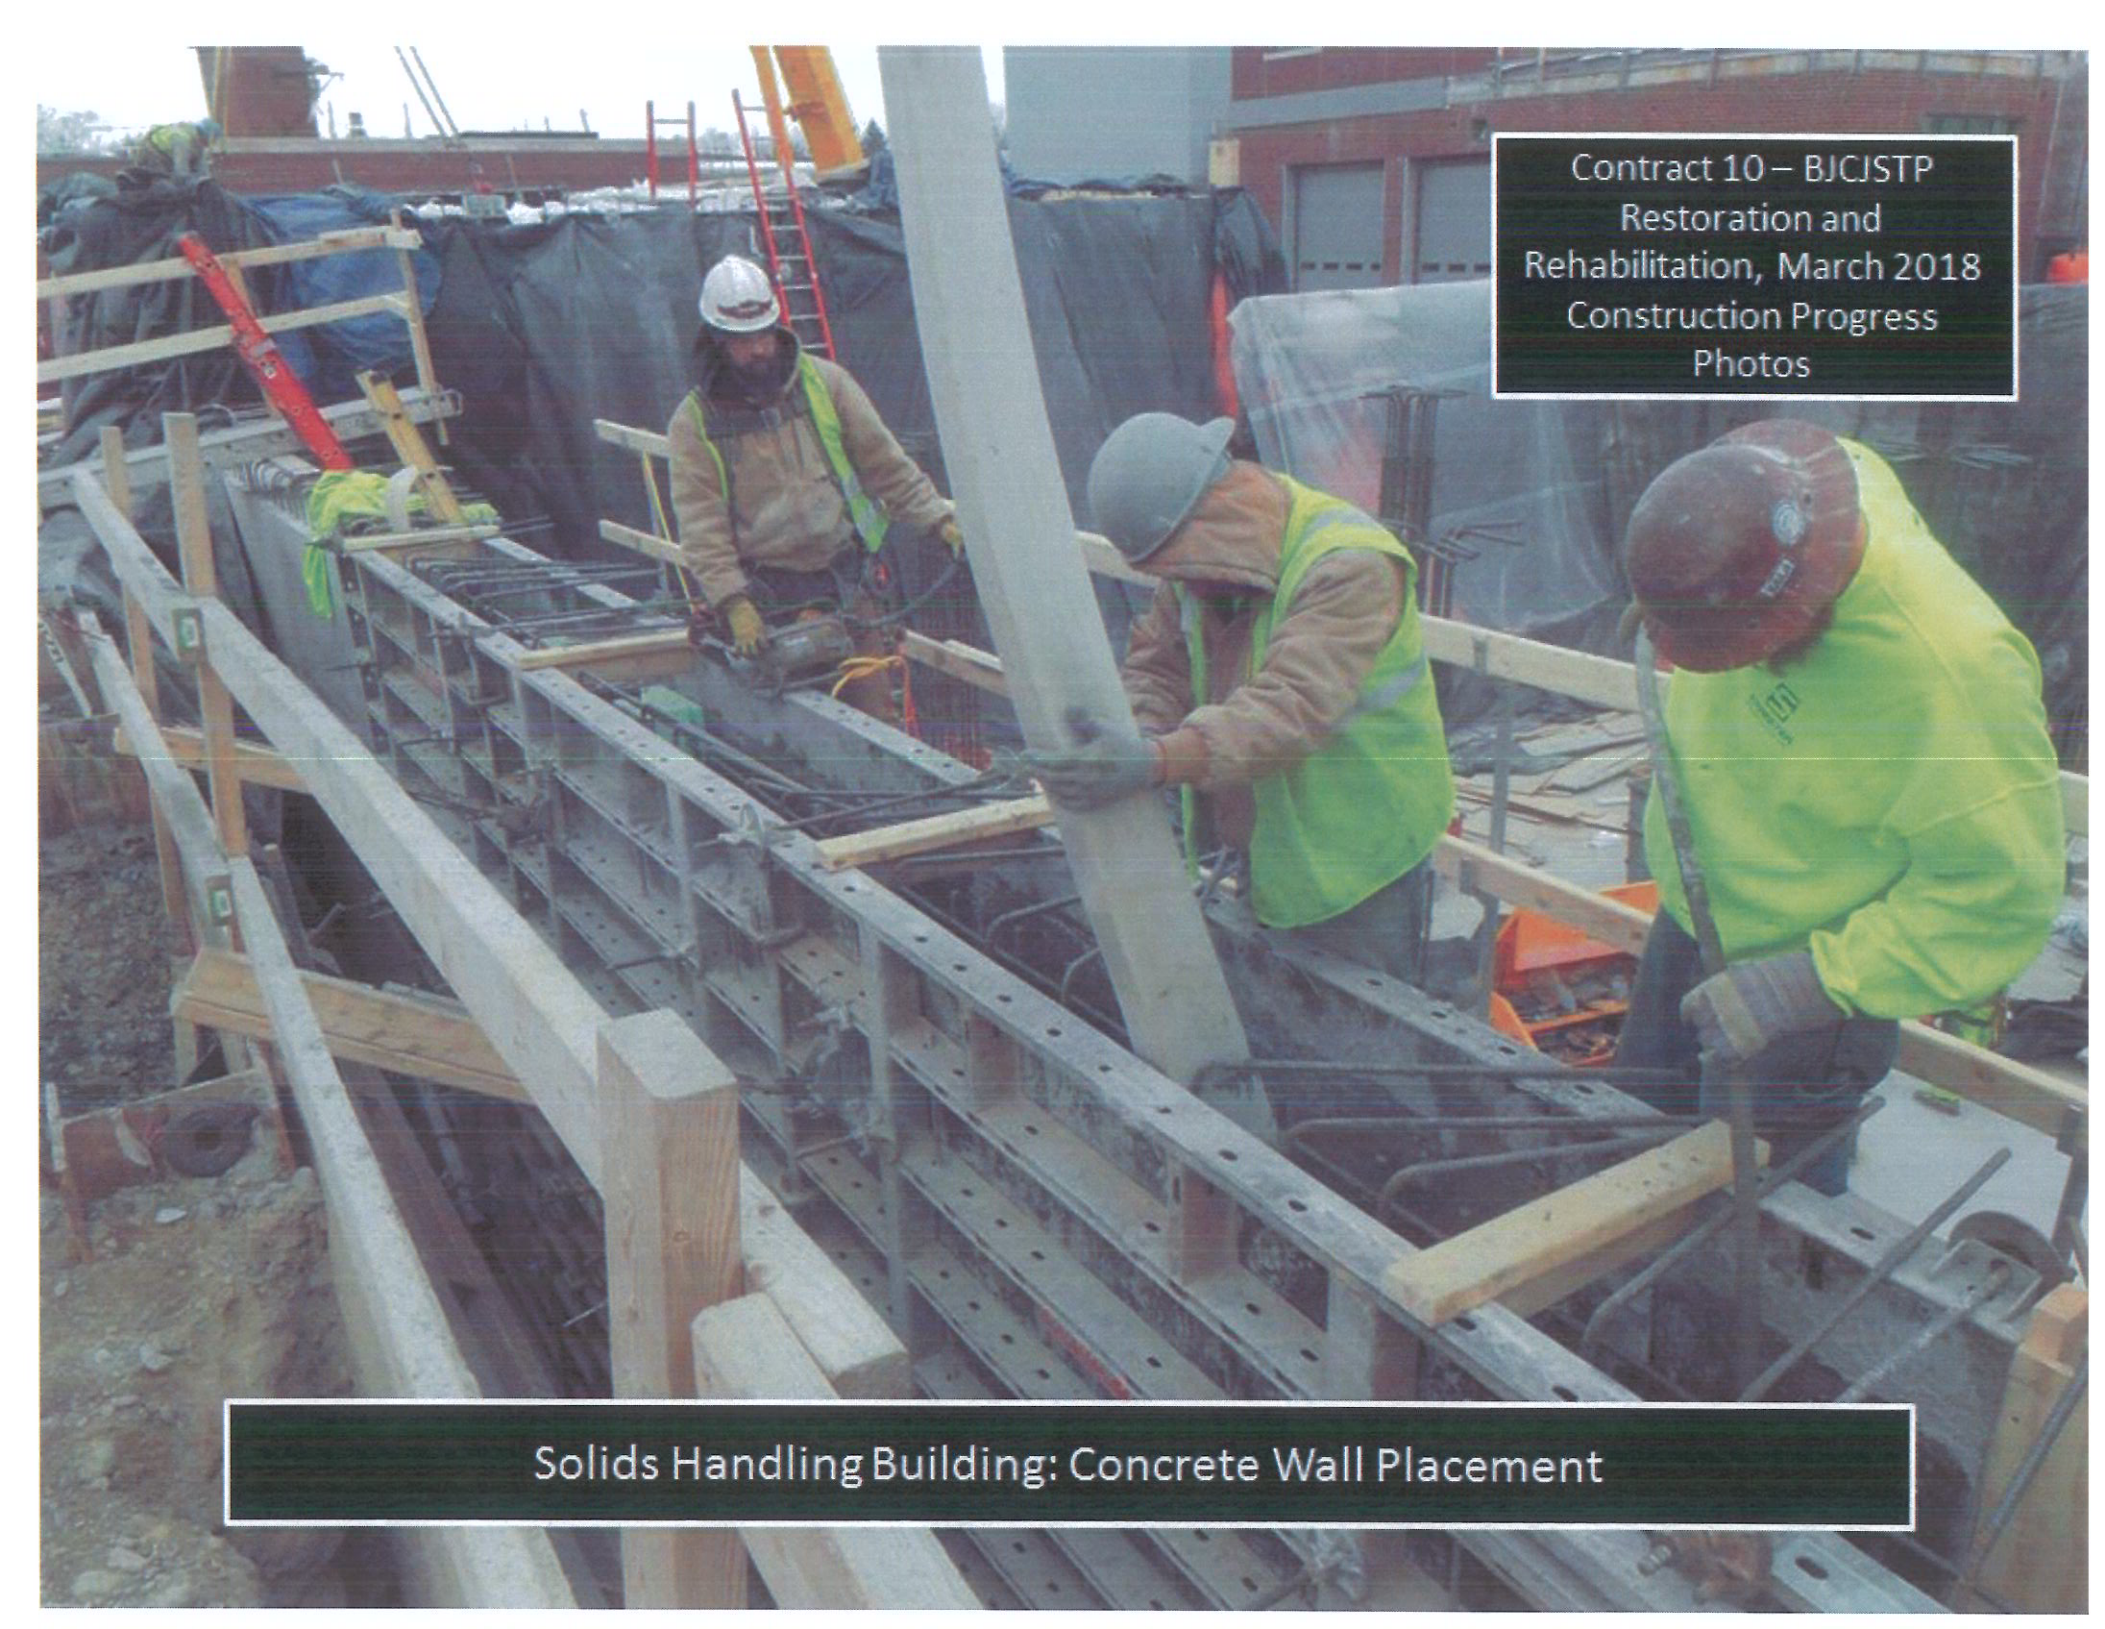
Solids Handling Building: Concrete Wall Placement

**Status:** Quandel got off to a late start but has made some progress this month. Concrete work for the new Solids Handling Building is progressing. The base slab is complete, and concrete work for the walls is progressing. Concrete walls for the new sludge holding tank are being completed. Quandel is still not making much progress on the removal and recertification of the gas conditioning equipment. They are alleging that they are not responsible for reconditioning the equipment. We are requesting a cost proposal from Quandel to recoat the inside of digesters 1 & 2, which are the two smaller digesters.
