October 2017 Monthly Report

BJCJSTP Rehabilitation and Restoration Project

Contract 5 – BICJSTP
Restoration and
Rehabilitation, October
2017 Construction Progress
Photos

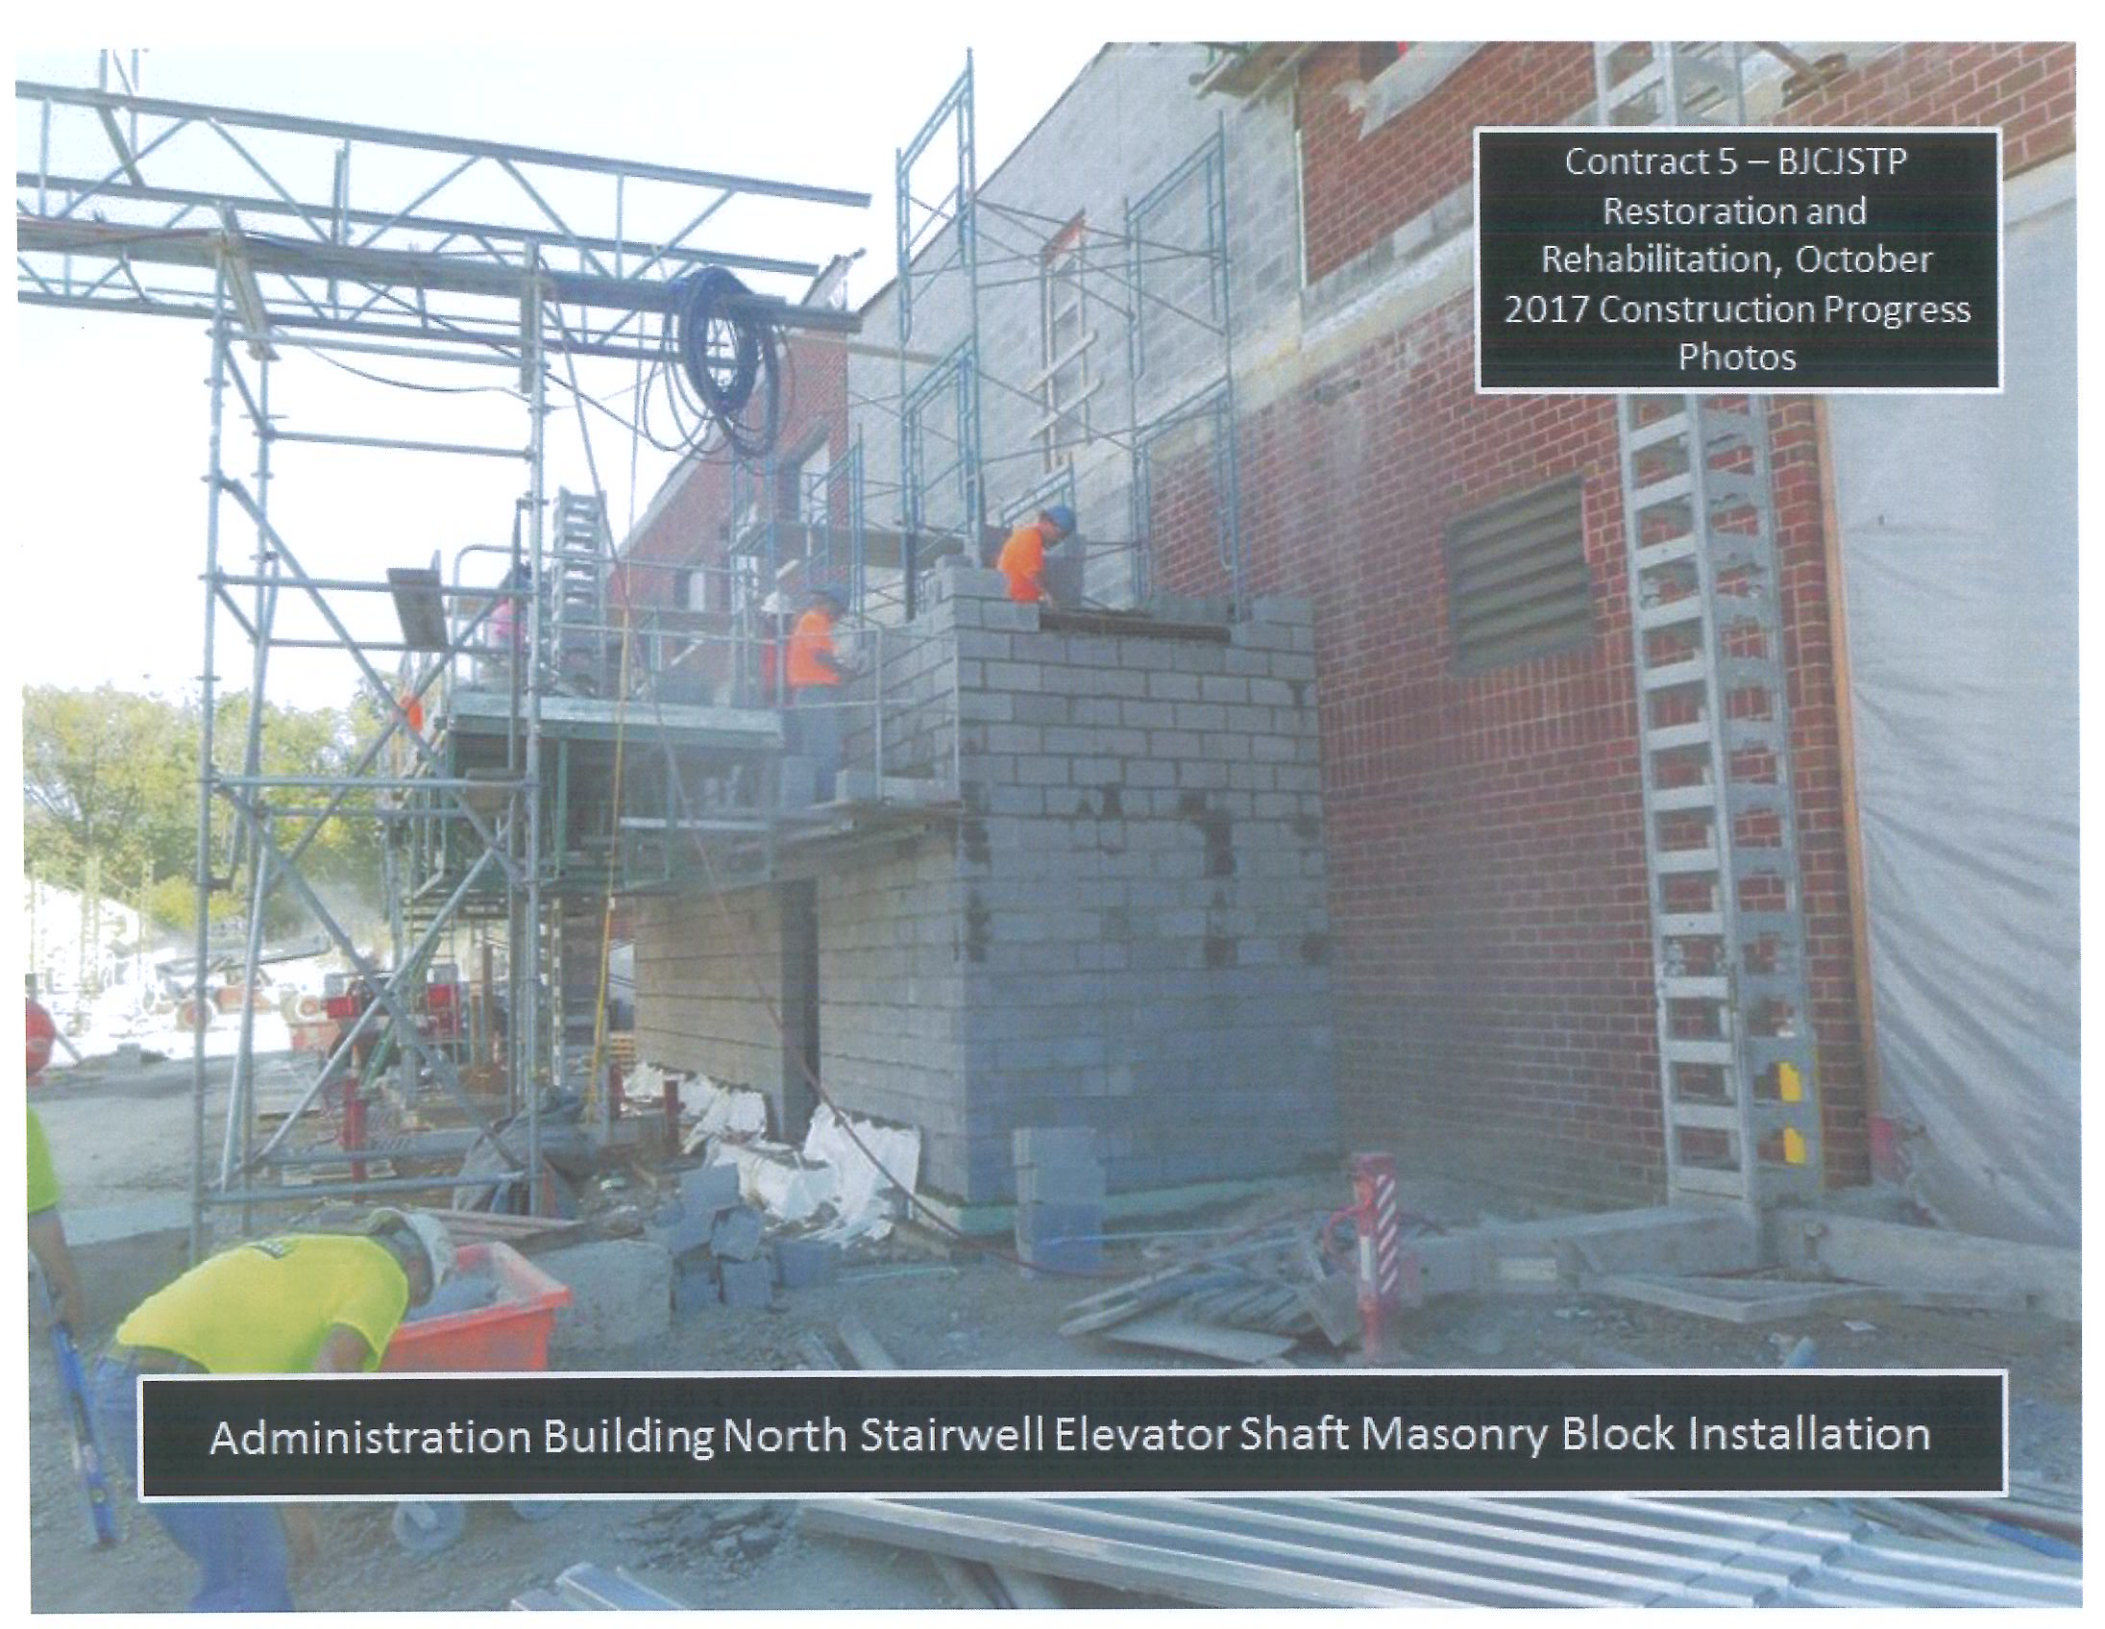
Administration Building North Stairwell Elevator Shaft Masonry Block Installation

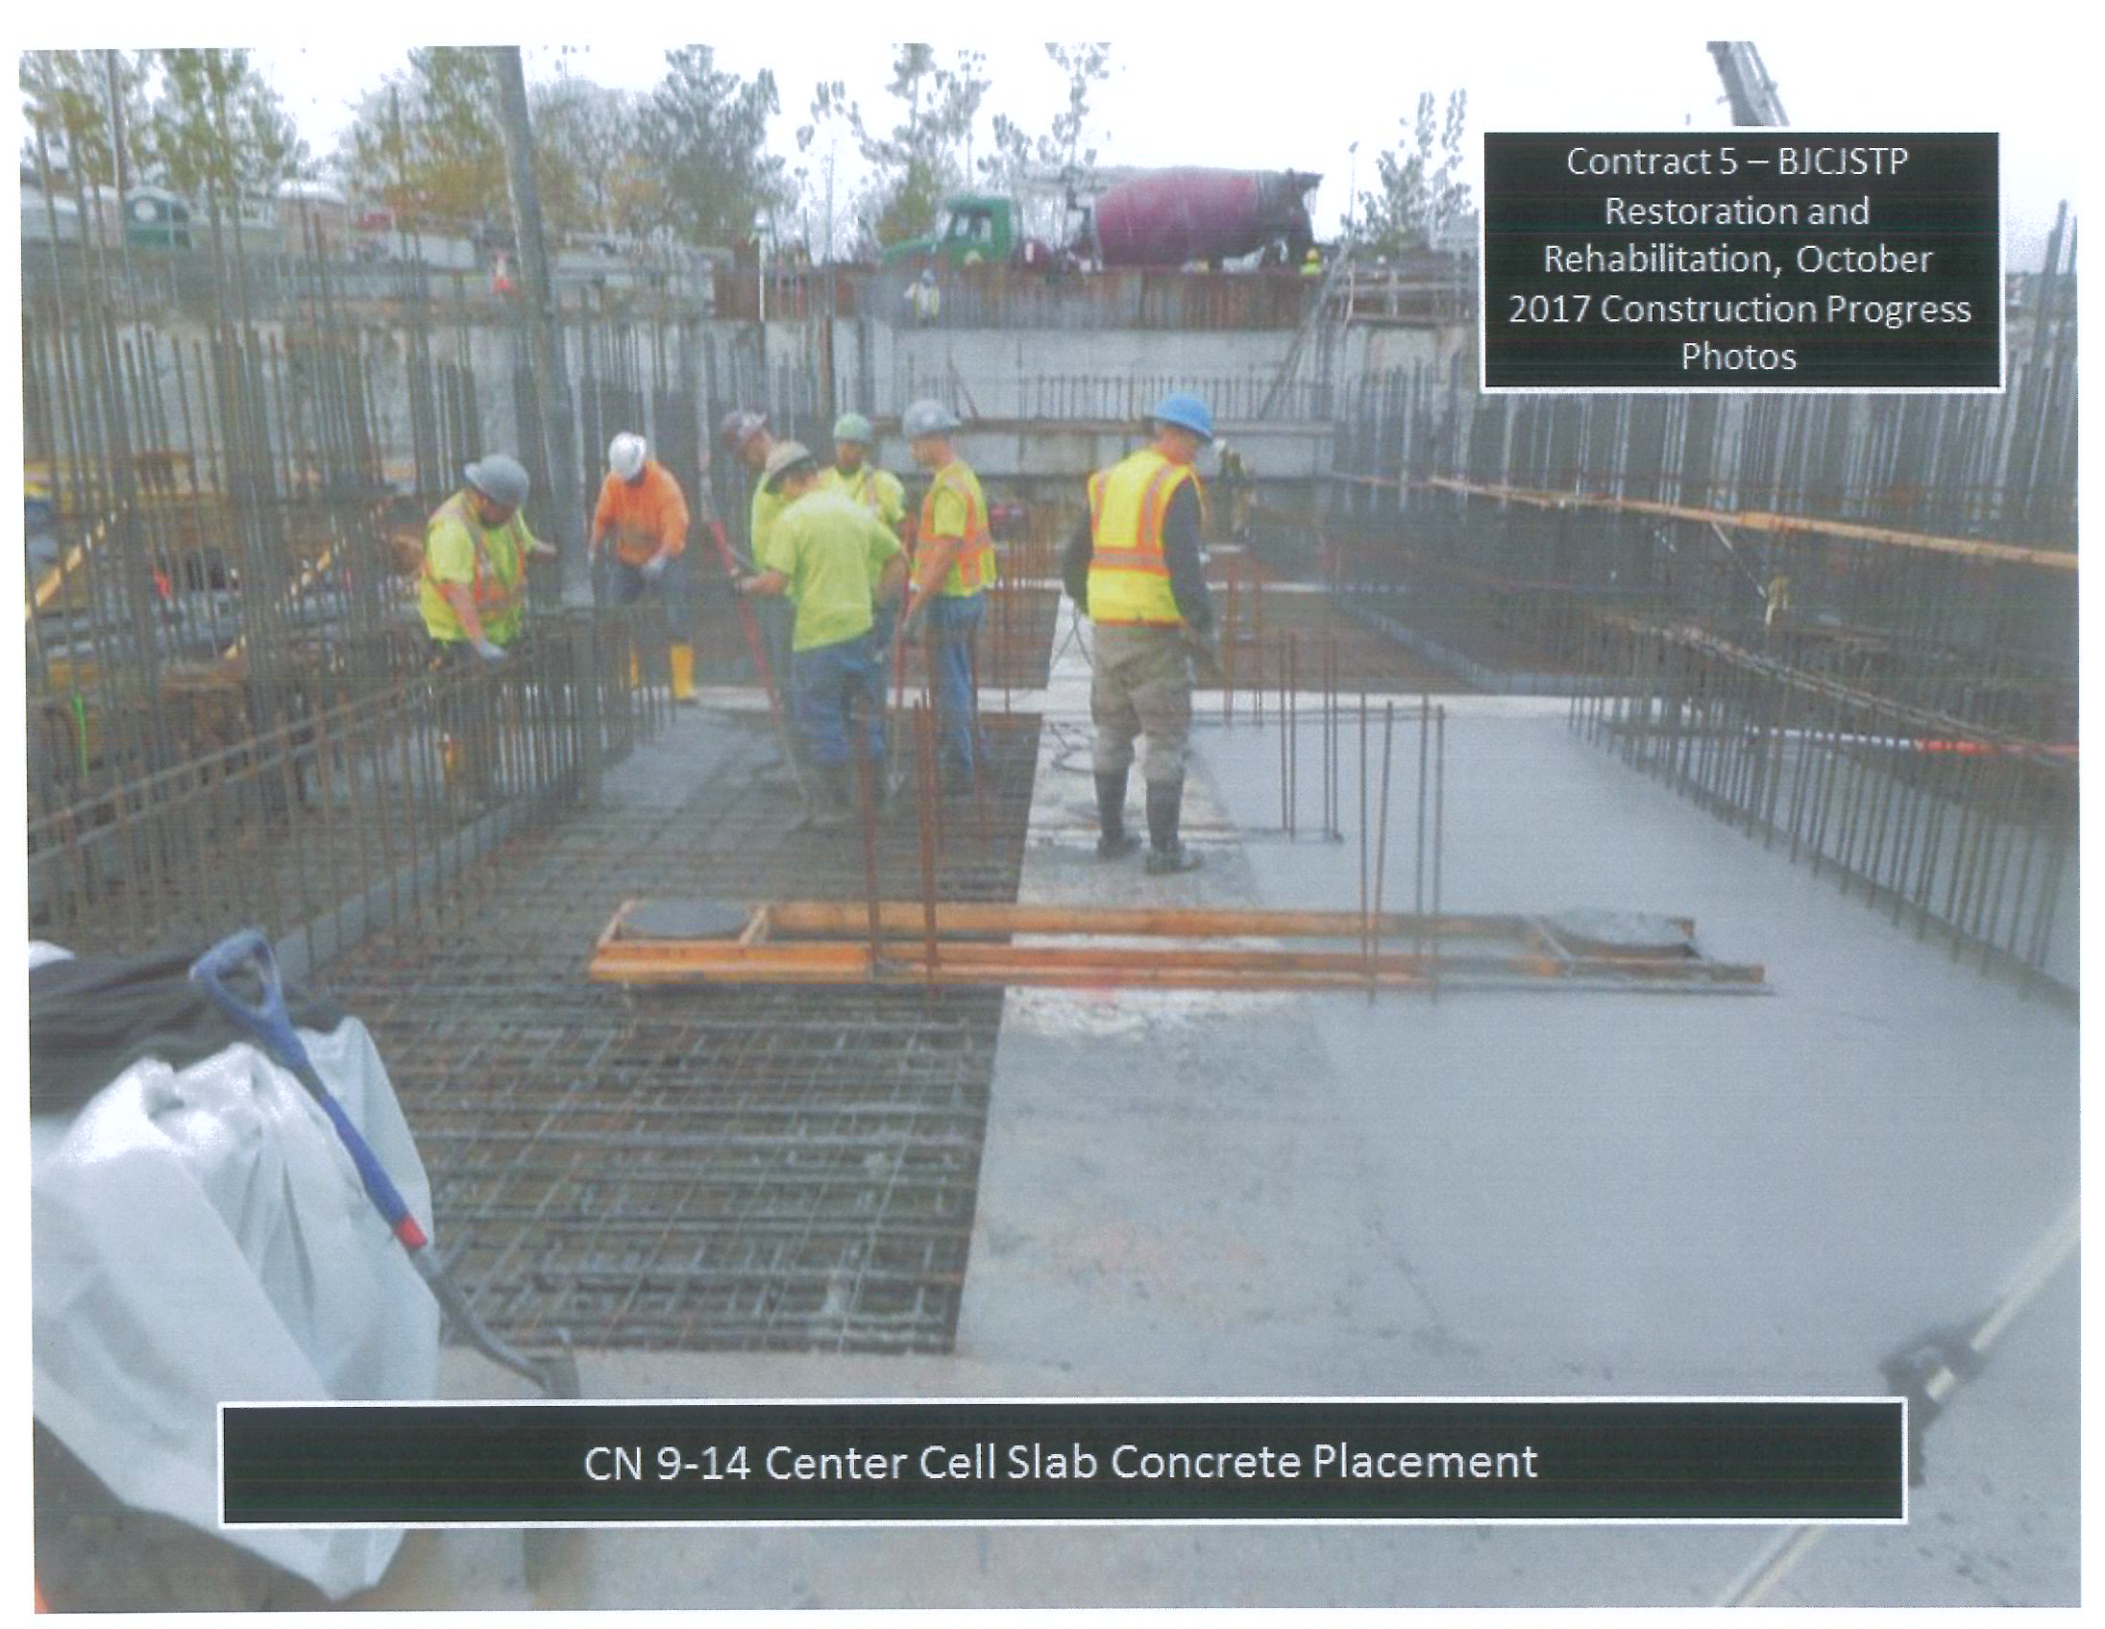
A photograph of a construction site for a concrete slab. Several workers in high-visibility vests and hard hats are standing on a partially completed slab. A network of steel rebar is visible, forming a grid pattern. In the background, a concrete mixer truck is parked on a higher level of the site. The scene is set outdoors with trees and buildings in the distance.

CN 9-14 Center Cell Slab Concrete Placement

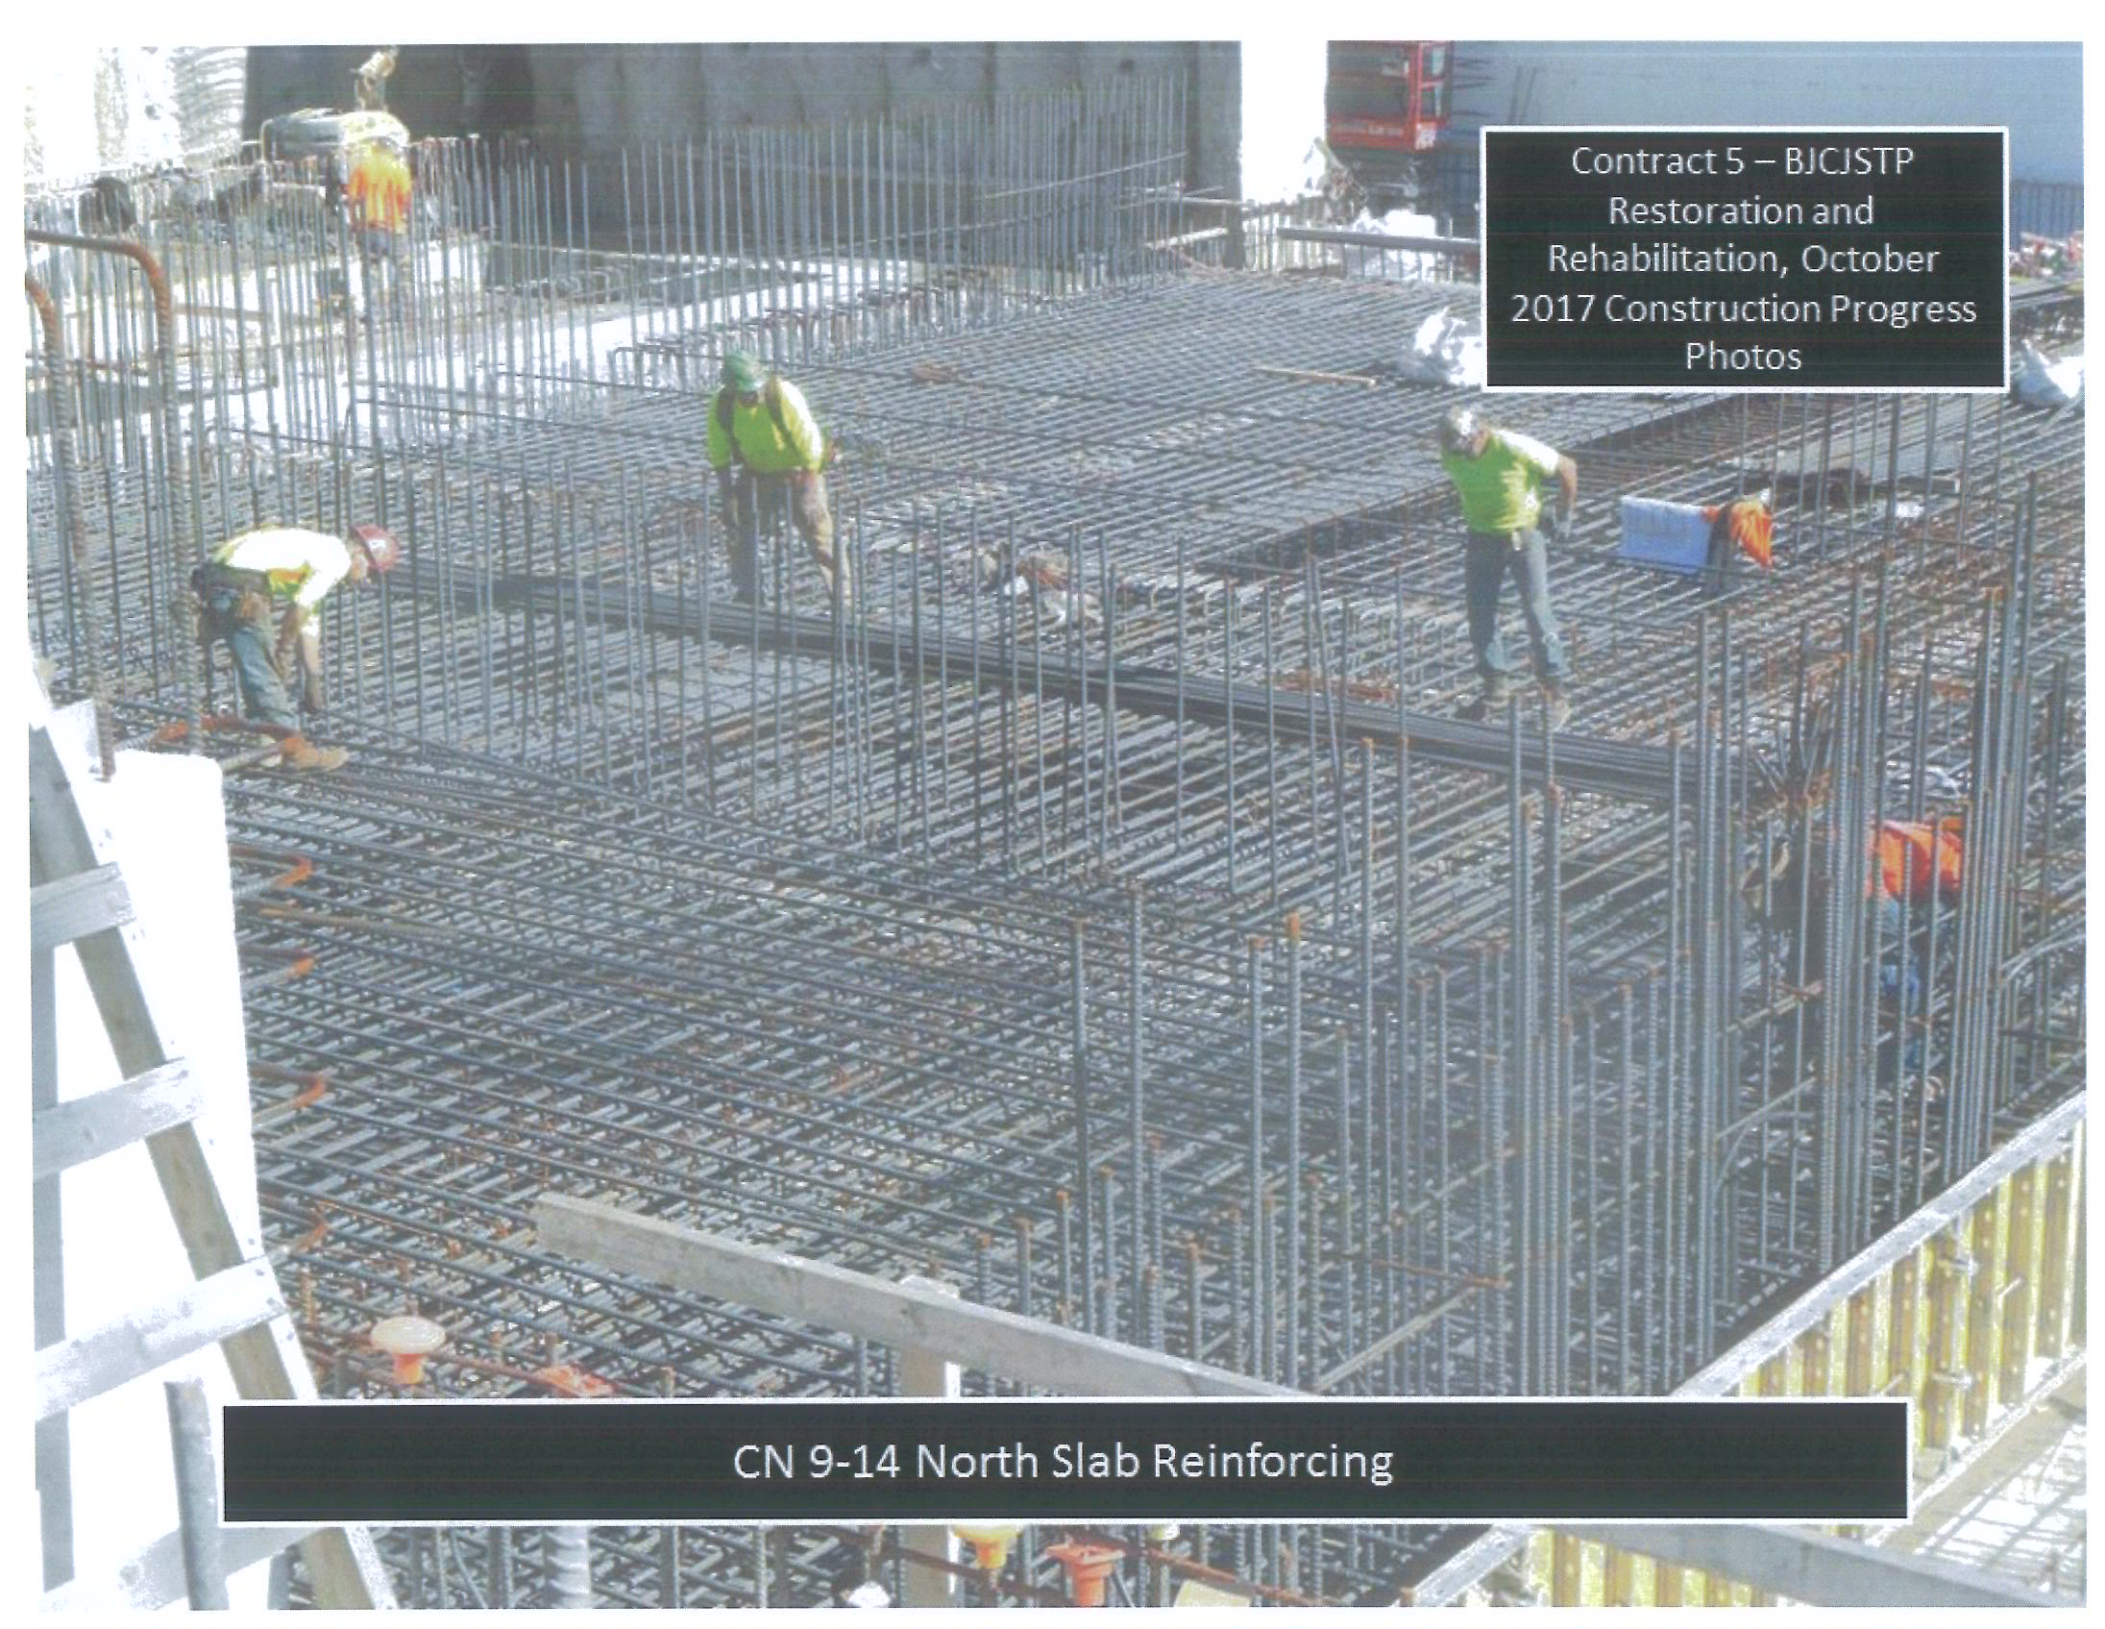
A high-angle photograph of a construction site. The main area is a large, flat concrete slab under construction, covered with a dense grid of steel reinforcement bars (rebar). Several workers in high-visibility vests and hard hats are positioned across the slab, some appearing to be adjusting or securing the rebar. In the background, there are concrete walls and a red truck. The scene is brightly lit, suggesting a clear day.

CN 9-14 North Slab Reinforcing

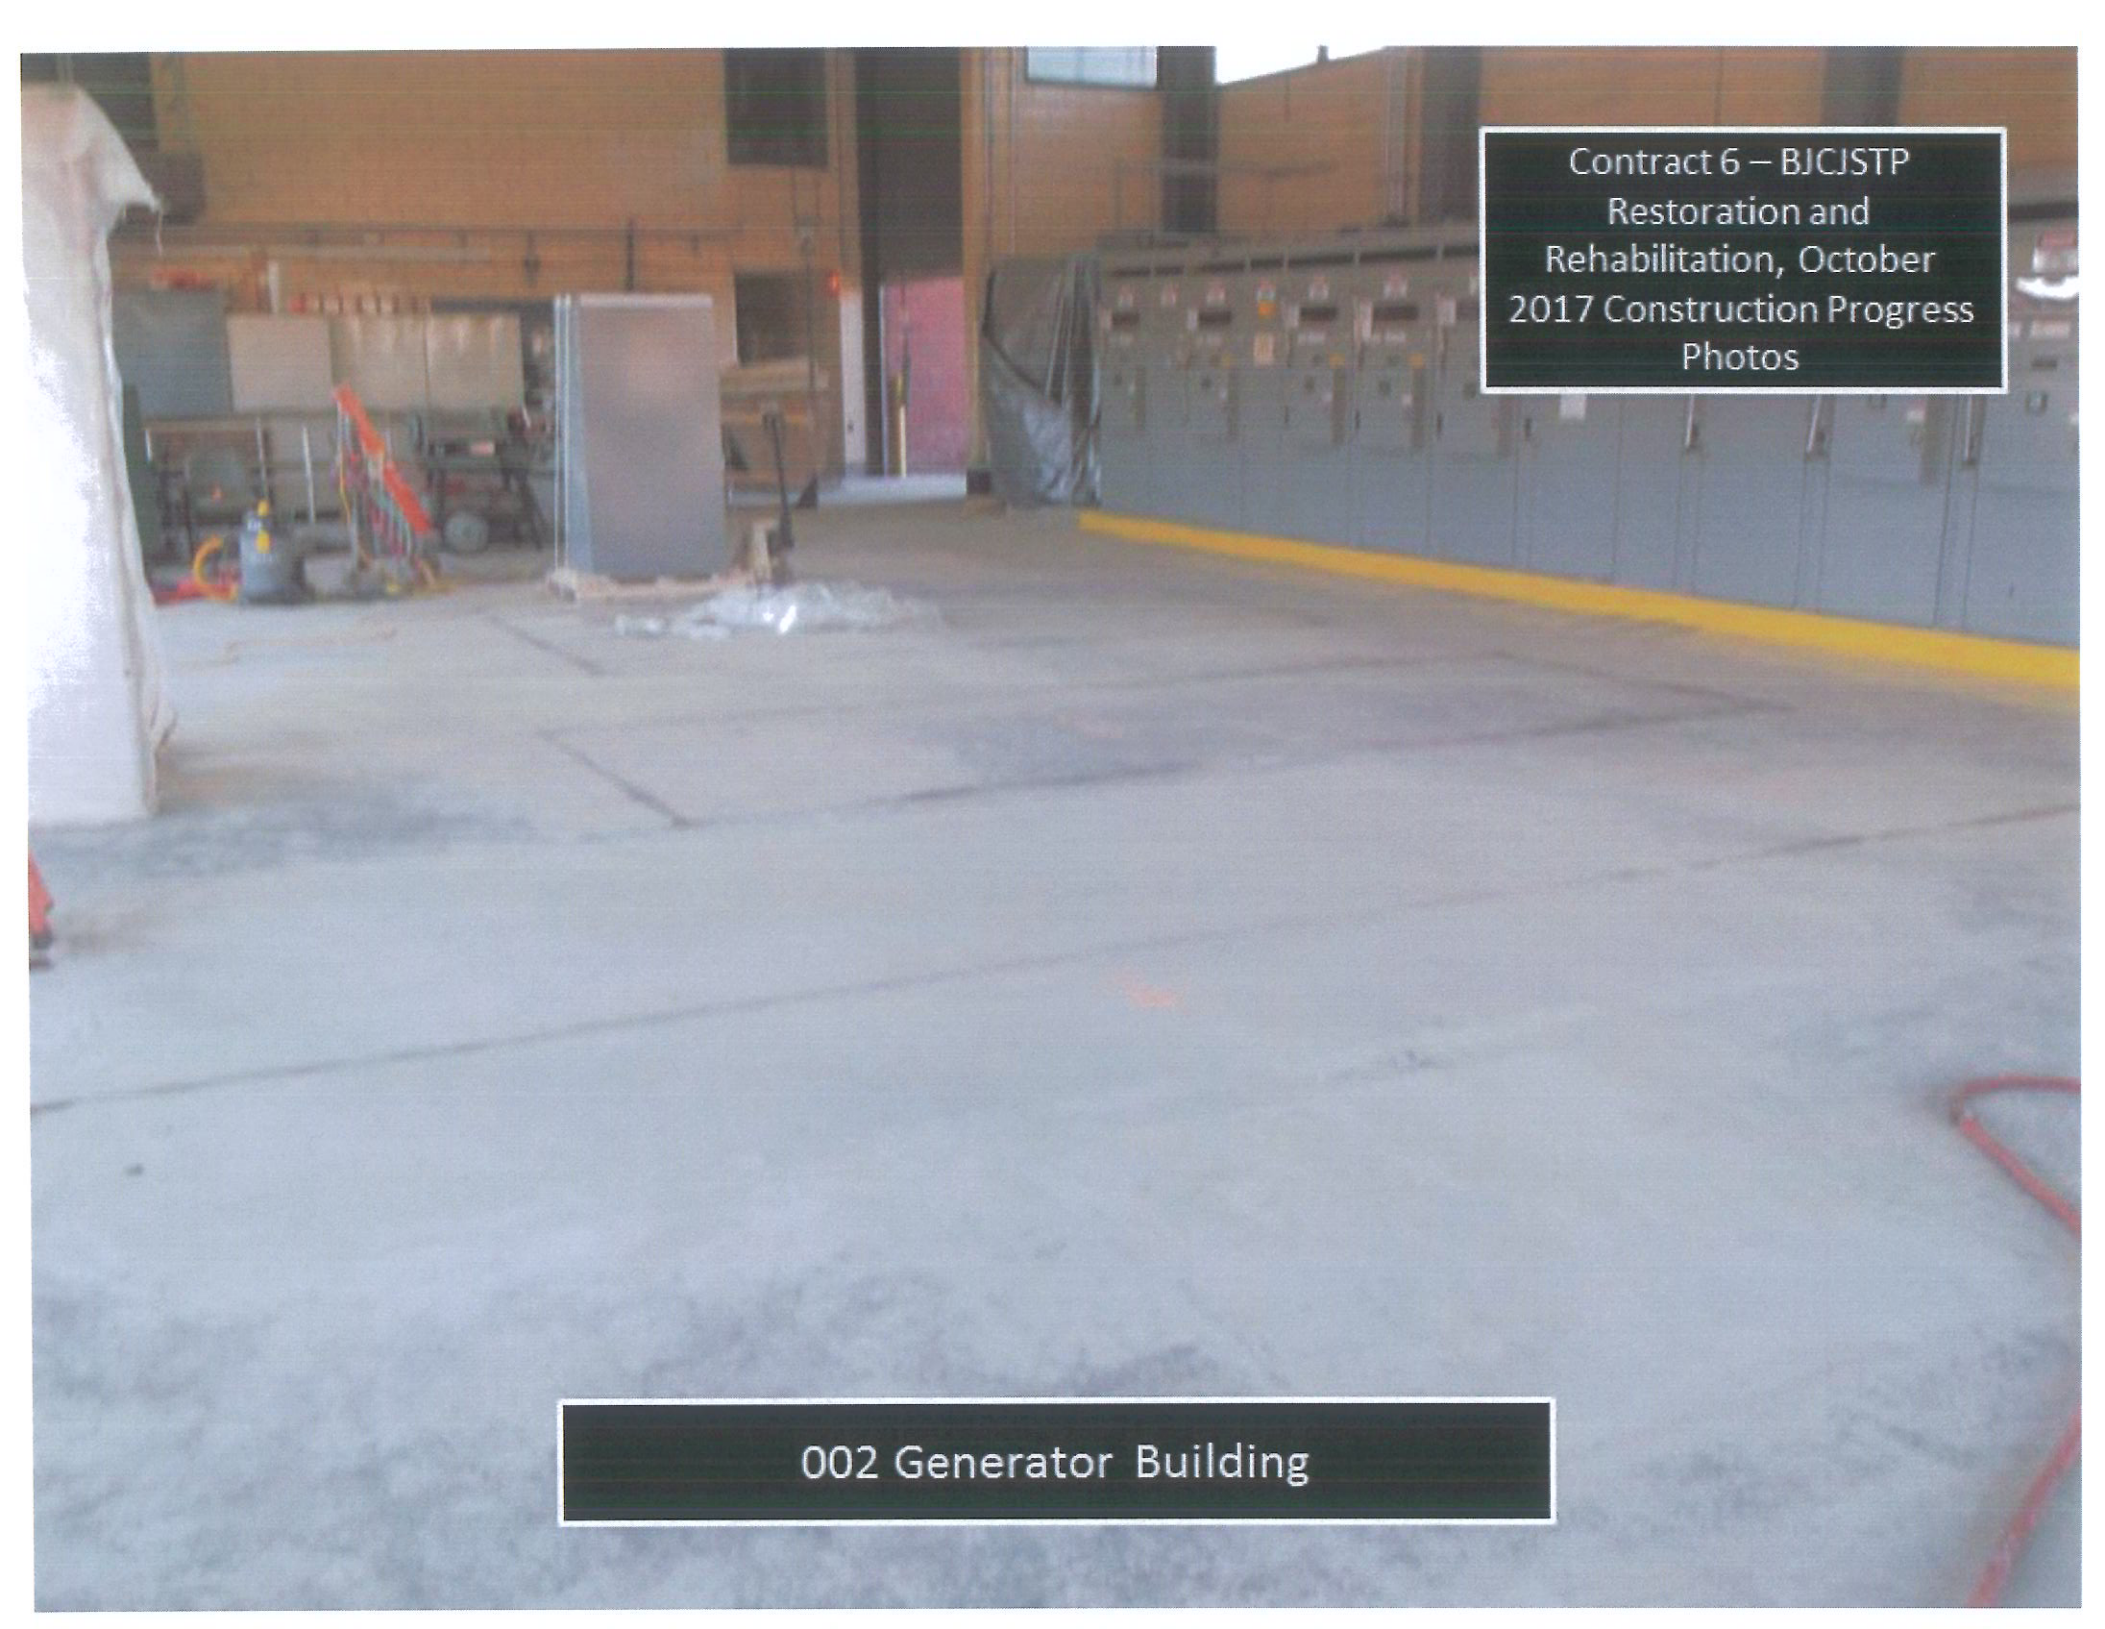
The image shows the interior of a large industrial building, identified as a generator building. The floor is made of large, light-colored concrete slabs. On the right side, there is a long wall of grey metal cabinets or control panels. A yellow safety line is painted along the base of this wall. In the background, there are various pieces of equipment, including what looks like a generator or a large motor, and some construction materials. The lighting is somewhat dim, typical of an industrial interior.

002 Generator Building

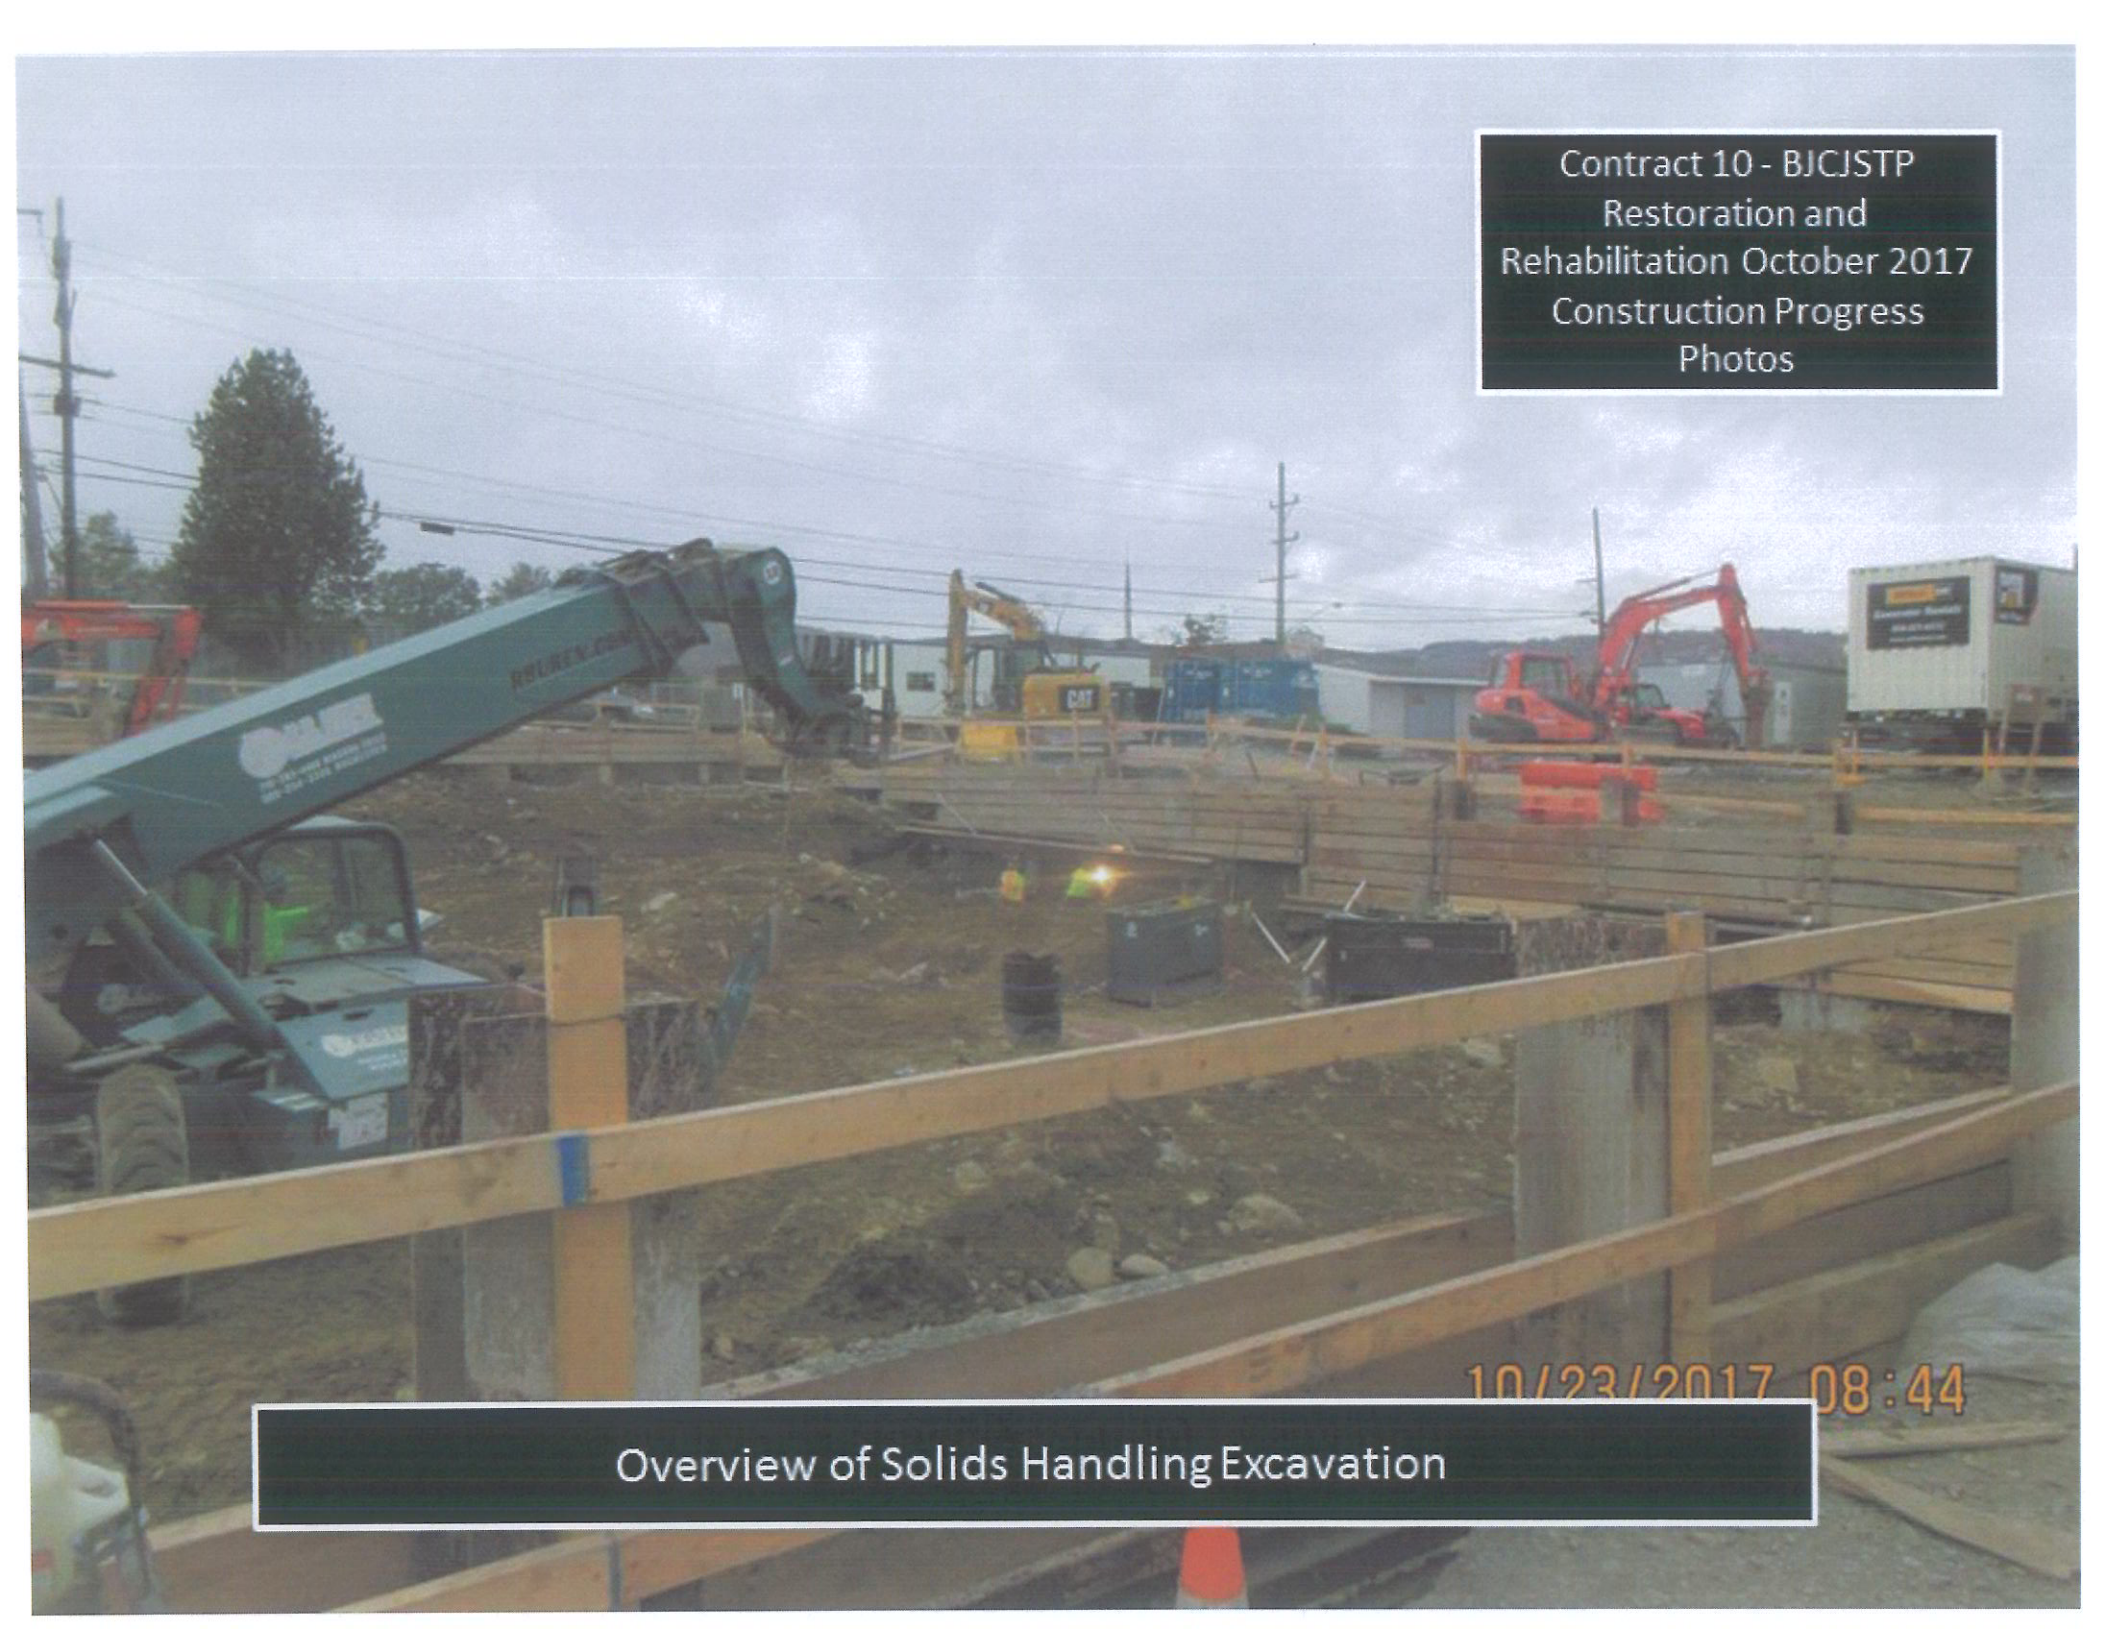
10/23/2017 08:44

Overview of Solids Handling Excavation

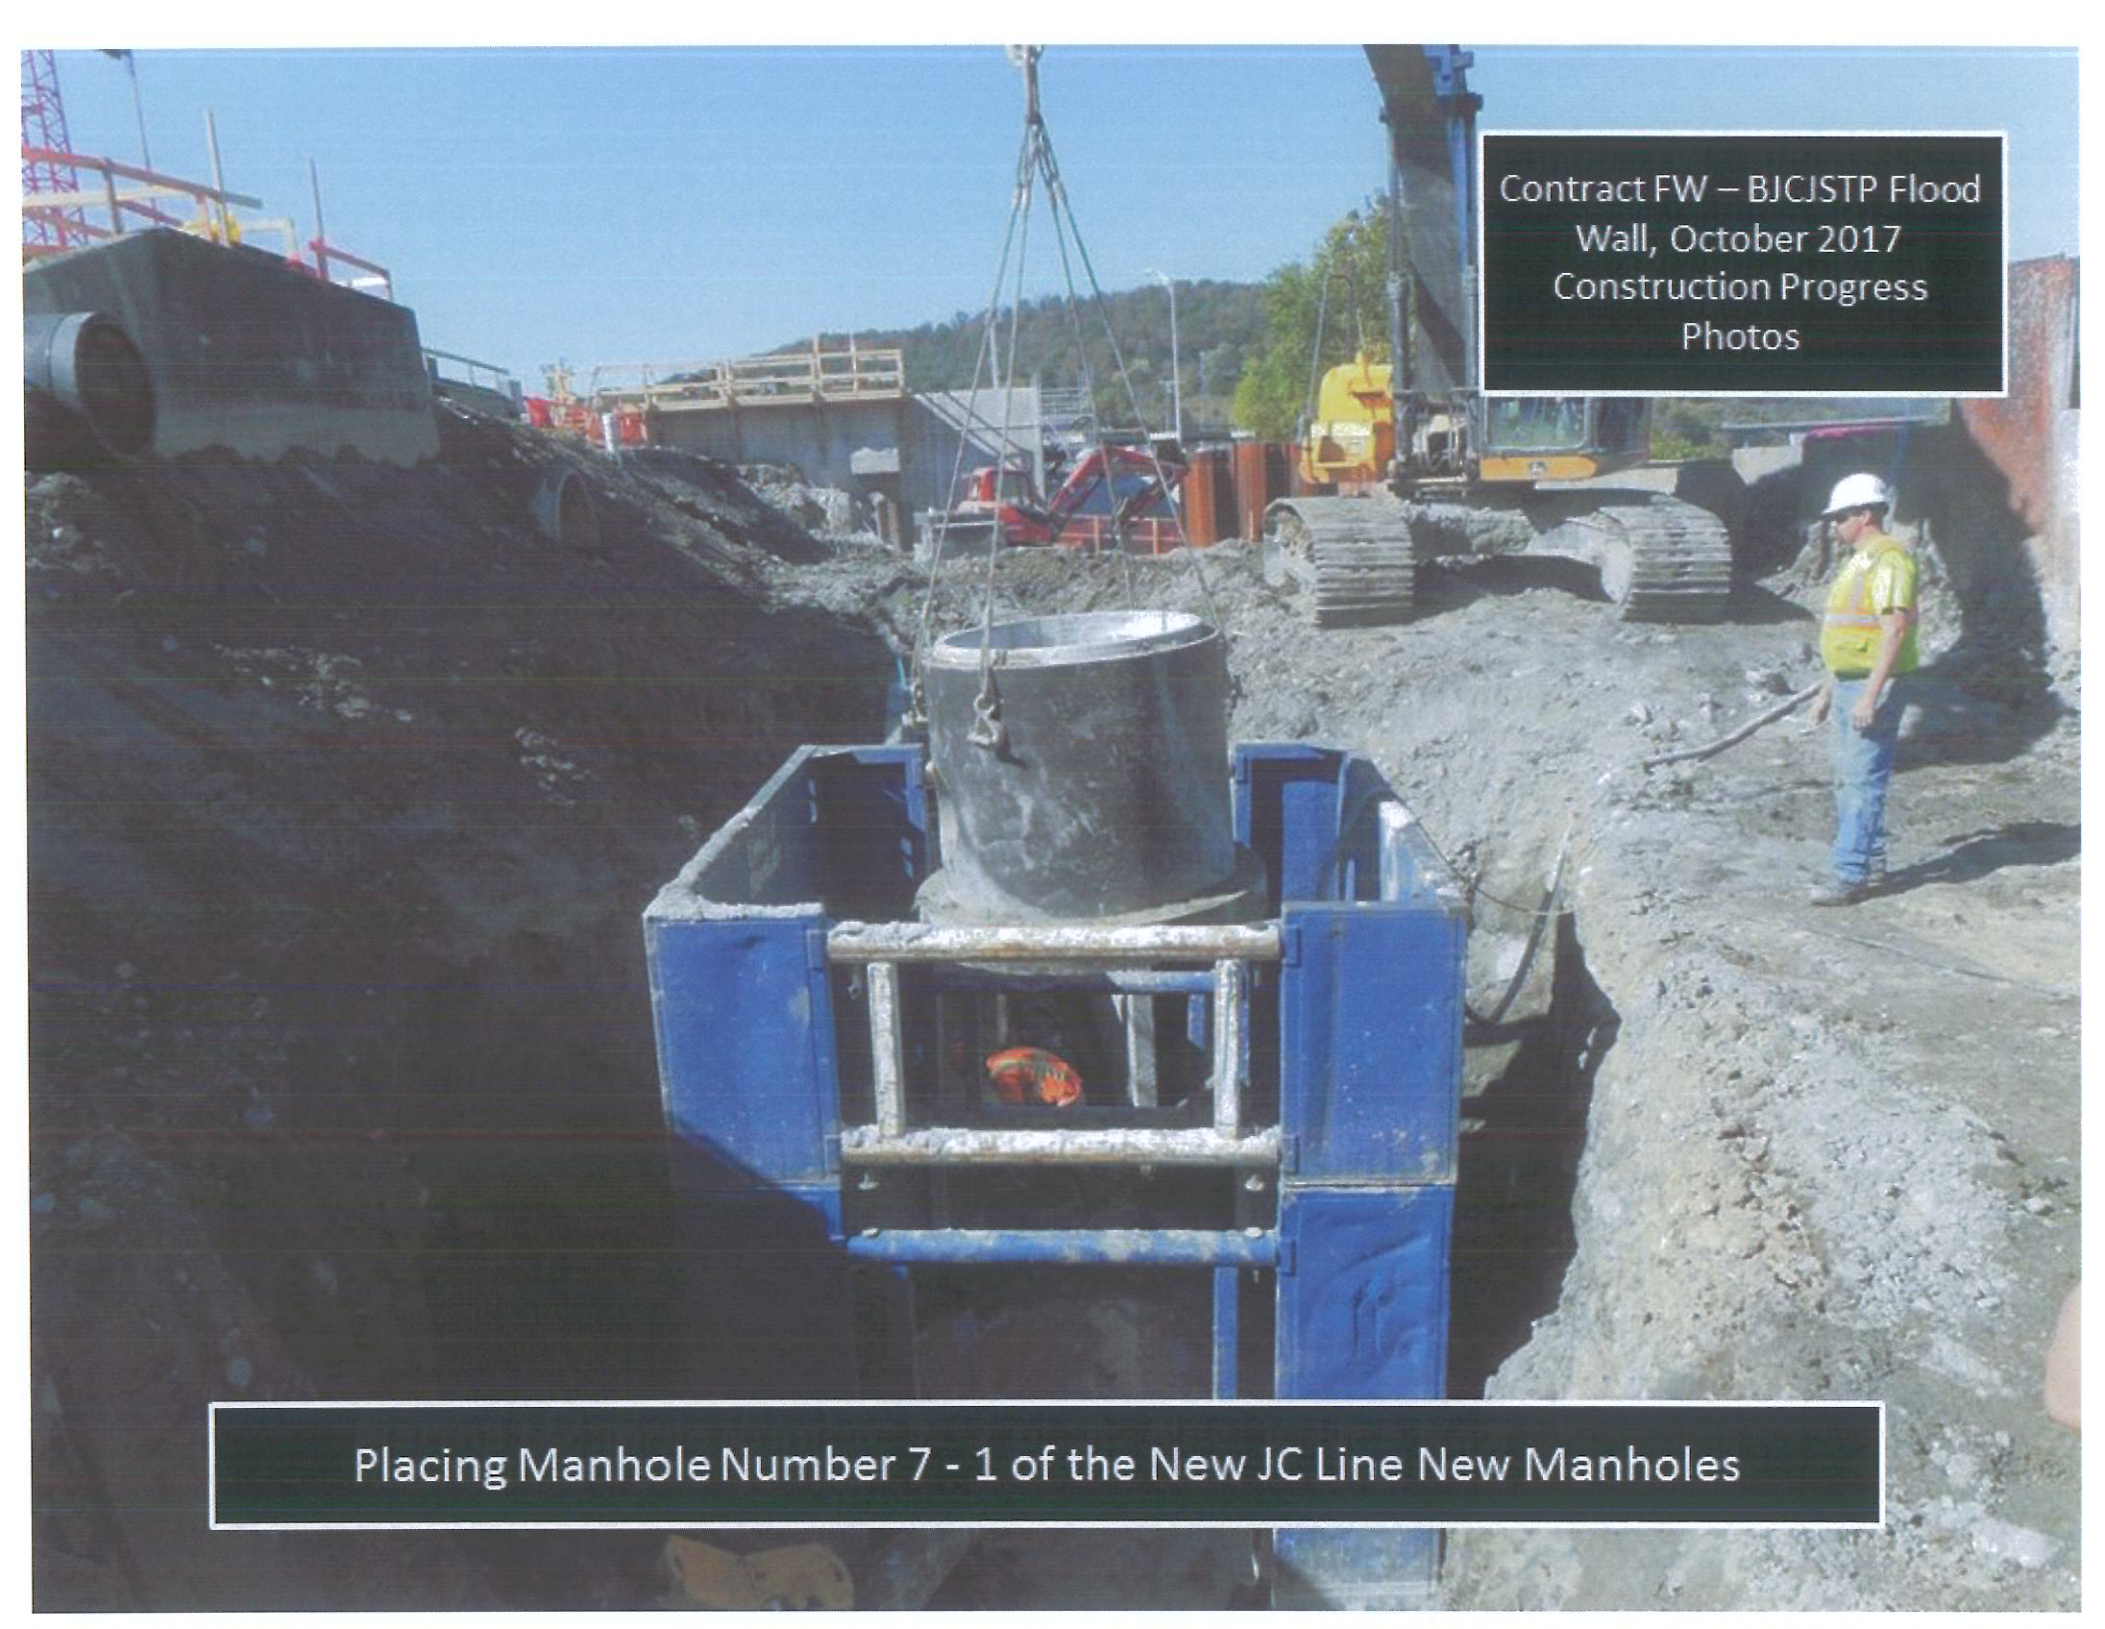
Placing Manhole Number 7 - 1 of the New JC Line New Manholes
