**Binghamton-Johnson City Joint Sewage
Treatment Plant Restoration and
Rehabilitation Project**

2017 Quarter 2 Report

*City of Binghamton
Village of Johnson City
Joint Sewage Board*

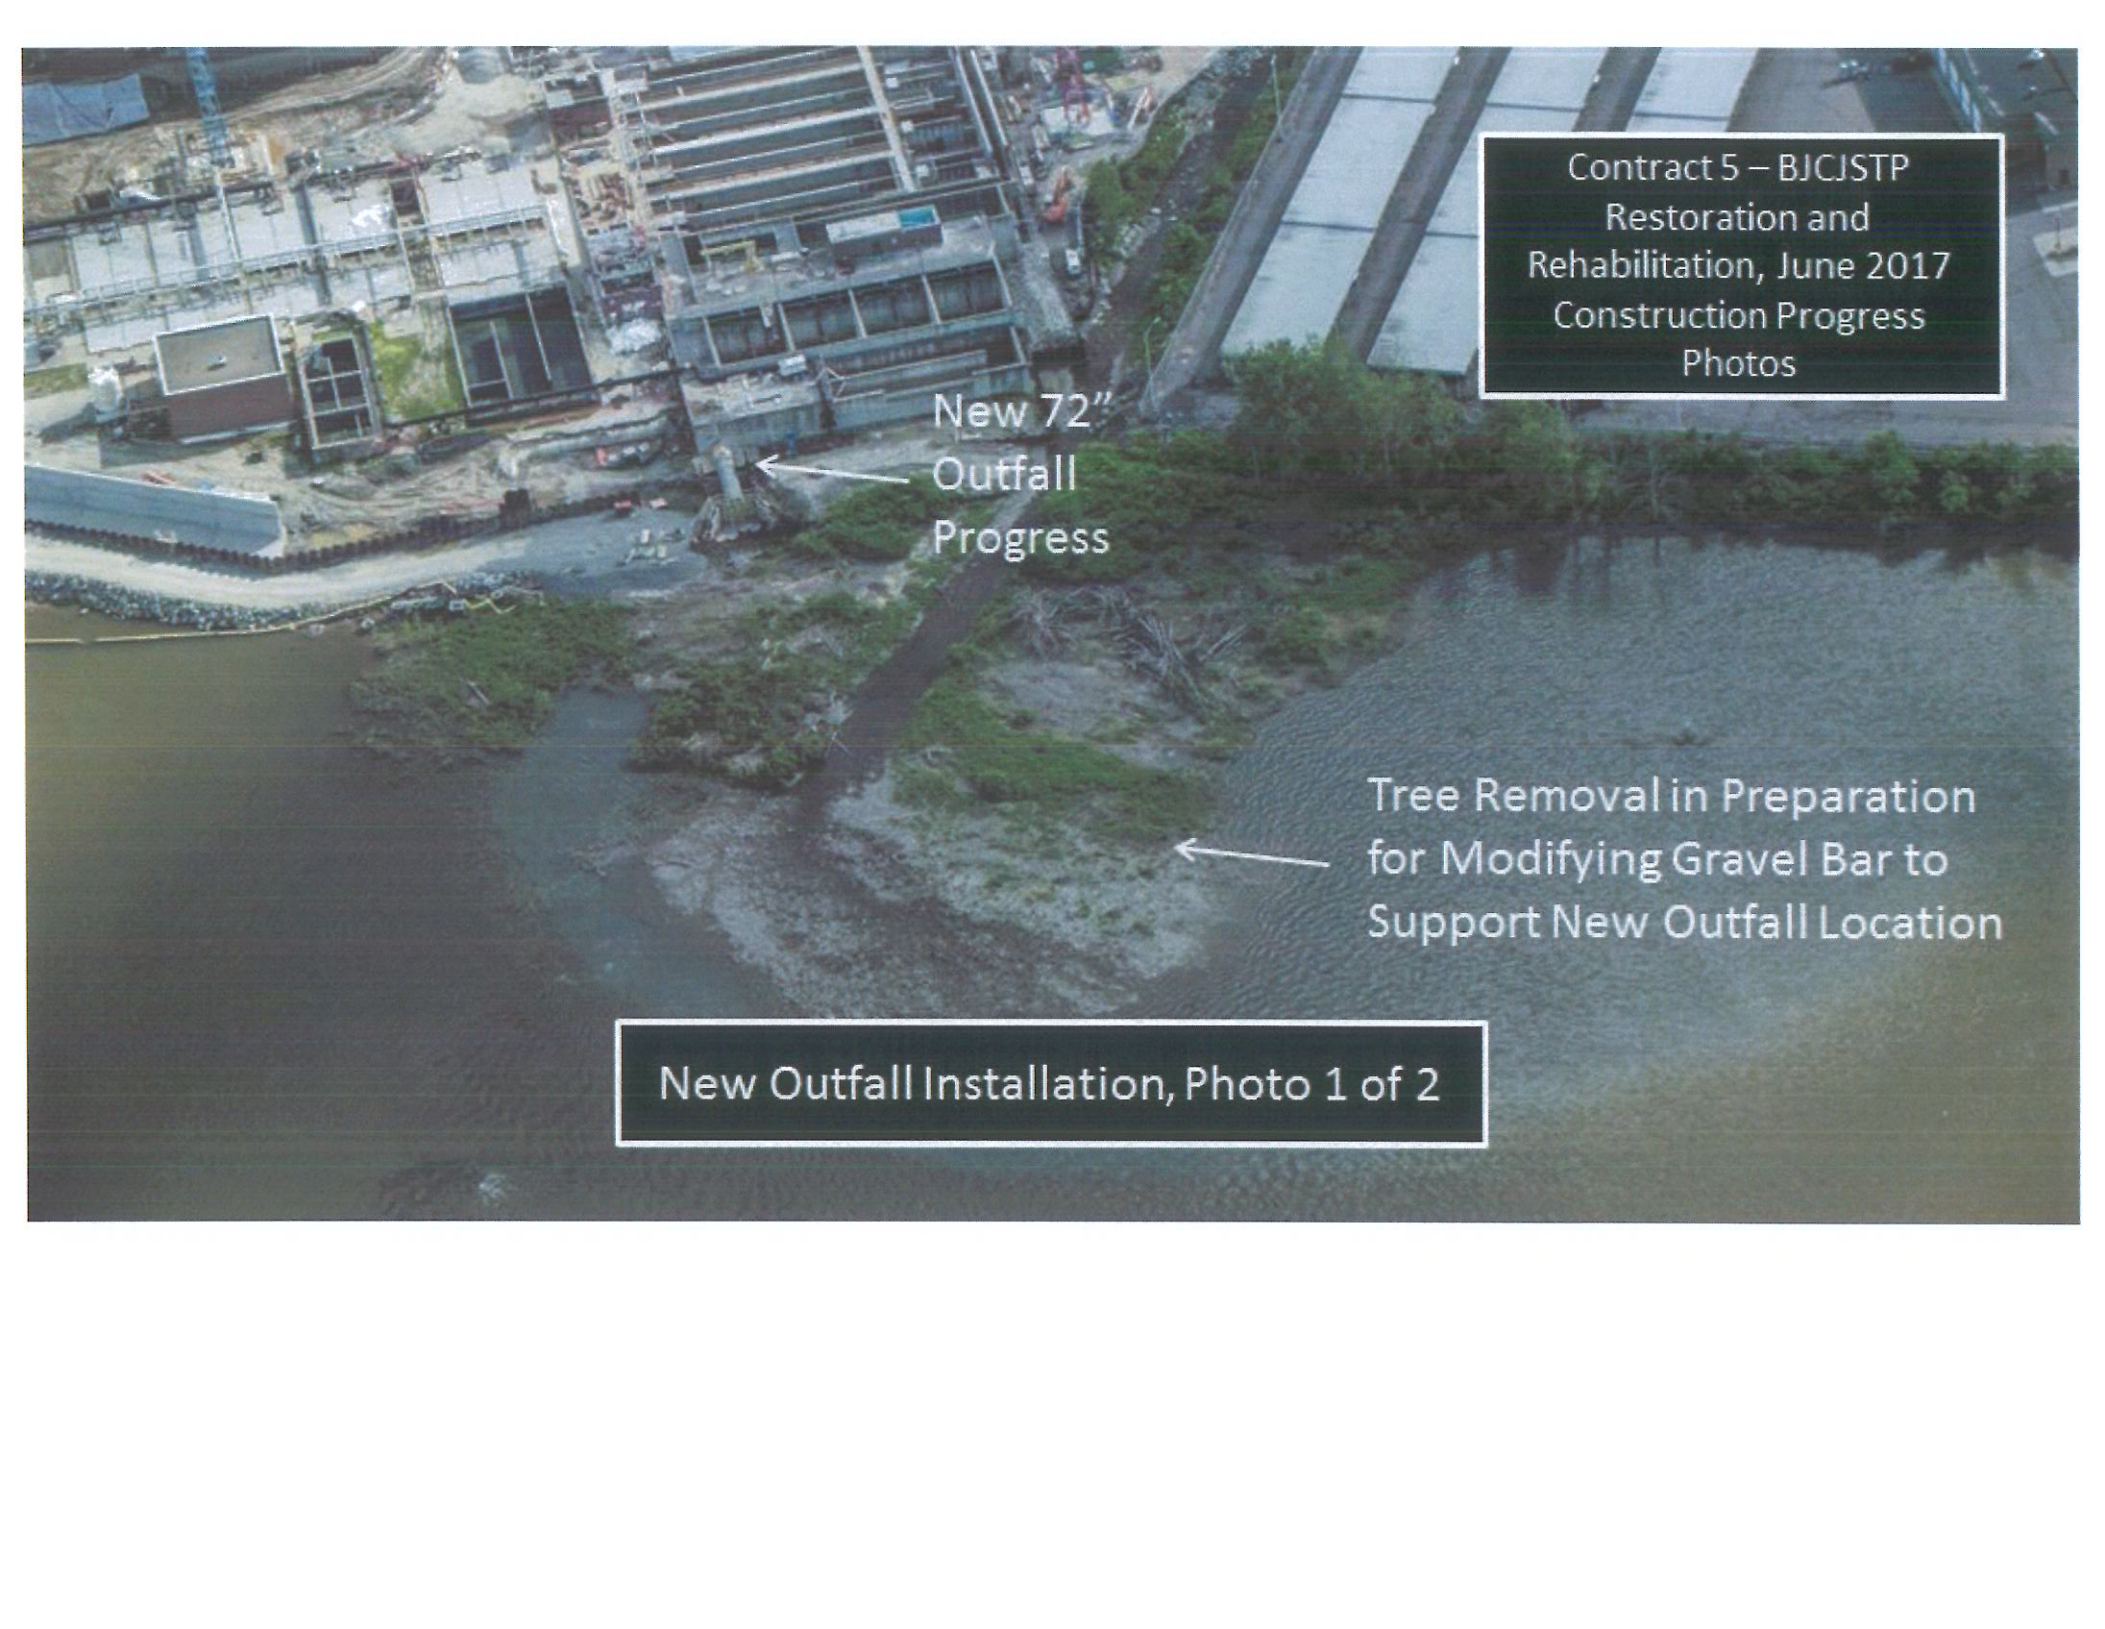
Contract 5 – BJCJSTP
Restoration and
Rehabilitation, June 2017
Construction Progress
Photos

New 72"
Outfall
Progress

New Outfall Installation, Photo 1 of 2

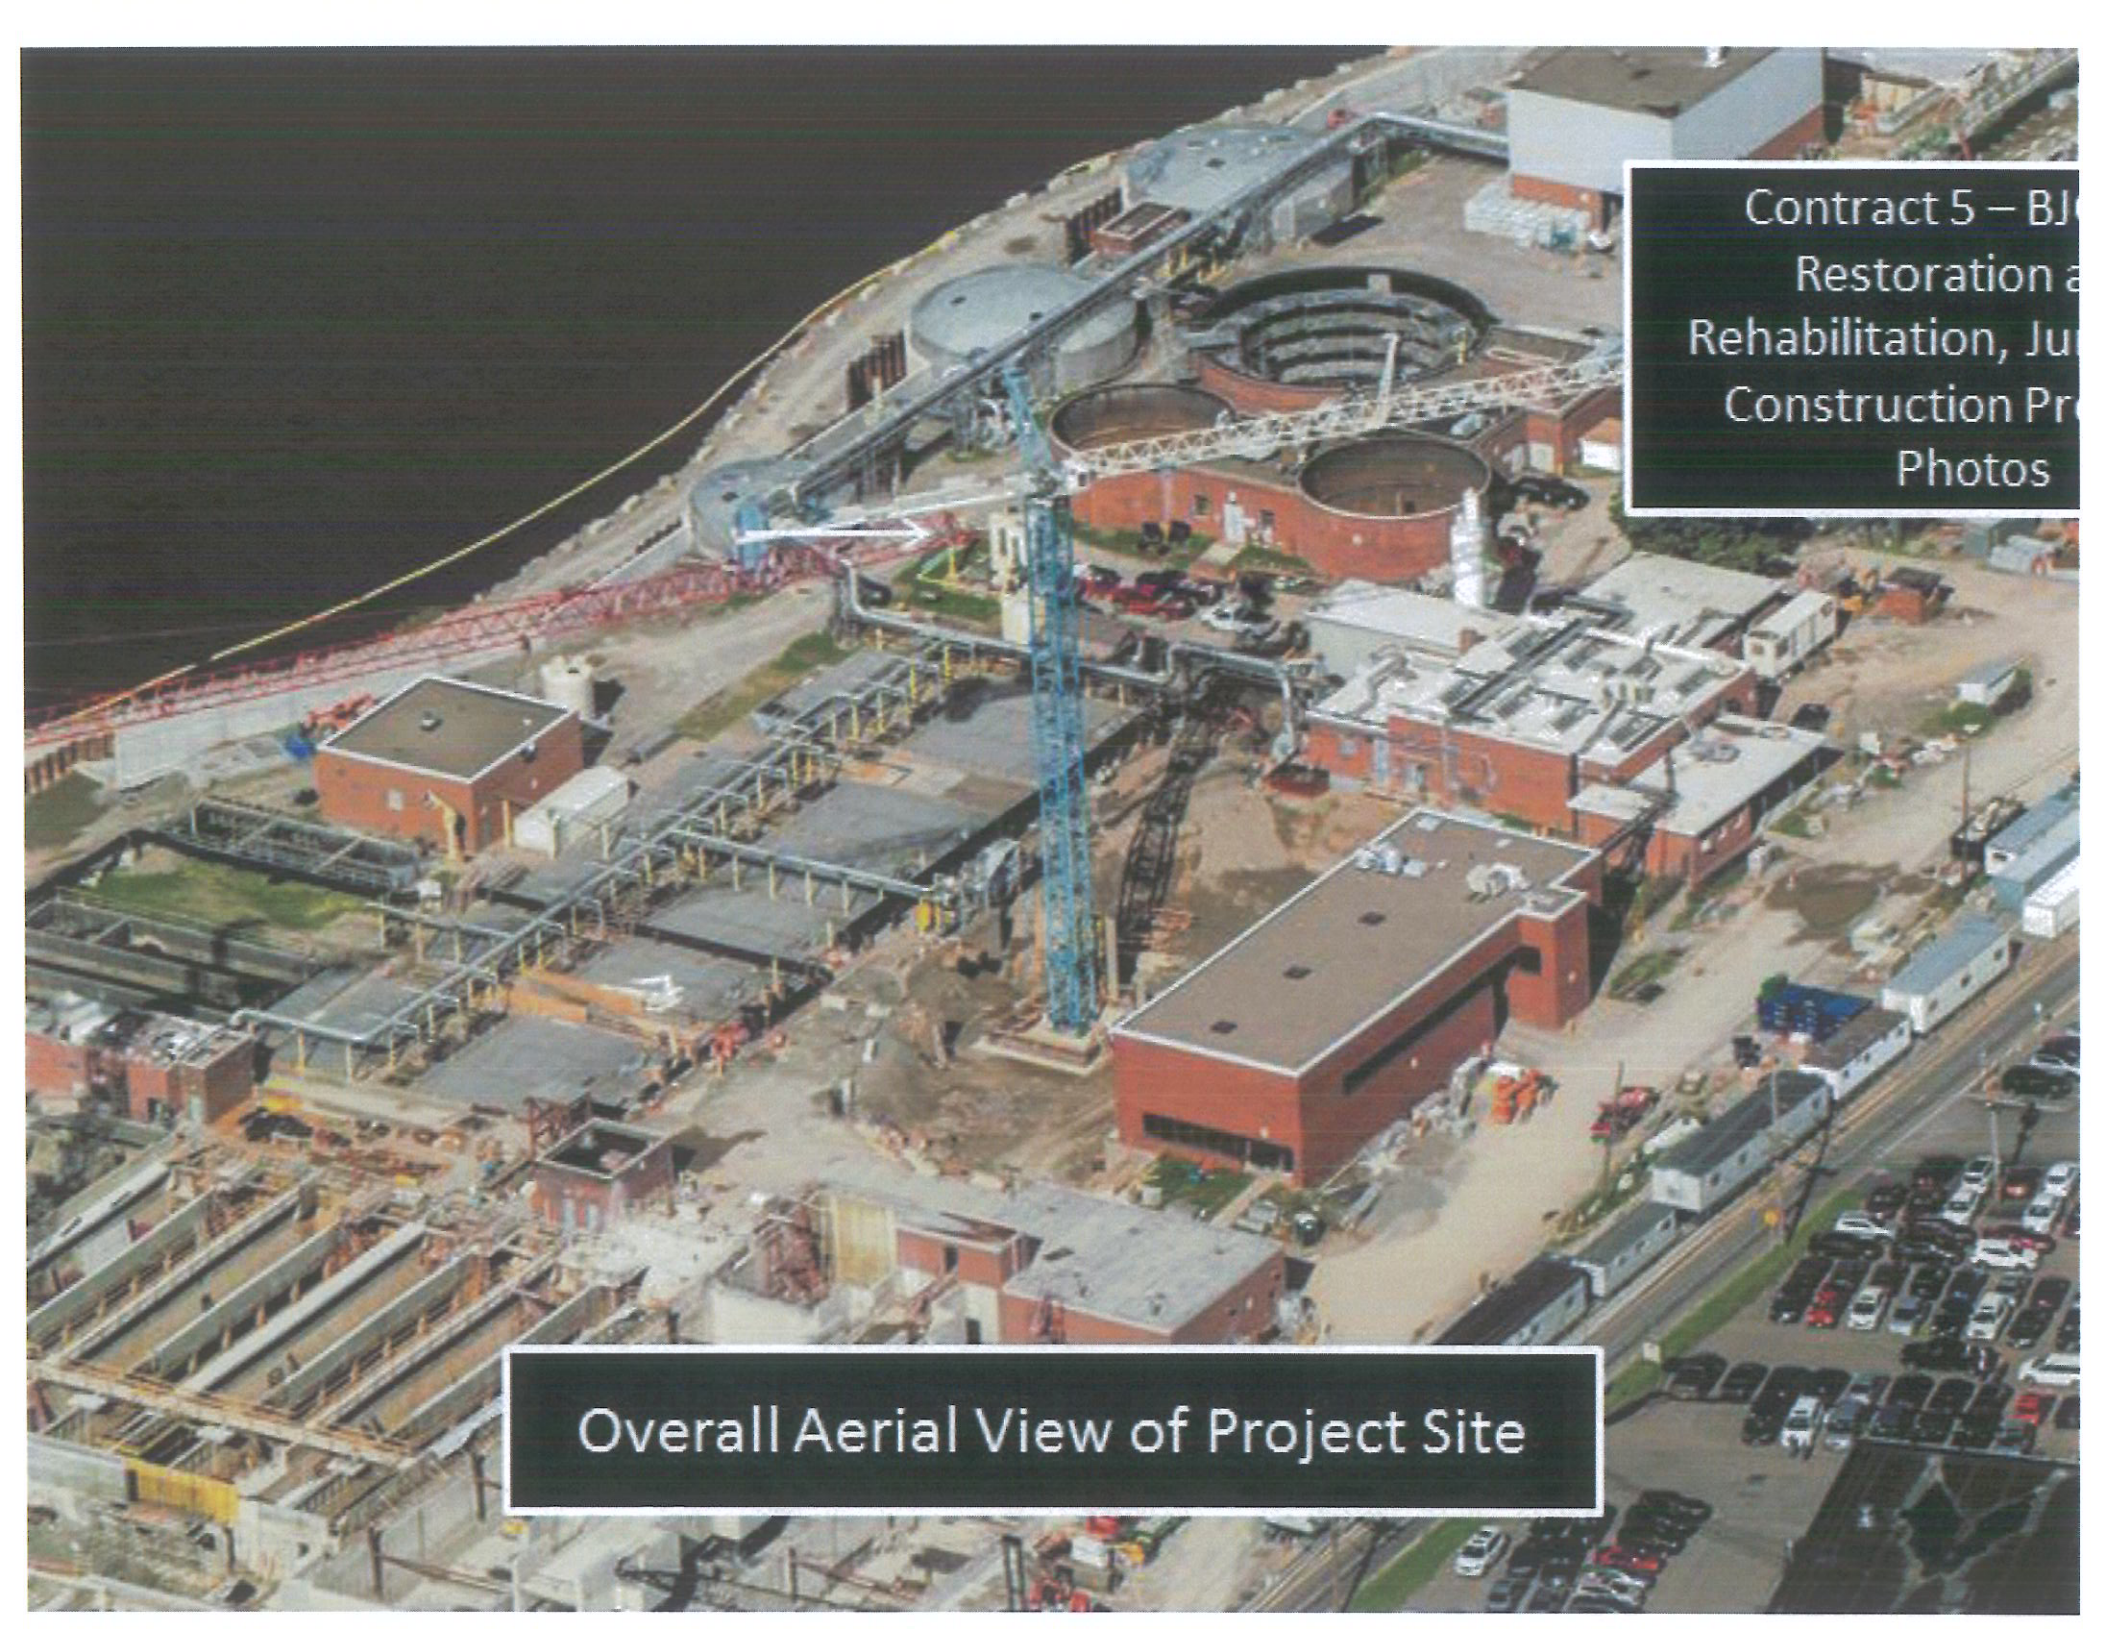
Overall Aerial View of Project Site

An aerial photograph of an industrial construction site. In the upper left, a large body of water is visible. The site features several large circular tanks, some with red brick walls and others with grey roofs. A prominent blue tower crane stands in the center. Various industrial buildings, some under construction with exposed steel frames, are scattered throughout. A parking lot with many cars is located in the lower right. The overall scene depicts a complex industrial restoration project.

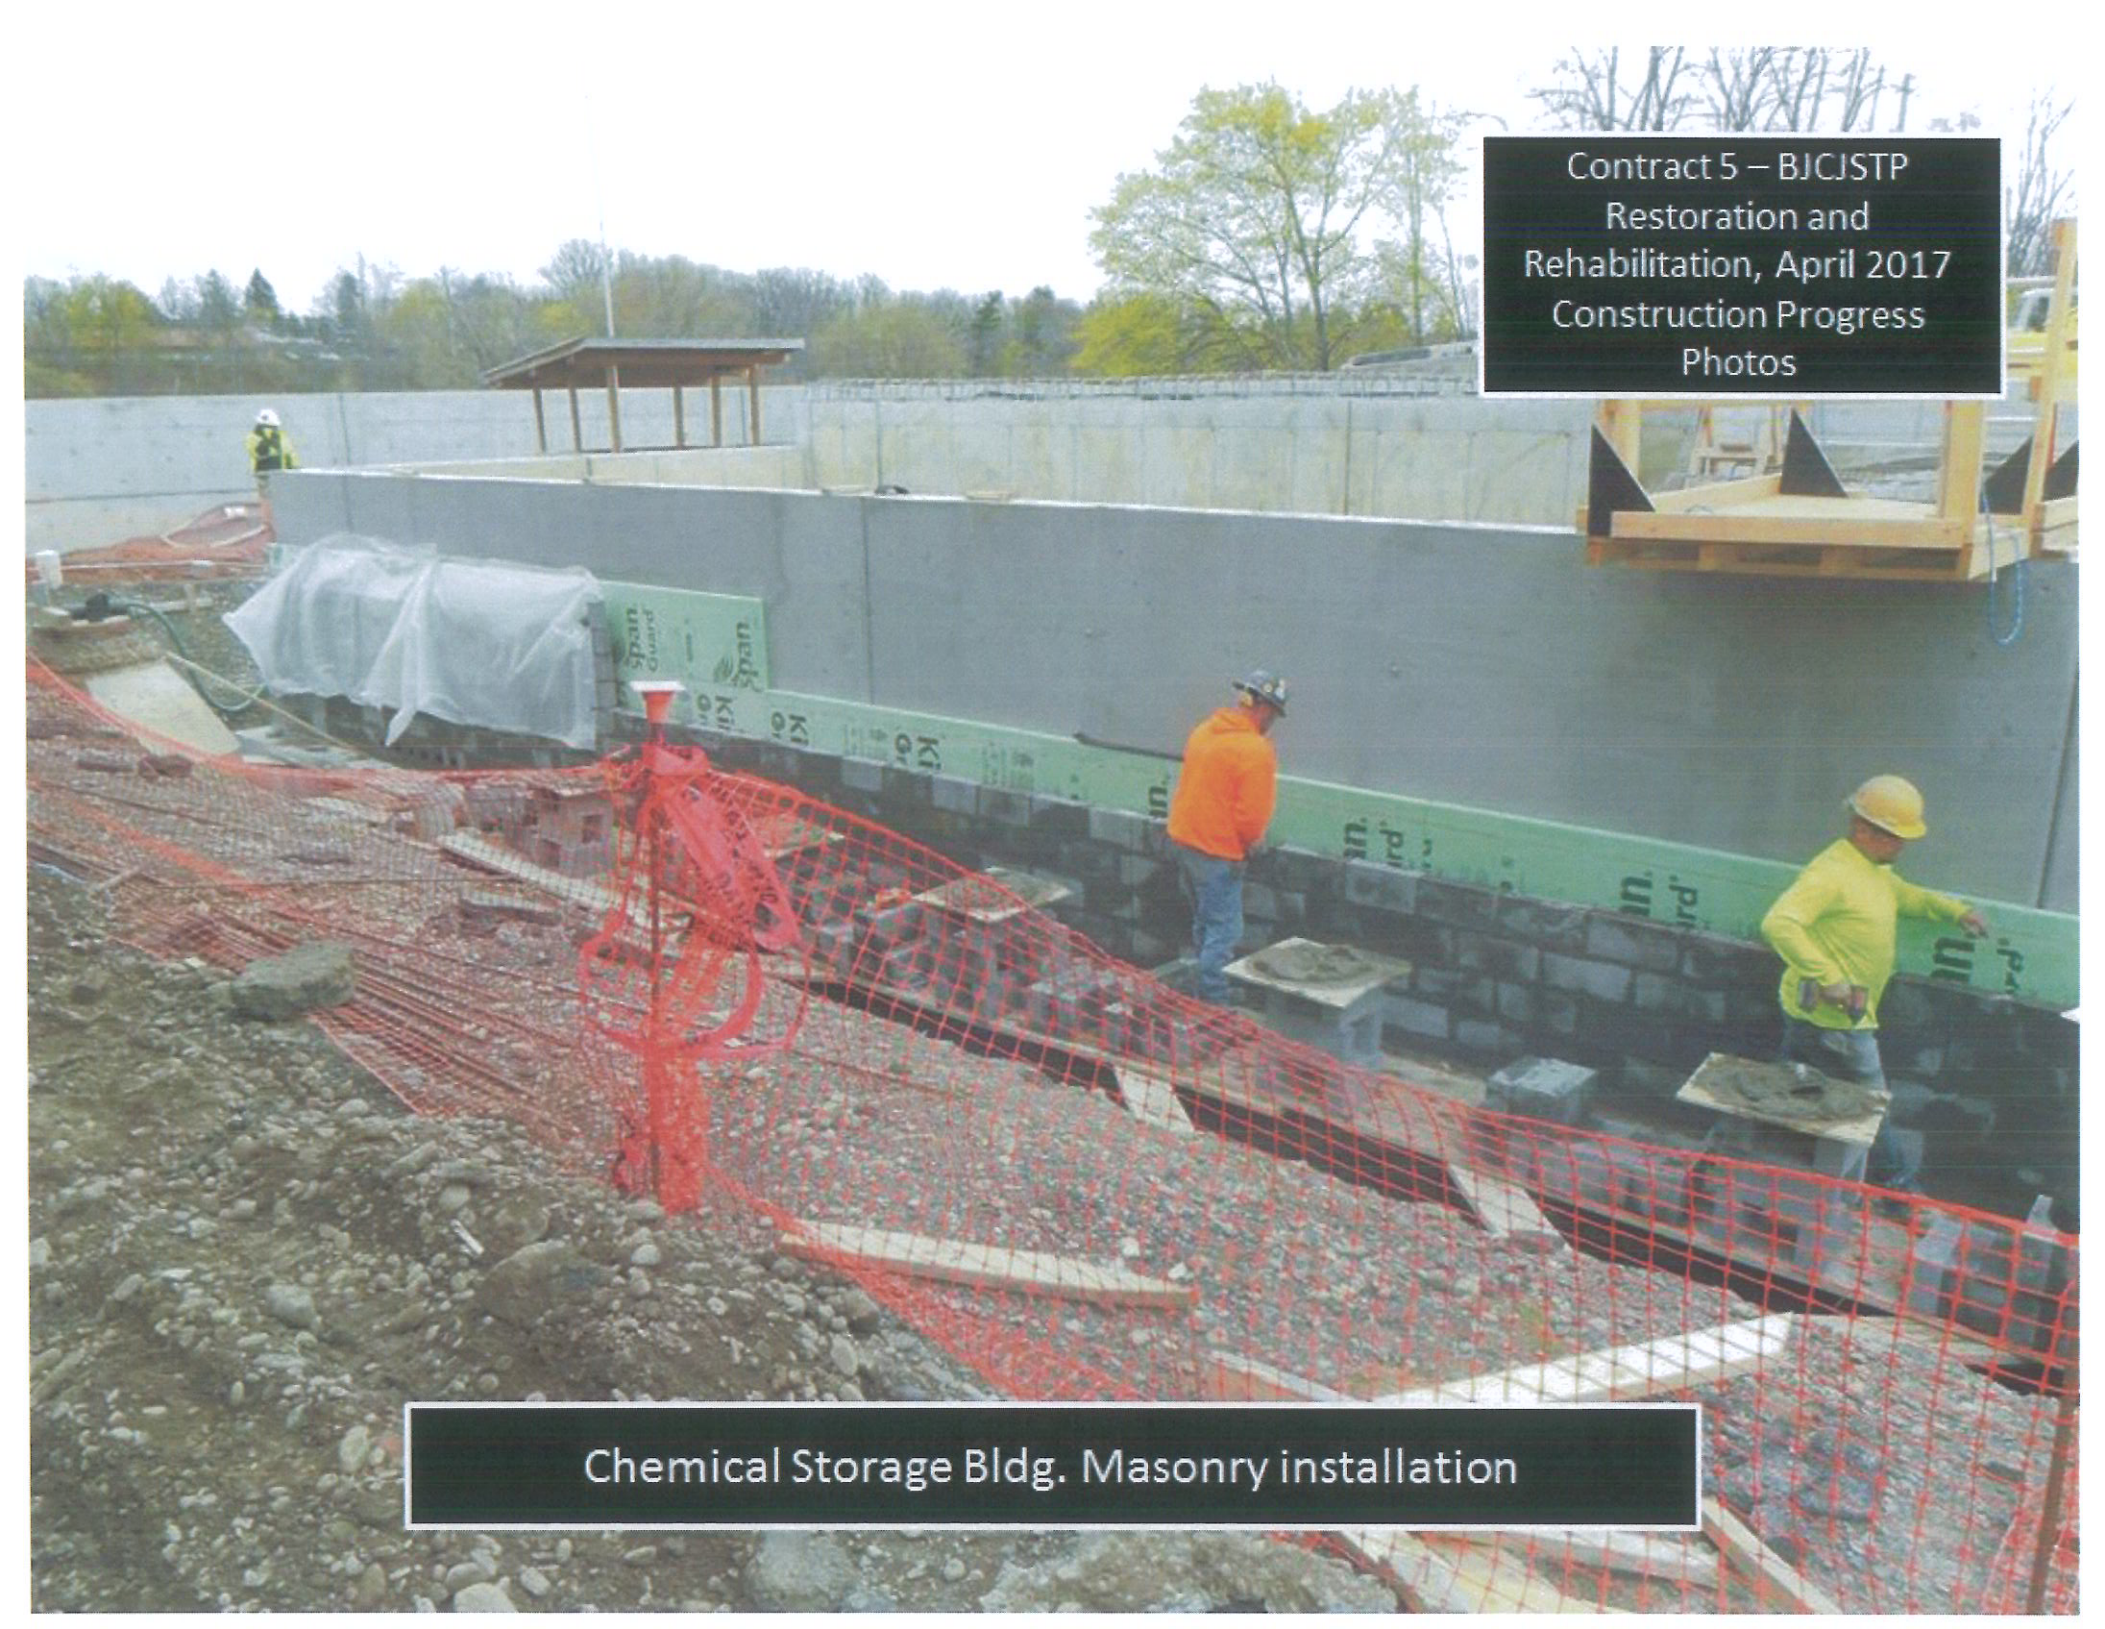
Contract 5 – BJCJSTP
Restoration and
Rehabilitation, April 2017
Construction Progress
Photos

Chemical Storage Bldg. Masonry installation

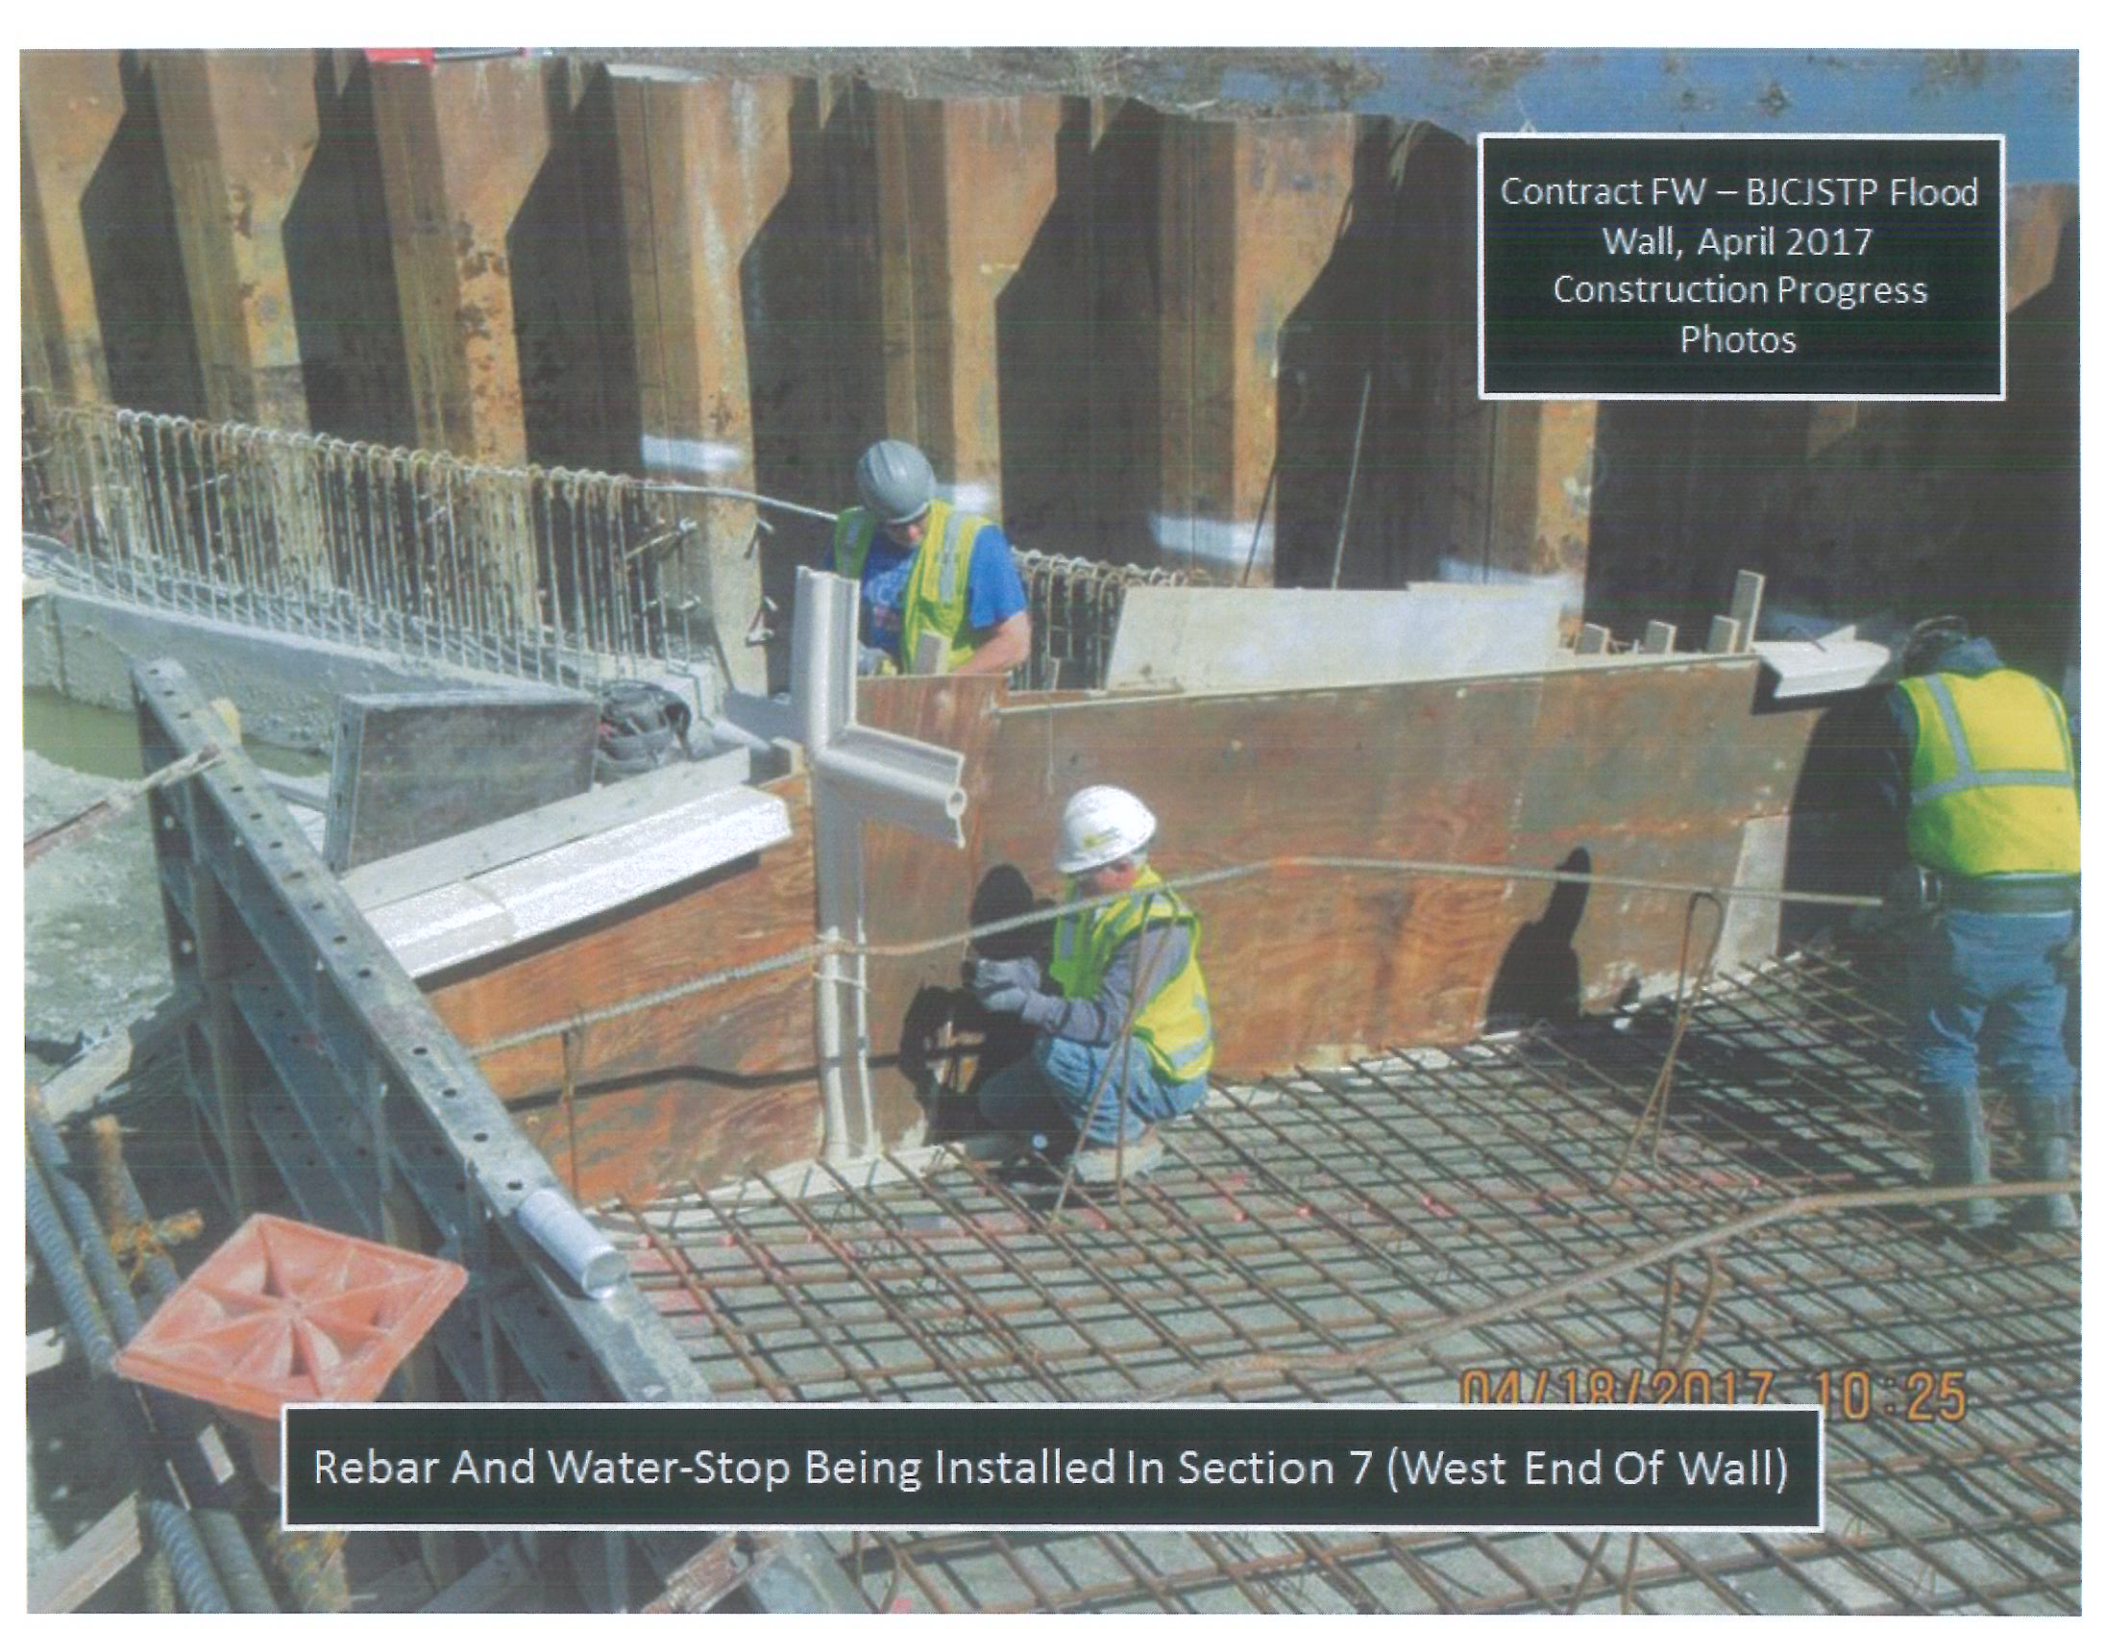
Contract FW – BJCJSTP Flood
Wall, April 2017
Construction Progress
Photos

A photograph of a construction site for a flood wall. The scene shows a large, rusted metal formwork structure. In the foreground, a dense grid of steel rebar is laid out on a concrete base. A worker in a white hard hat and yellow safety vest is kneeling on the rebar, working on a vertical pipe or water-stop. Another worker in a blue shirt and yellow vest is standing nearby. A third worker in a yellow vest is visible on the right side of the frame. The background shows more of the formwork structure. The overall environment is industrial and construction-oriented.

Rebar And Water-Stop Being Installed In Section 7 (West End Of Wall)

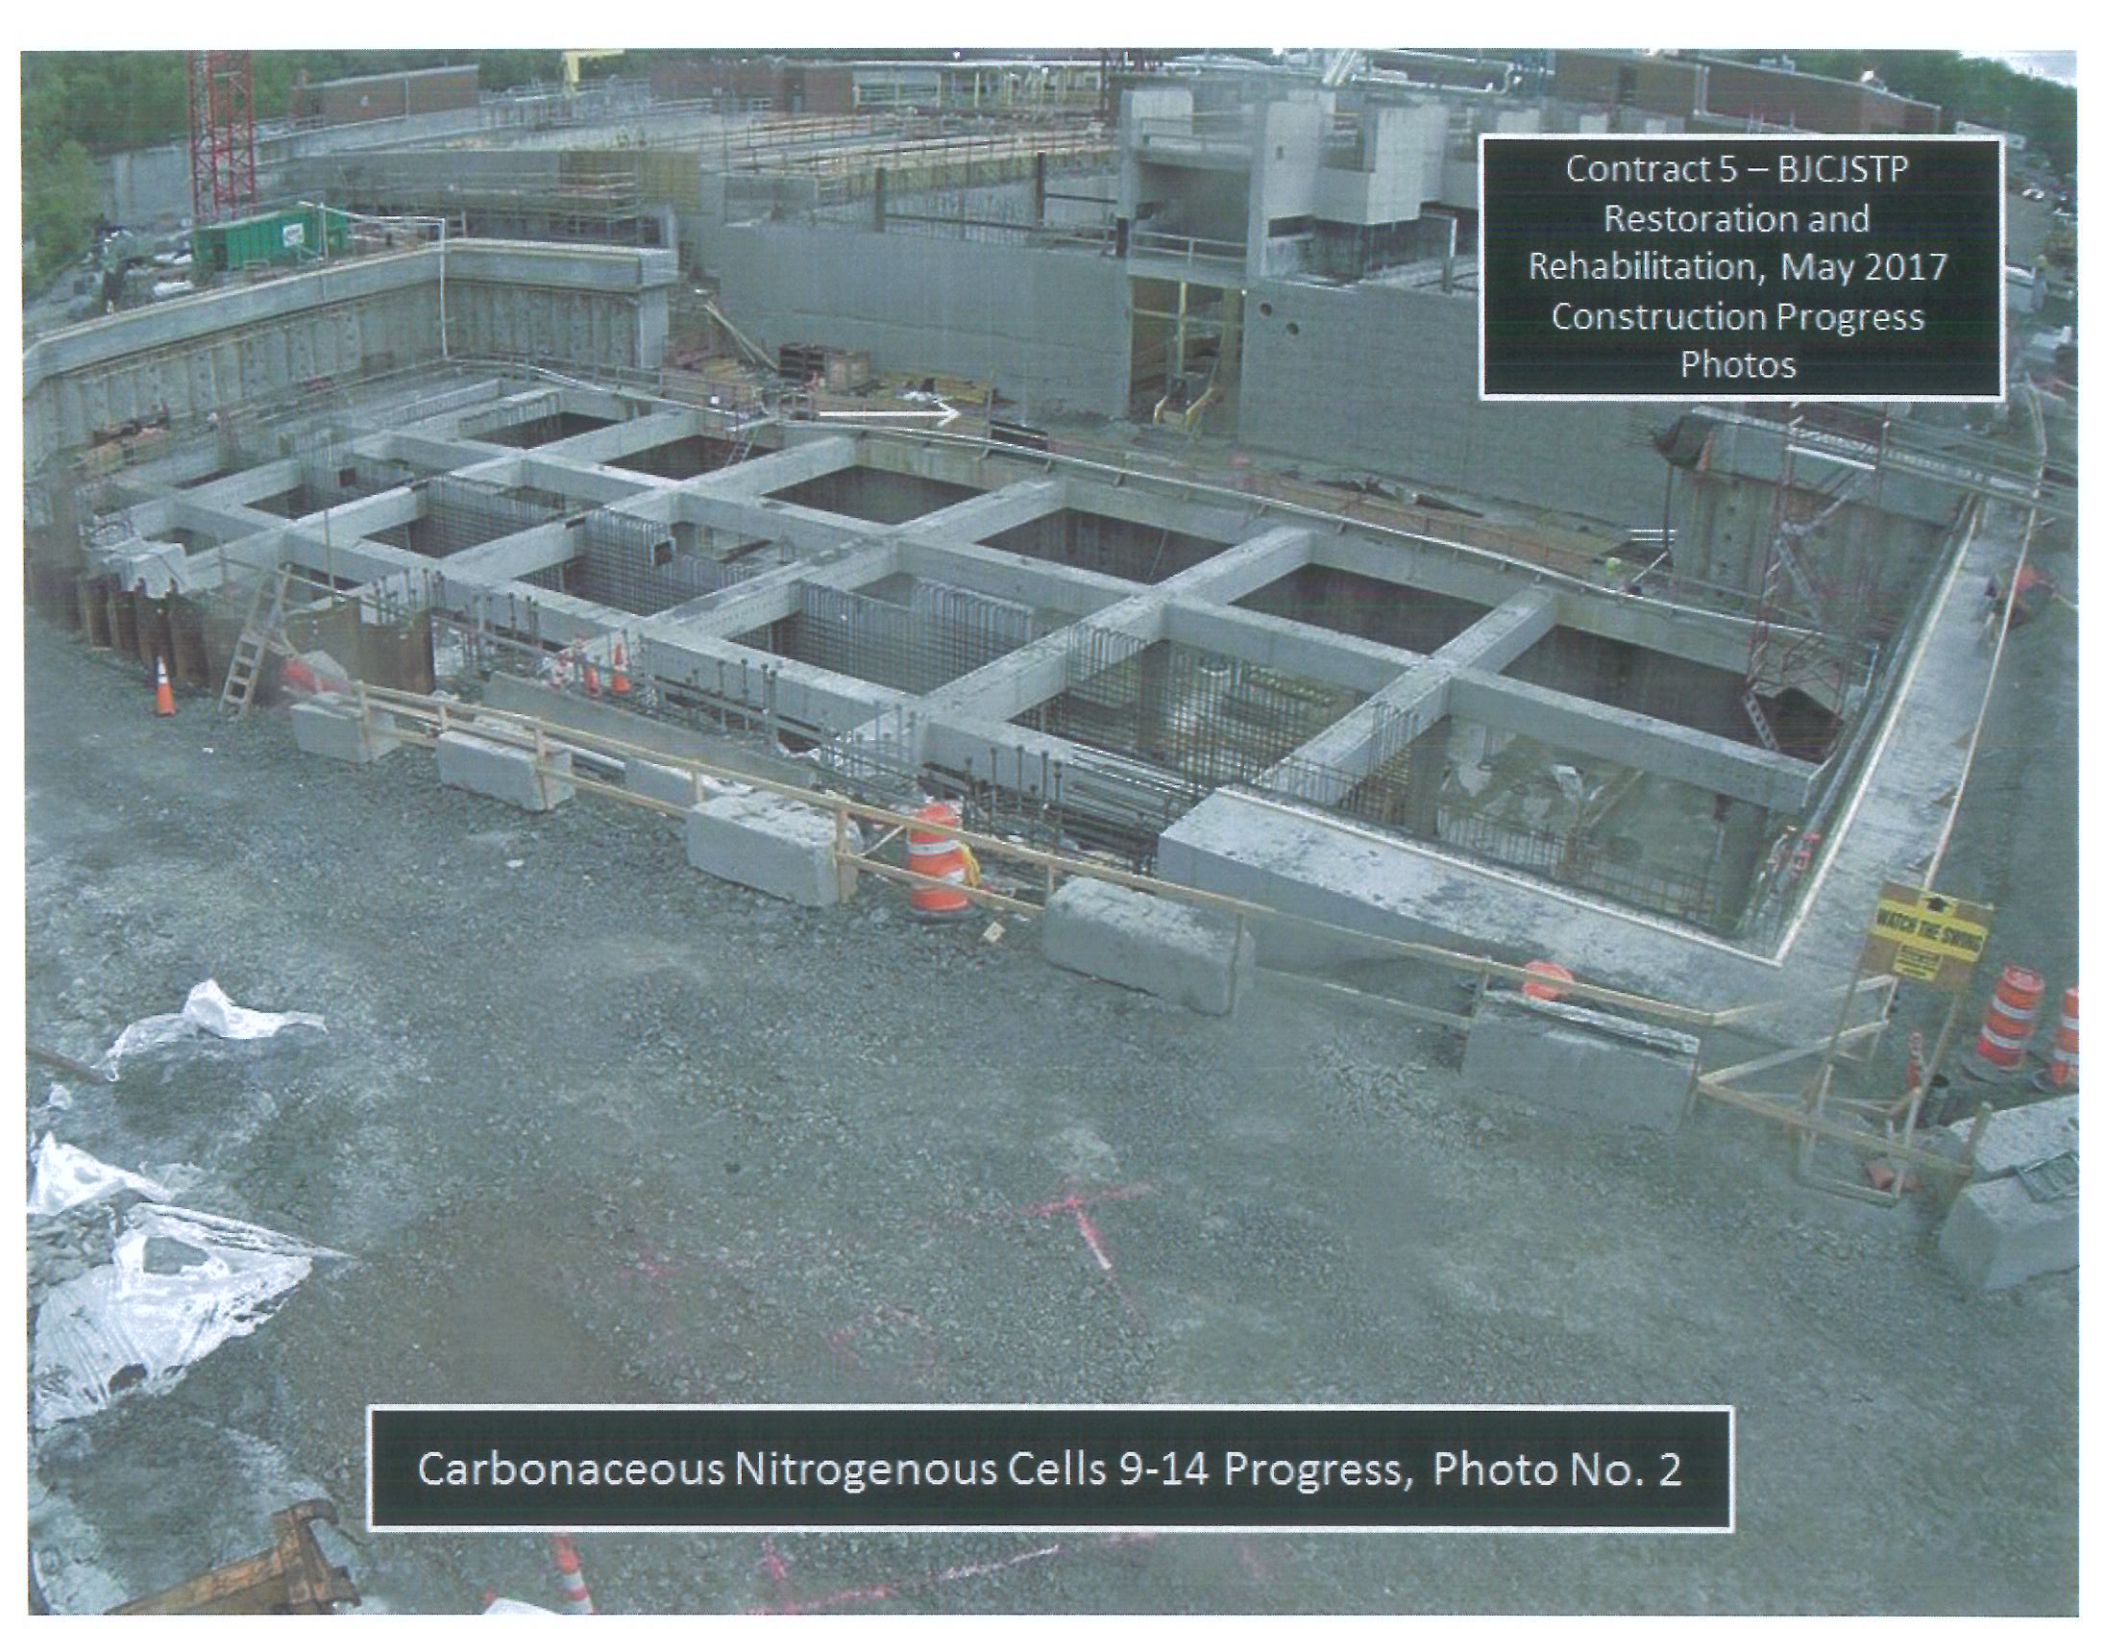
Contract 5 – BJCJSTP
Restoration and
Rehabilitation, May 2017
Construction Progress
Photos

Carbonaceous Nitrogenous Cells 9-14 Progress, Photo No. 2

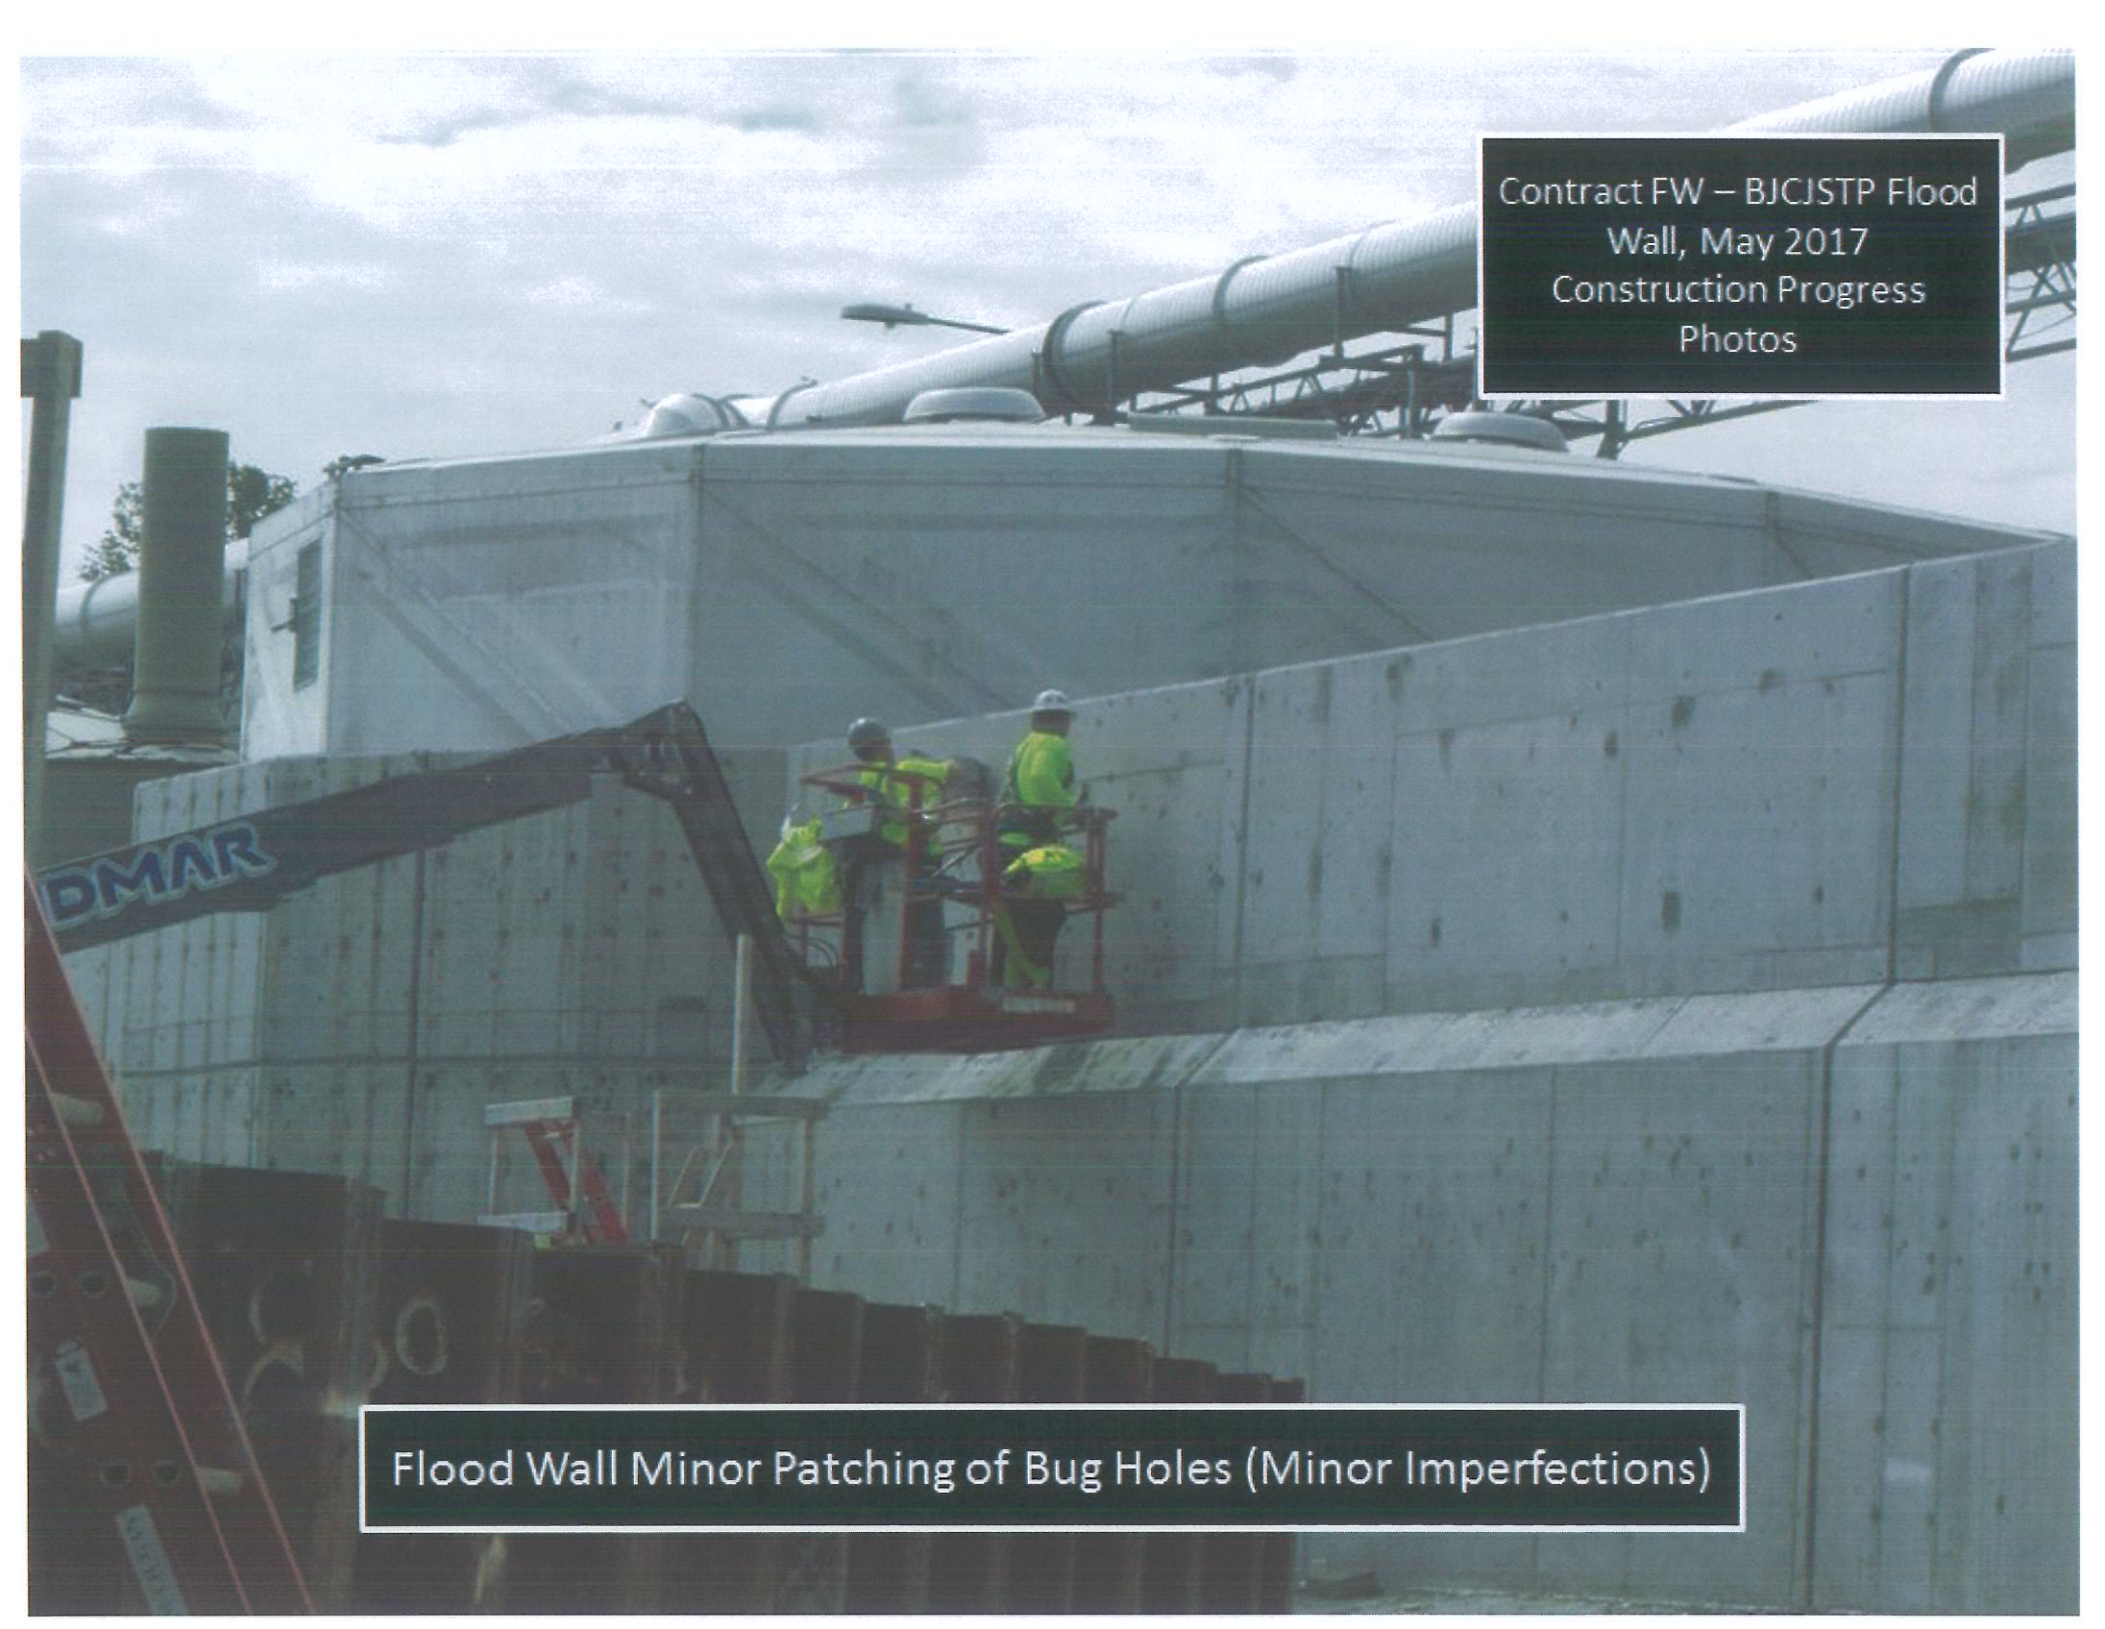
Contract FW – BJCJSTP Flood
Wall, May 2017
Construction Progress
Photos

Flood Wall Minor Patching of Bug Holes (Minor Imperfections)
