**Binghamton-Johnson City Joint Sewage
Treatment Plant Restoration and
Rehabilitation Project**

2017 Quarter 2 Report

*City of Binghamton
Village of Johnson City
Joint Sewage Board*

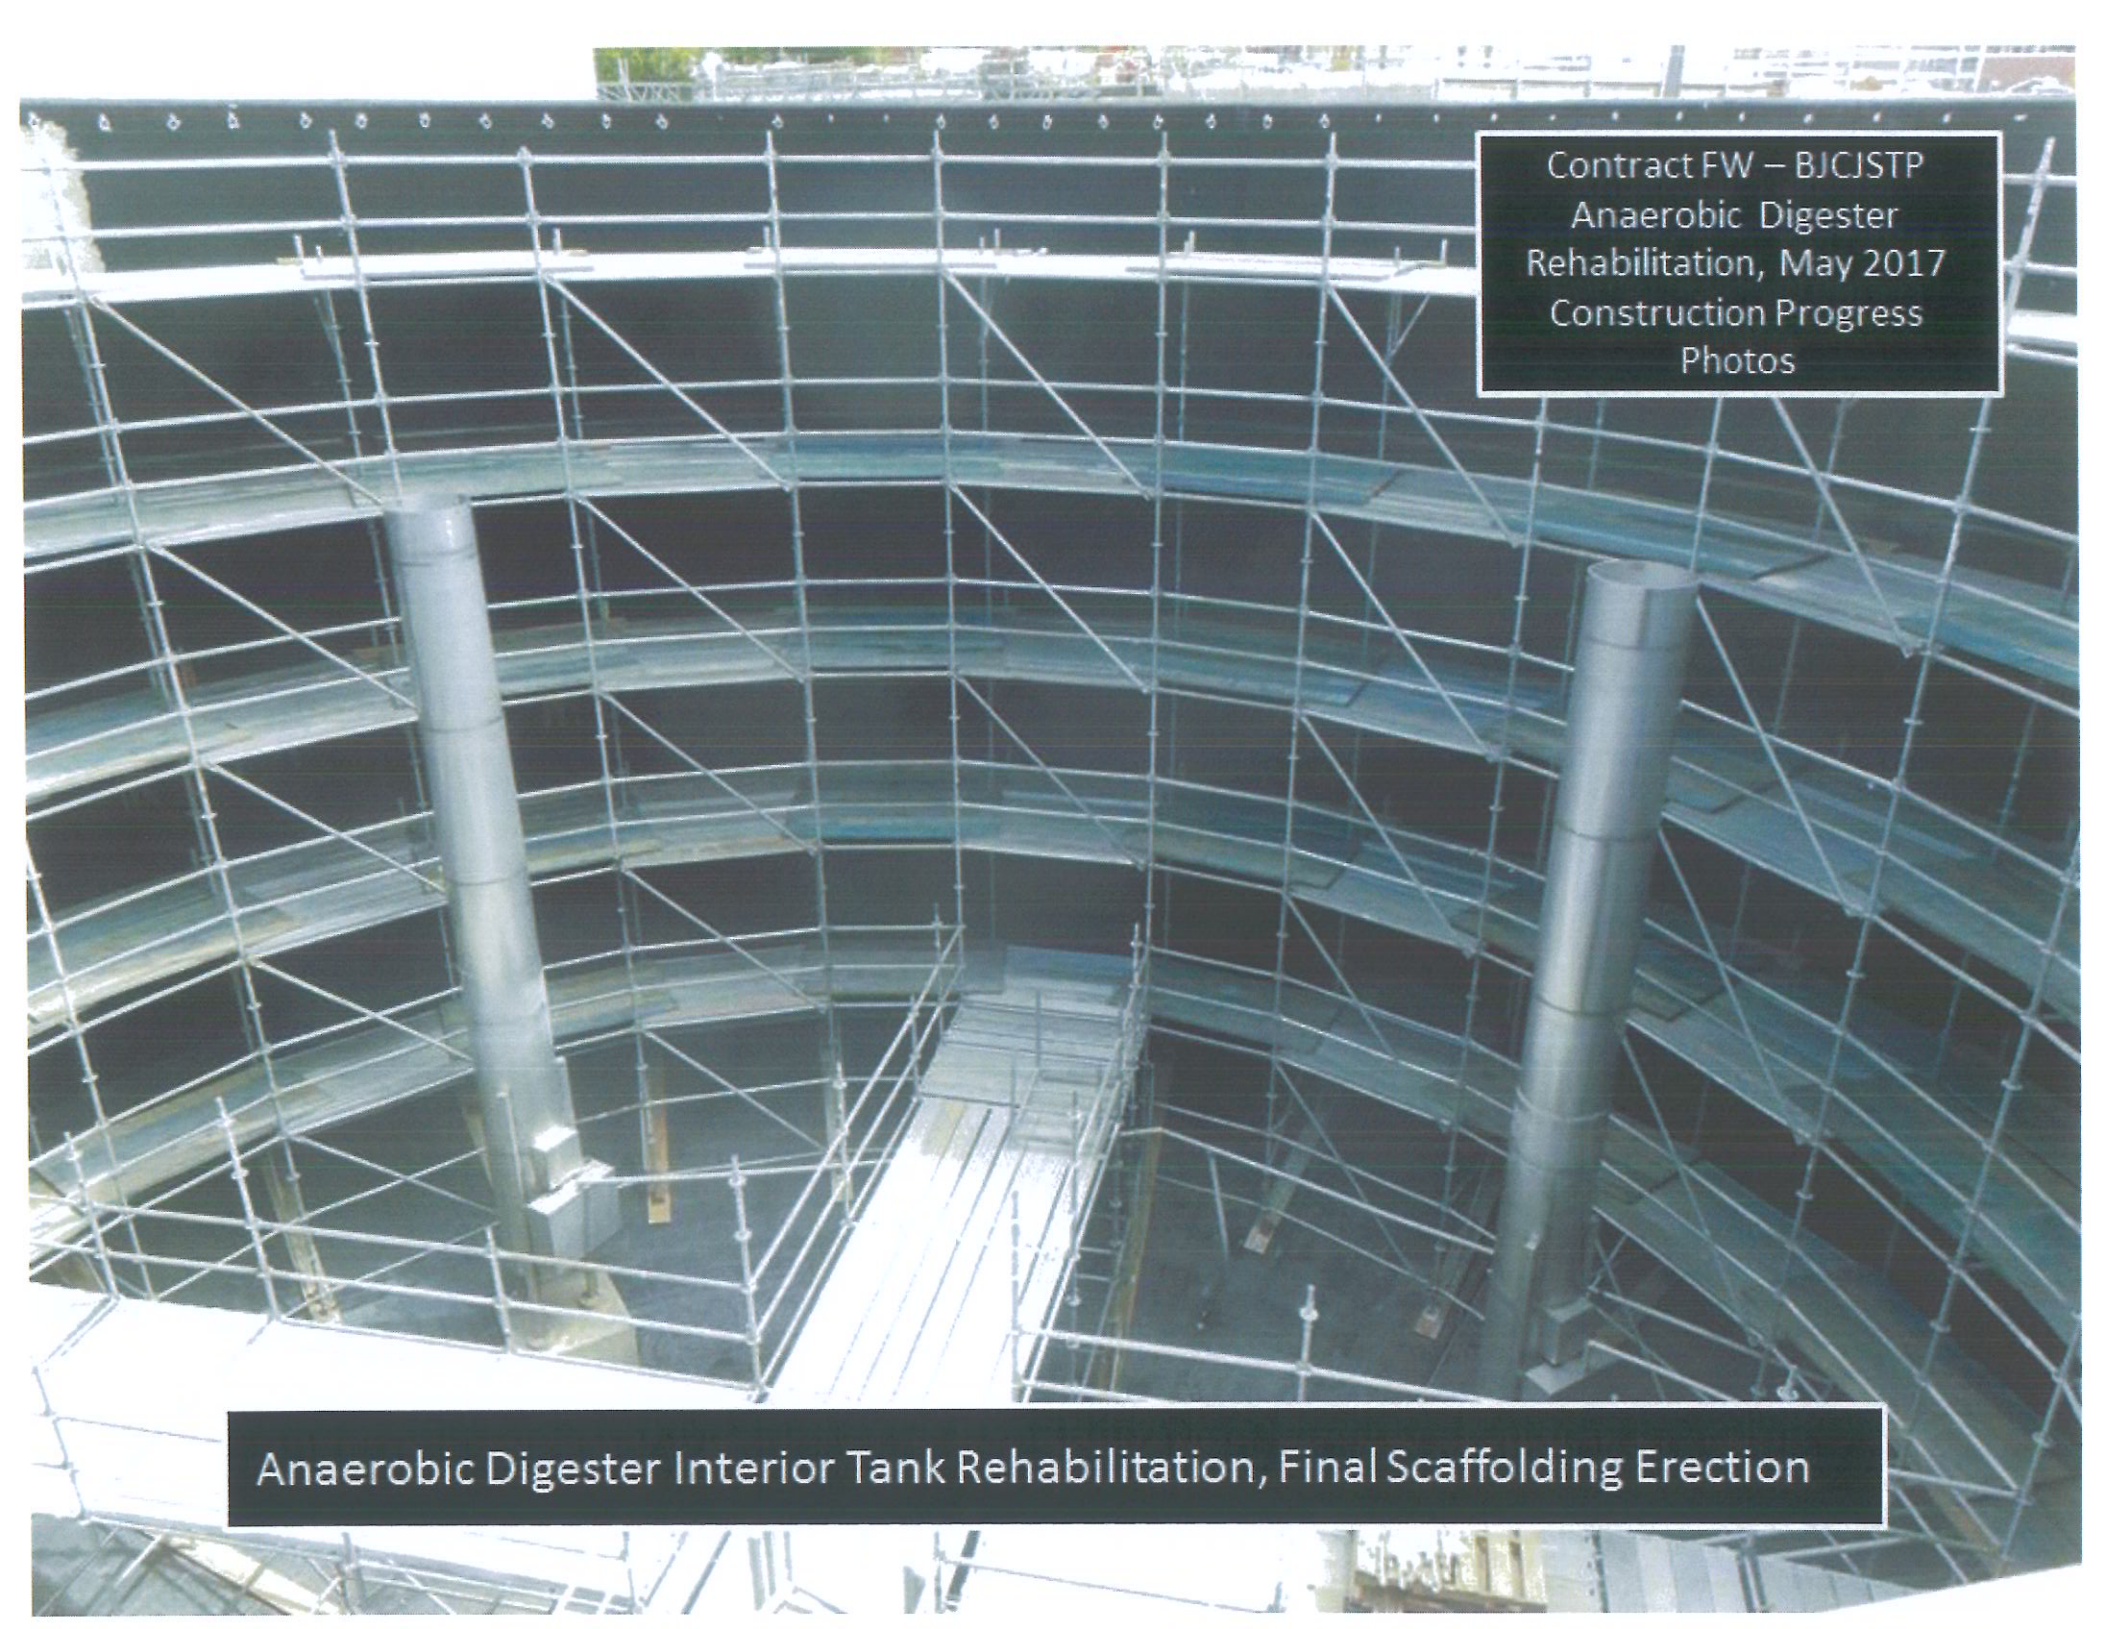
Contract FW – BJCJSTP
Anaerobic Digester
Rehabilitation, May 2017
Construction Progress
Photos

Anaerobic Digester Interior Tank Rehabilitation, Final Scaffolding Erection
