**Binghamton-Johnson City Joint Sewage
Treatment Plant Restoration and
Rehabilitation Project**

2017 Quarter 3 Report

*City of Binghamton
Village of Johnson City
Joint Sewage Board*

September 2017

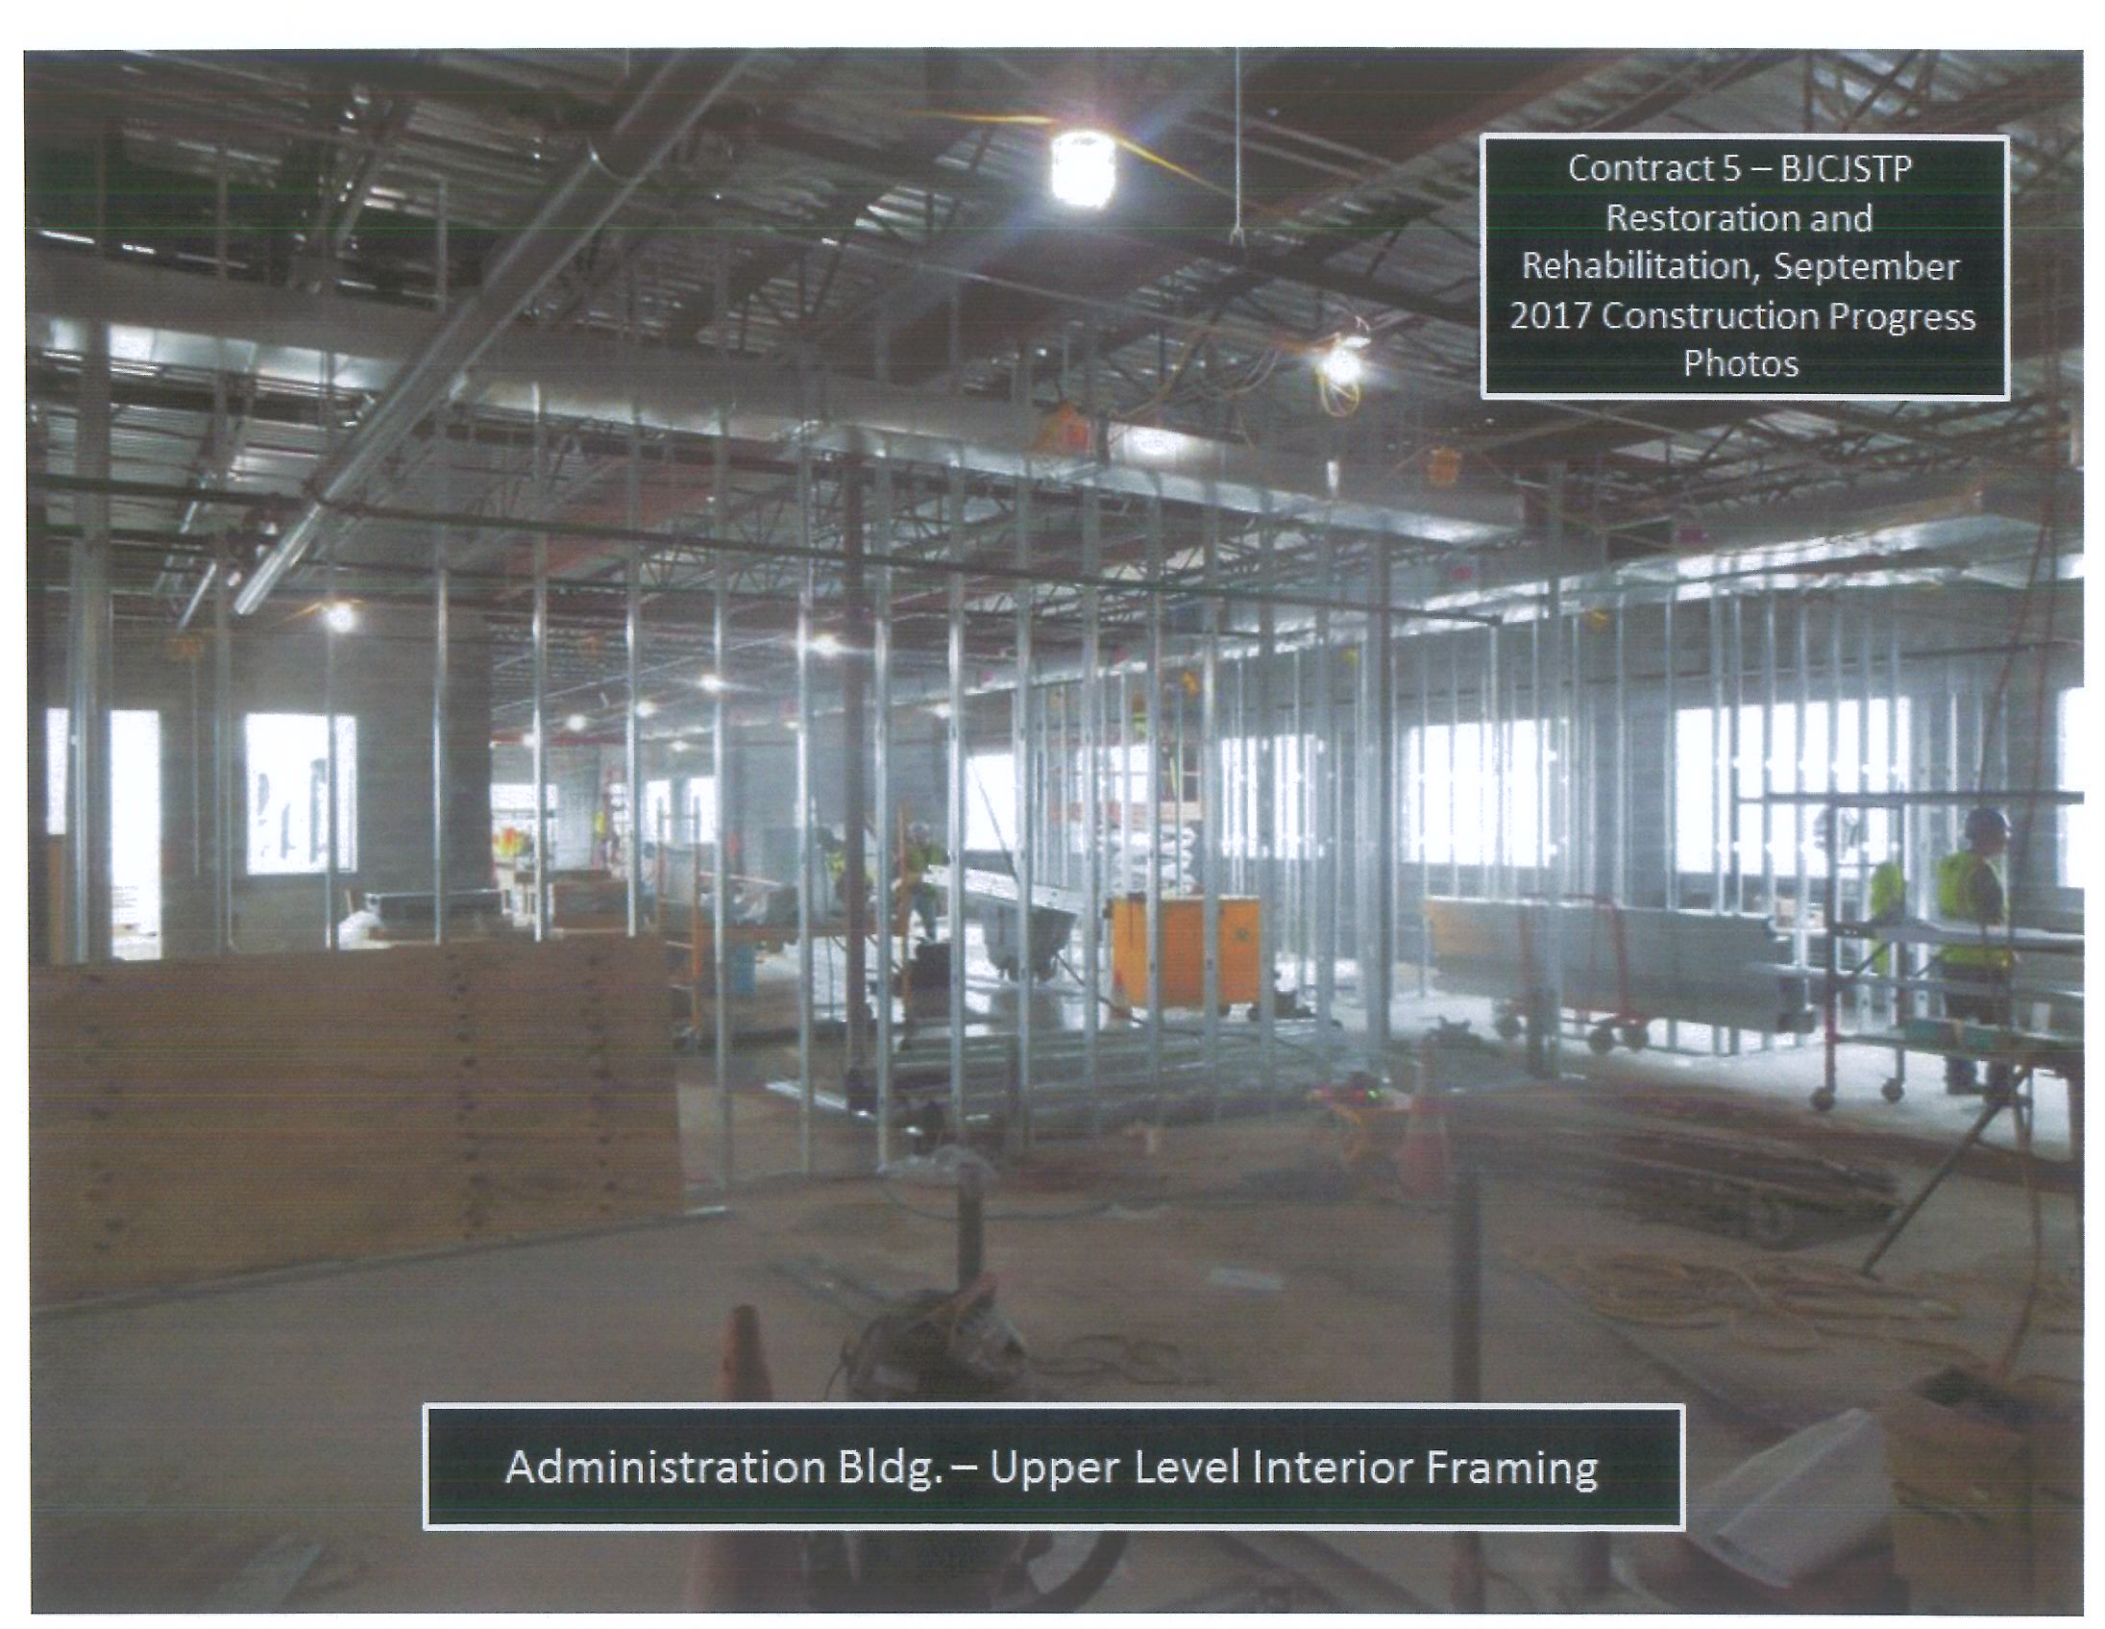
Contract 5 – BJCJSTP
Restoration and
Rehabilitation, September
2017 Construction Progress
Photos

A wide-angle photograph of a large, open-plan interior space under construction. The ceiling is high and features a complex network of steel trusses and beams. Numerous vertical metal studs are in place, forming the skeleton for walls and partitions. The floor is a smooth, light-colored concrete. In the background, several workers in high-visibility vests are visible near a work area. The lighting is provided by several bright, industrial-style pendant lights hanging from the ceiling. The overall atmosphere is one of active construction.

Administration Bldg. – Upper Level Interior Framing

Concrete work in C-N Cells has begun and is scheduled to be completed in early to middle of 2018. The work on the new Administration Building is scheduled to complete in December 2017. The Master Schedule was updated to show the status of the work from the month of September through the end of 2018. The latest draft shows that the Phase I Milestone is scheduled to be completed in August 2018 and the Phase 2 Milestone is scheduled to complete in early 2019. The Kruger submittal is nearing completion and the precast concrete elements and some equipment have already arrived to the project.

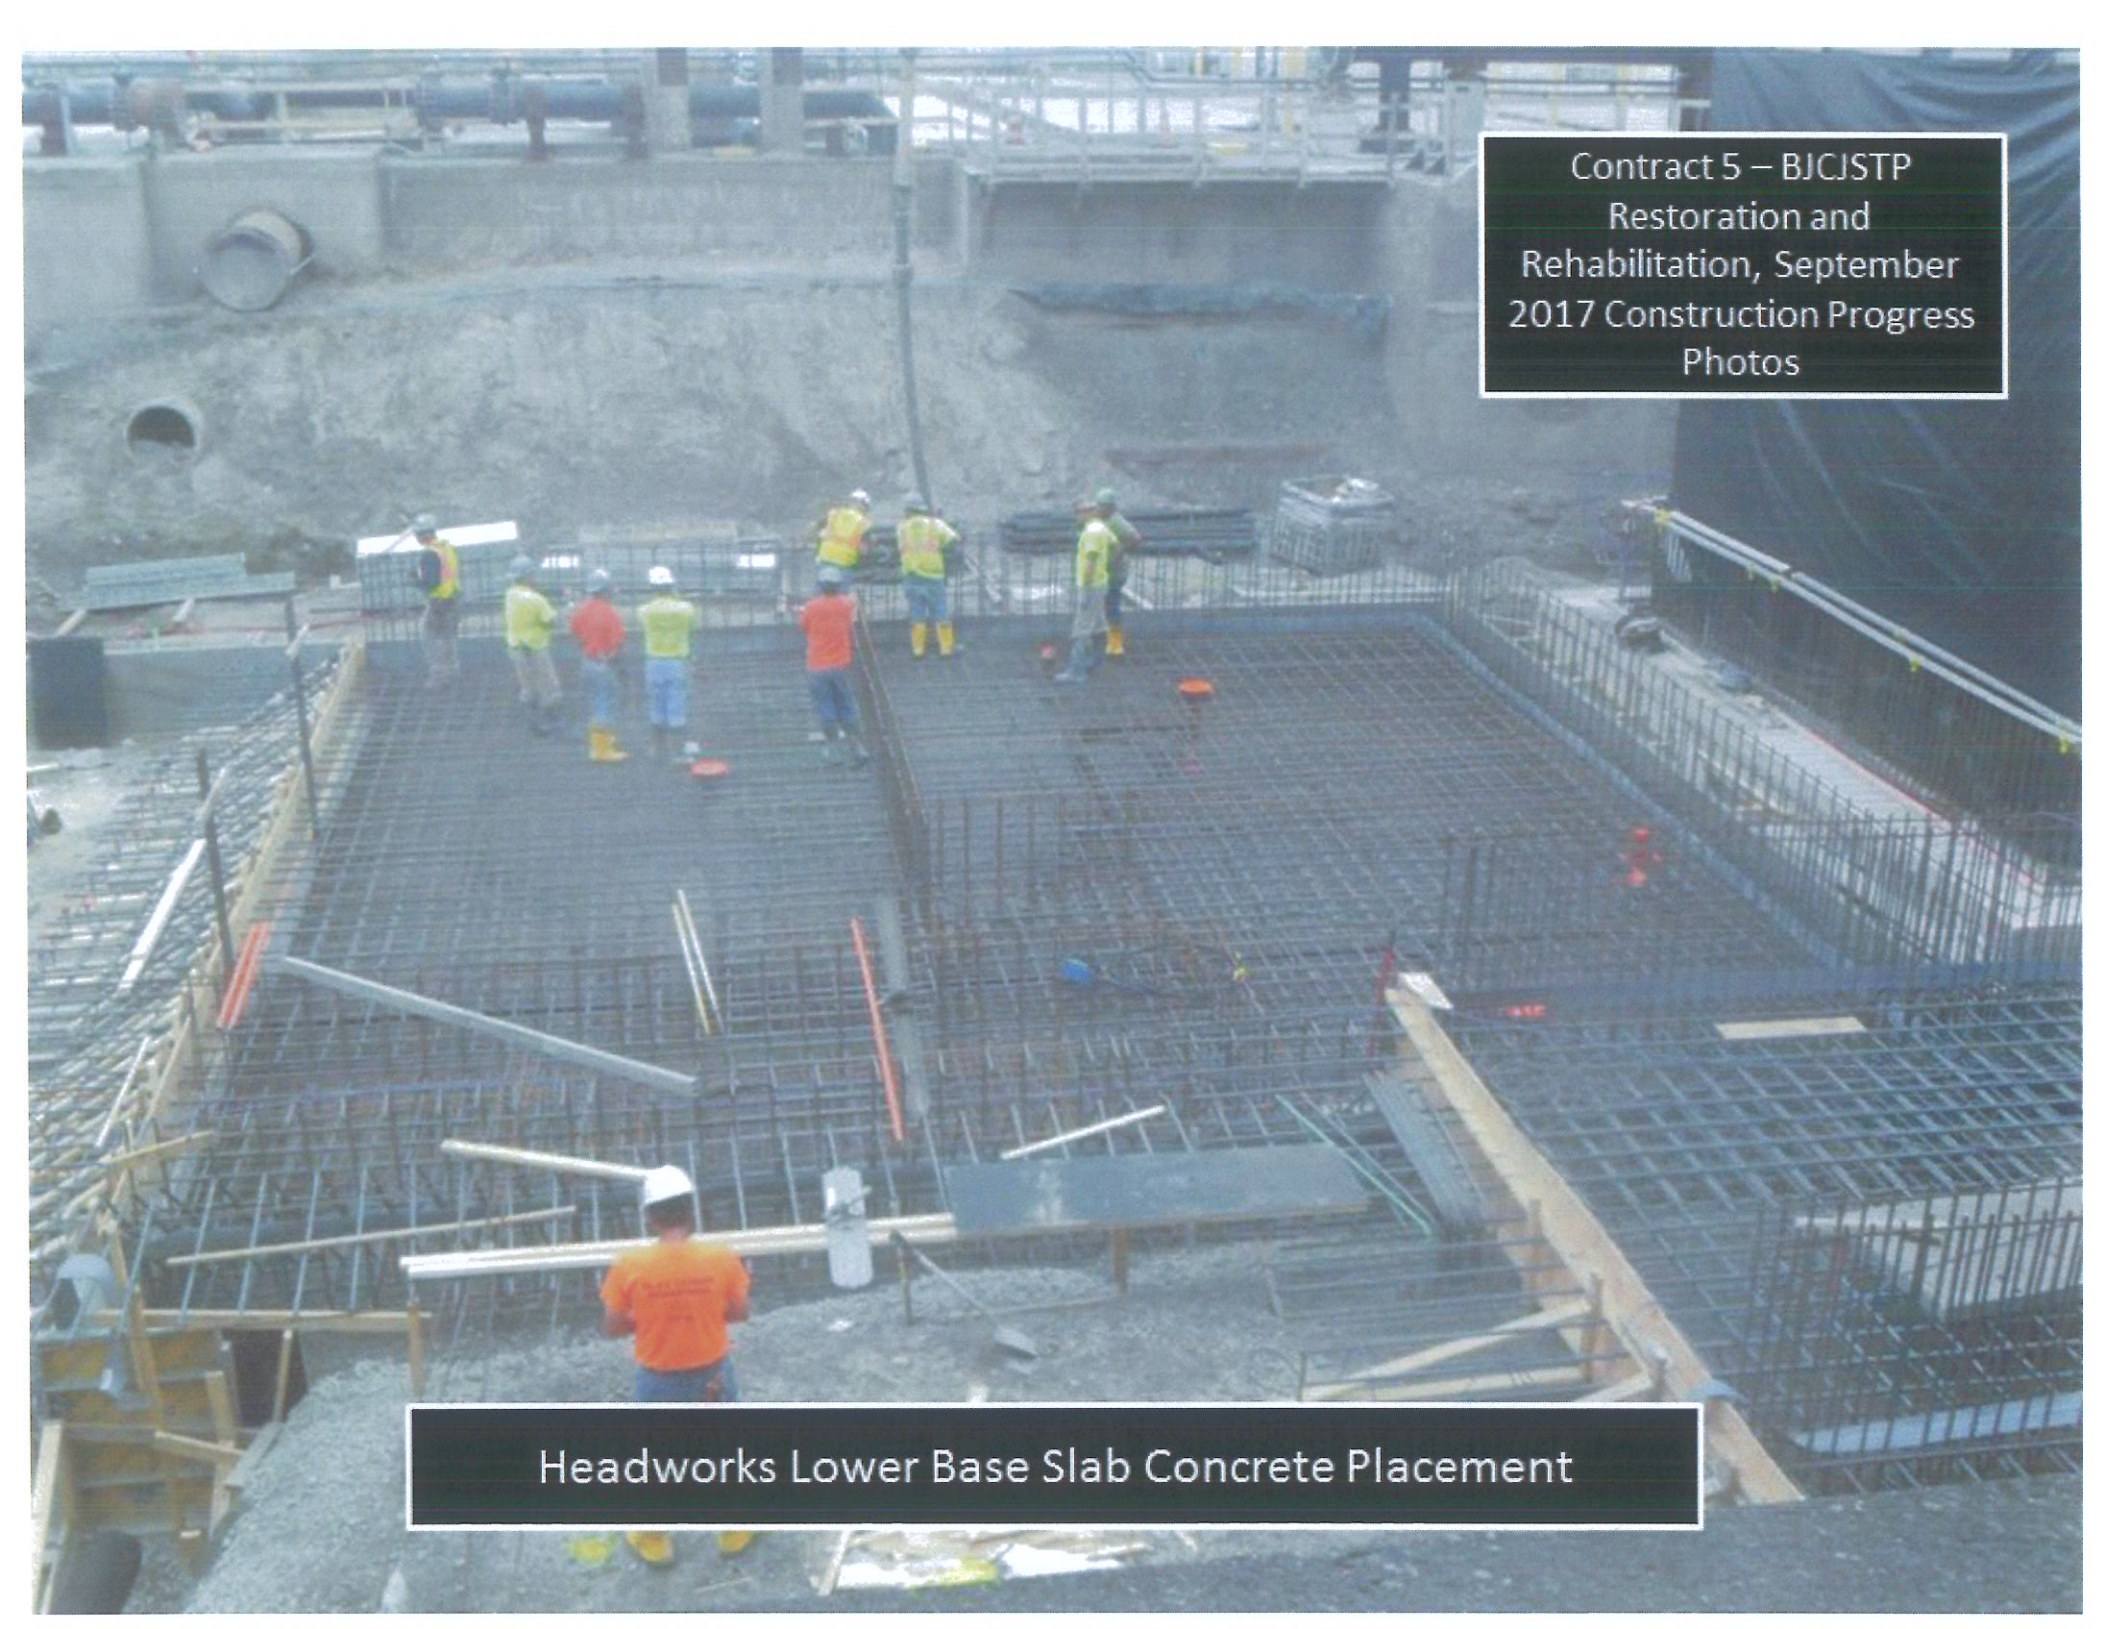
Contract 5 – BJCJSTP
Restoration and
Rehabilitation, September
2017 Construction Progress
Photos

Headworks Lower Base Slab Concrete Placement

Status: The NTP for Contract No. 5 was issued on May 27, 2016, which complied with milestone requirements in the revised Consent Order. During this quarter, the concrete work for the new Headworks and BAF Backwash Treatment Facility began. Concrete work for the walls for the BAF Backwash Treatment Facility began this quarter. The concrete work is nearing completion for the primary clarifiers 7-10. Demolition is nearing completion in the CN Cells 1-8 and UV Reactor. Concrete work and block work continued this quarter on the Administration Building and the Chemical Storage Building. The roof has been installed on the new Administration Building, and the roof should be installed on the new Chemical Building during the next quarter. Brick work for the new Administration Building is nearing completion, and should be completed next month. Work inside the Maintenance Building is progressing. The interior walls are nearing completion in the new Administration Building. The Contractor has a target date for obtaining the Certificate of Occupancy for the Administration Building before the end of the next quarter.

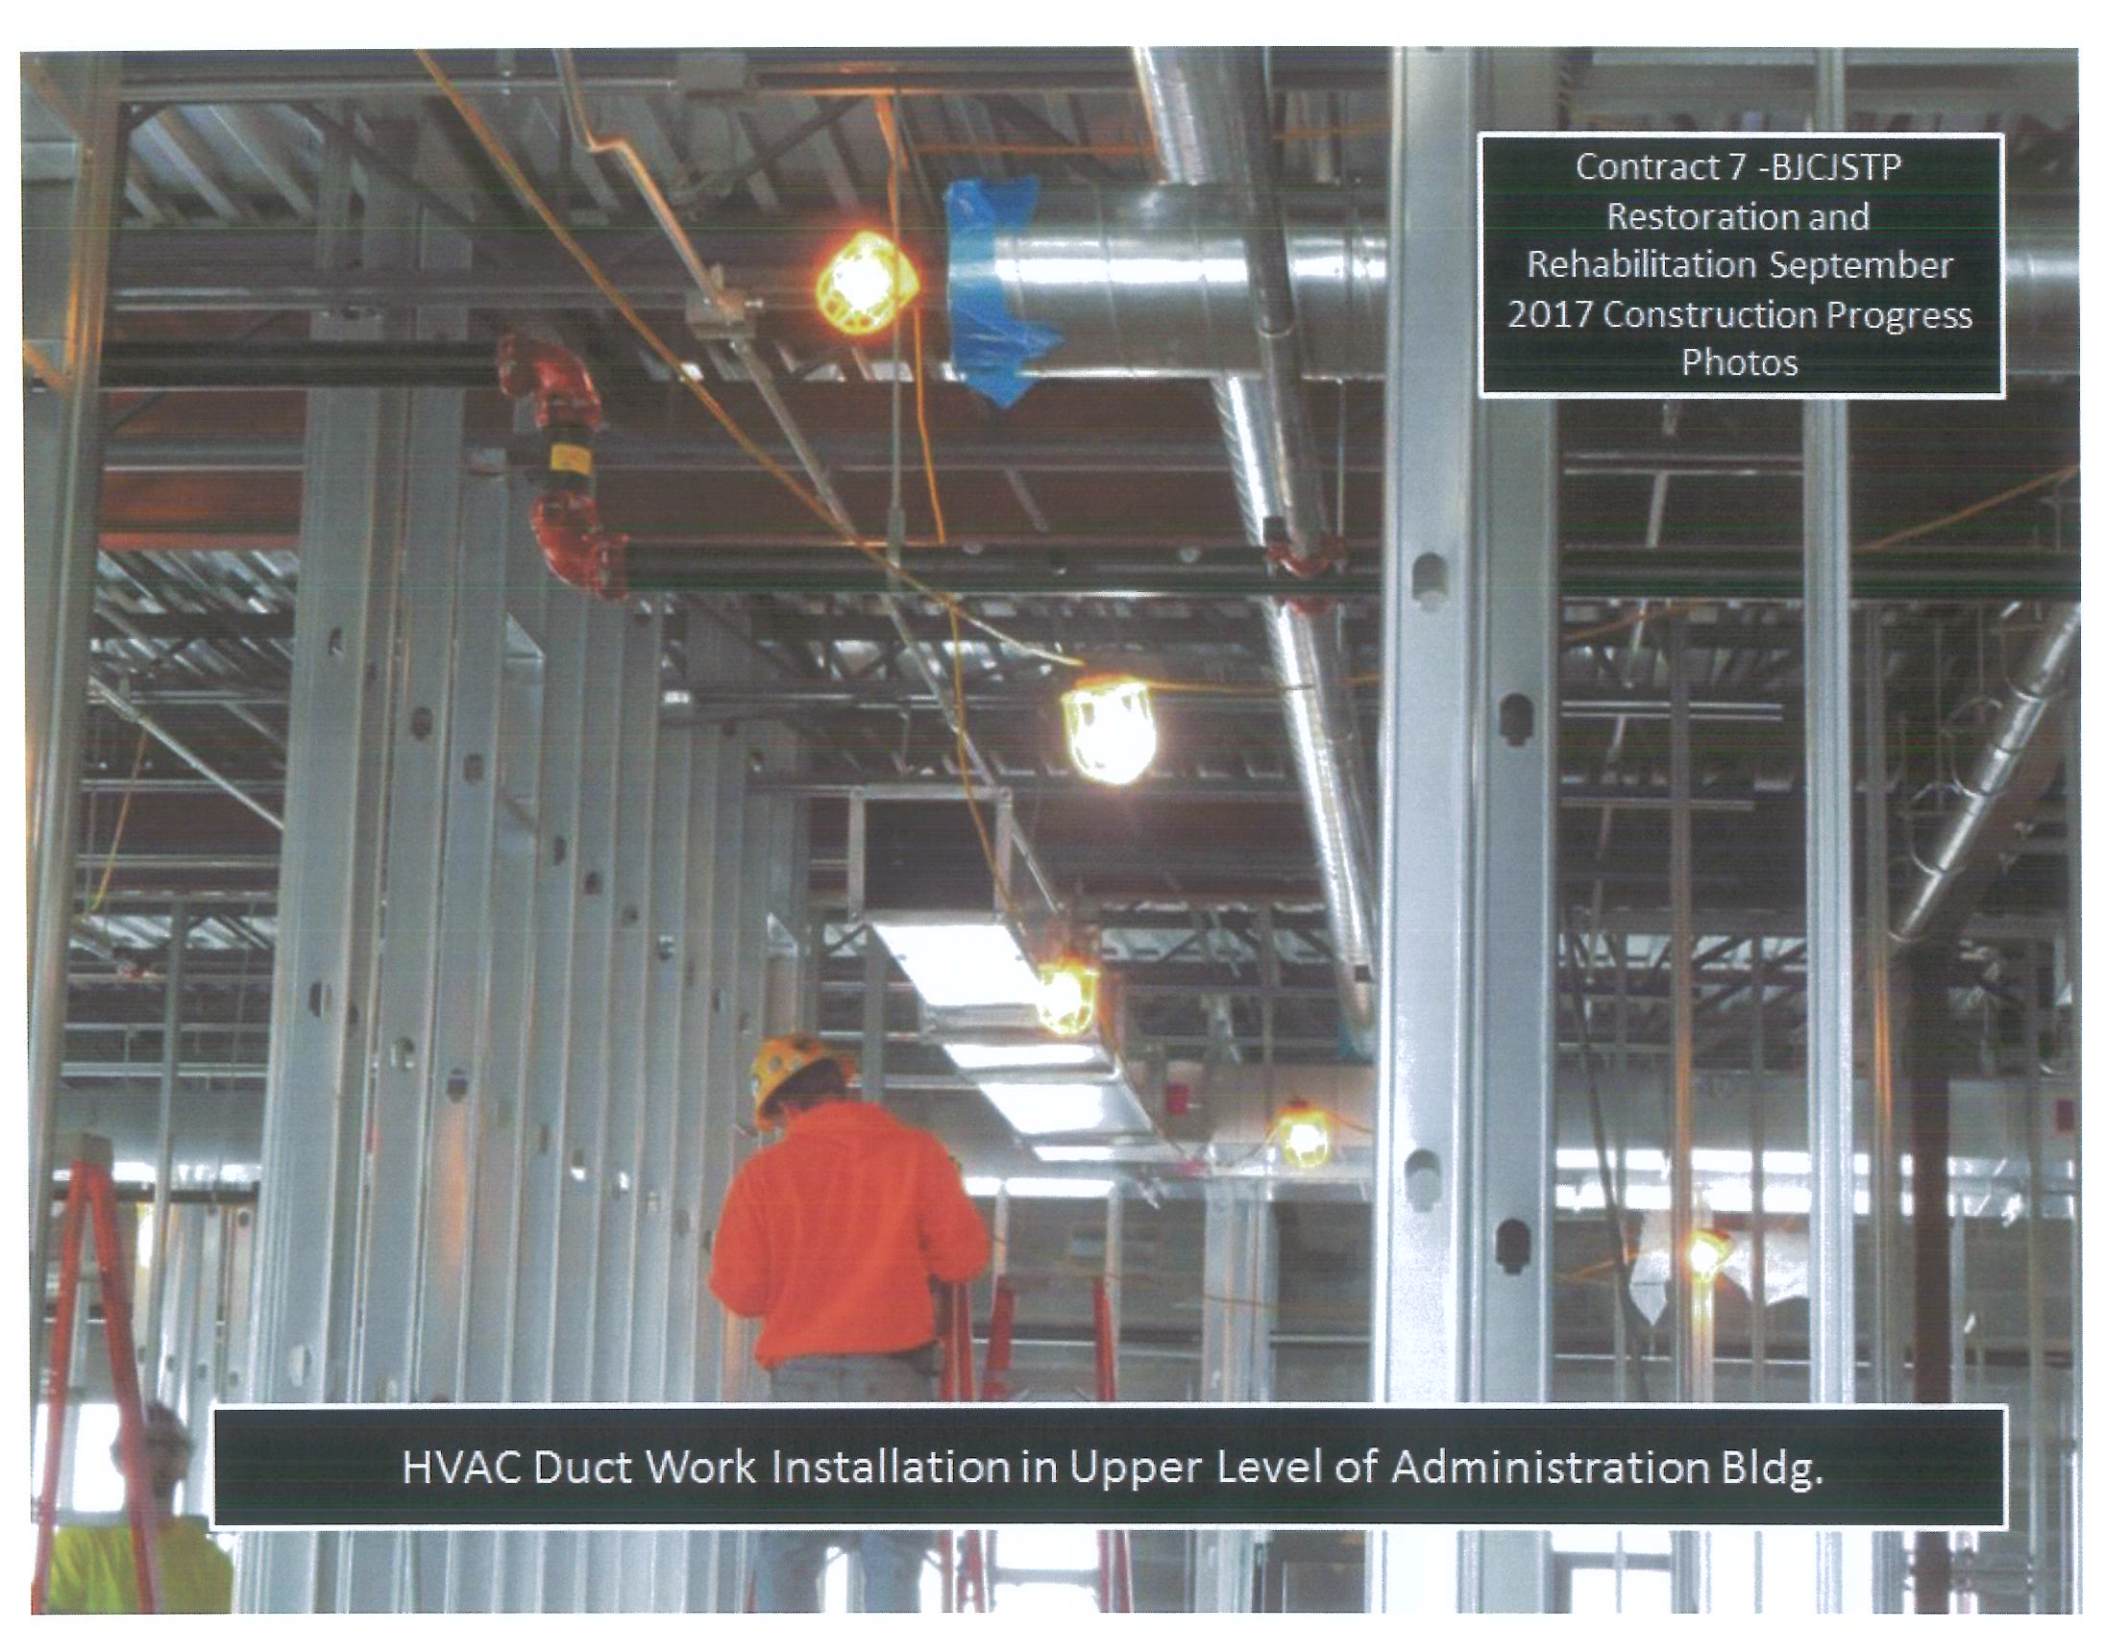
Contract 7 -BJCJSTP
Restoration and
Rehabilitation September
2017 Construction Progress
Photos

HVAC Duct Work Installation in Upper Level of Administration Bldg.

Status: Contract No. 7 was awarded on May 27, 2016 in compliance with the DEC milestones in the Consent Order. The contractor continued submitting material submittals for the HVAC Equipment for the project this quarter. They continue to provide supporting information for the development of the CPM schedule, and have acknowledged they can meet the required milestones of the Consent Order. They continued installing the HVAC equipment in the Maintenance and Administration Building.

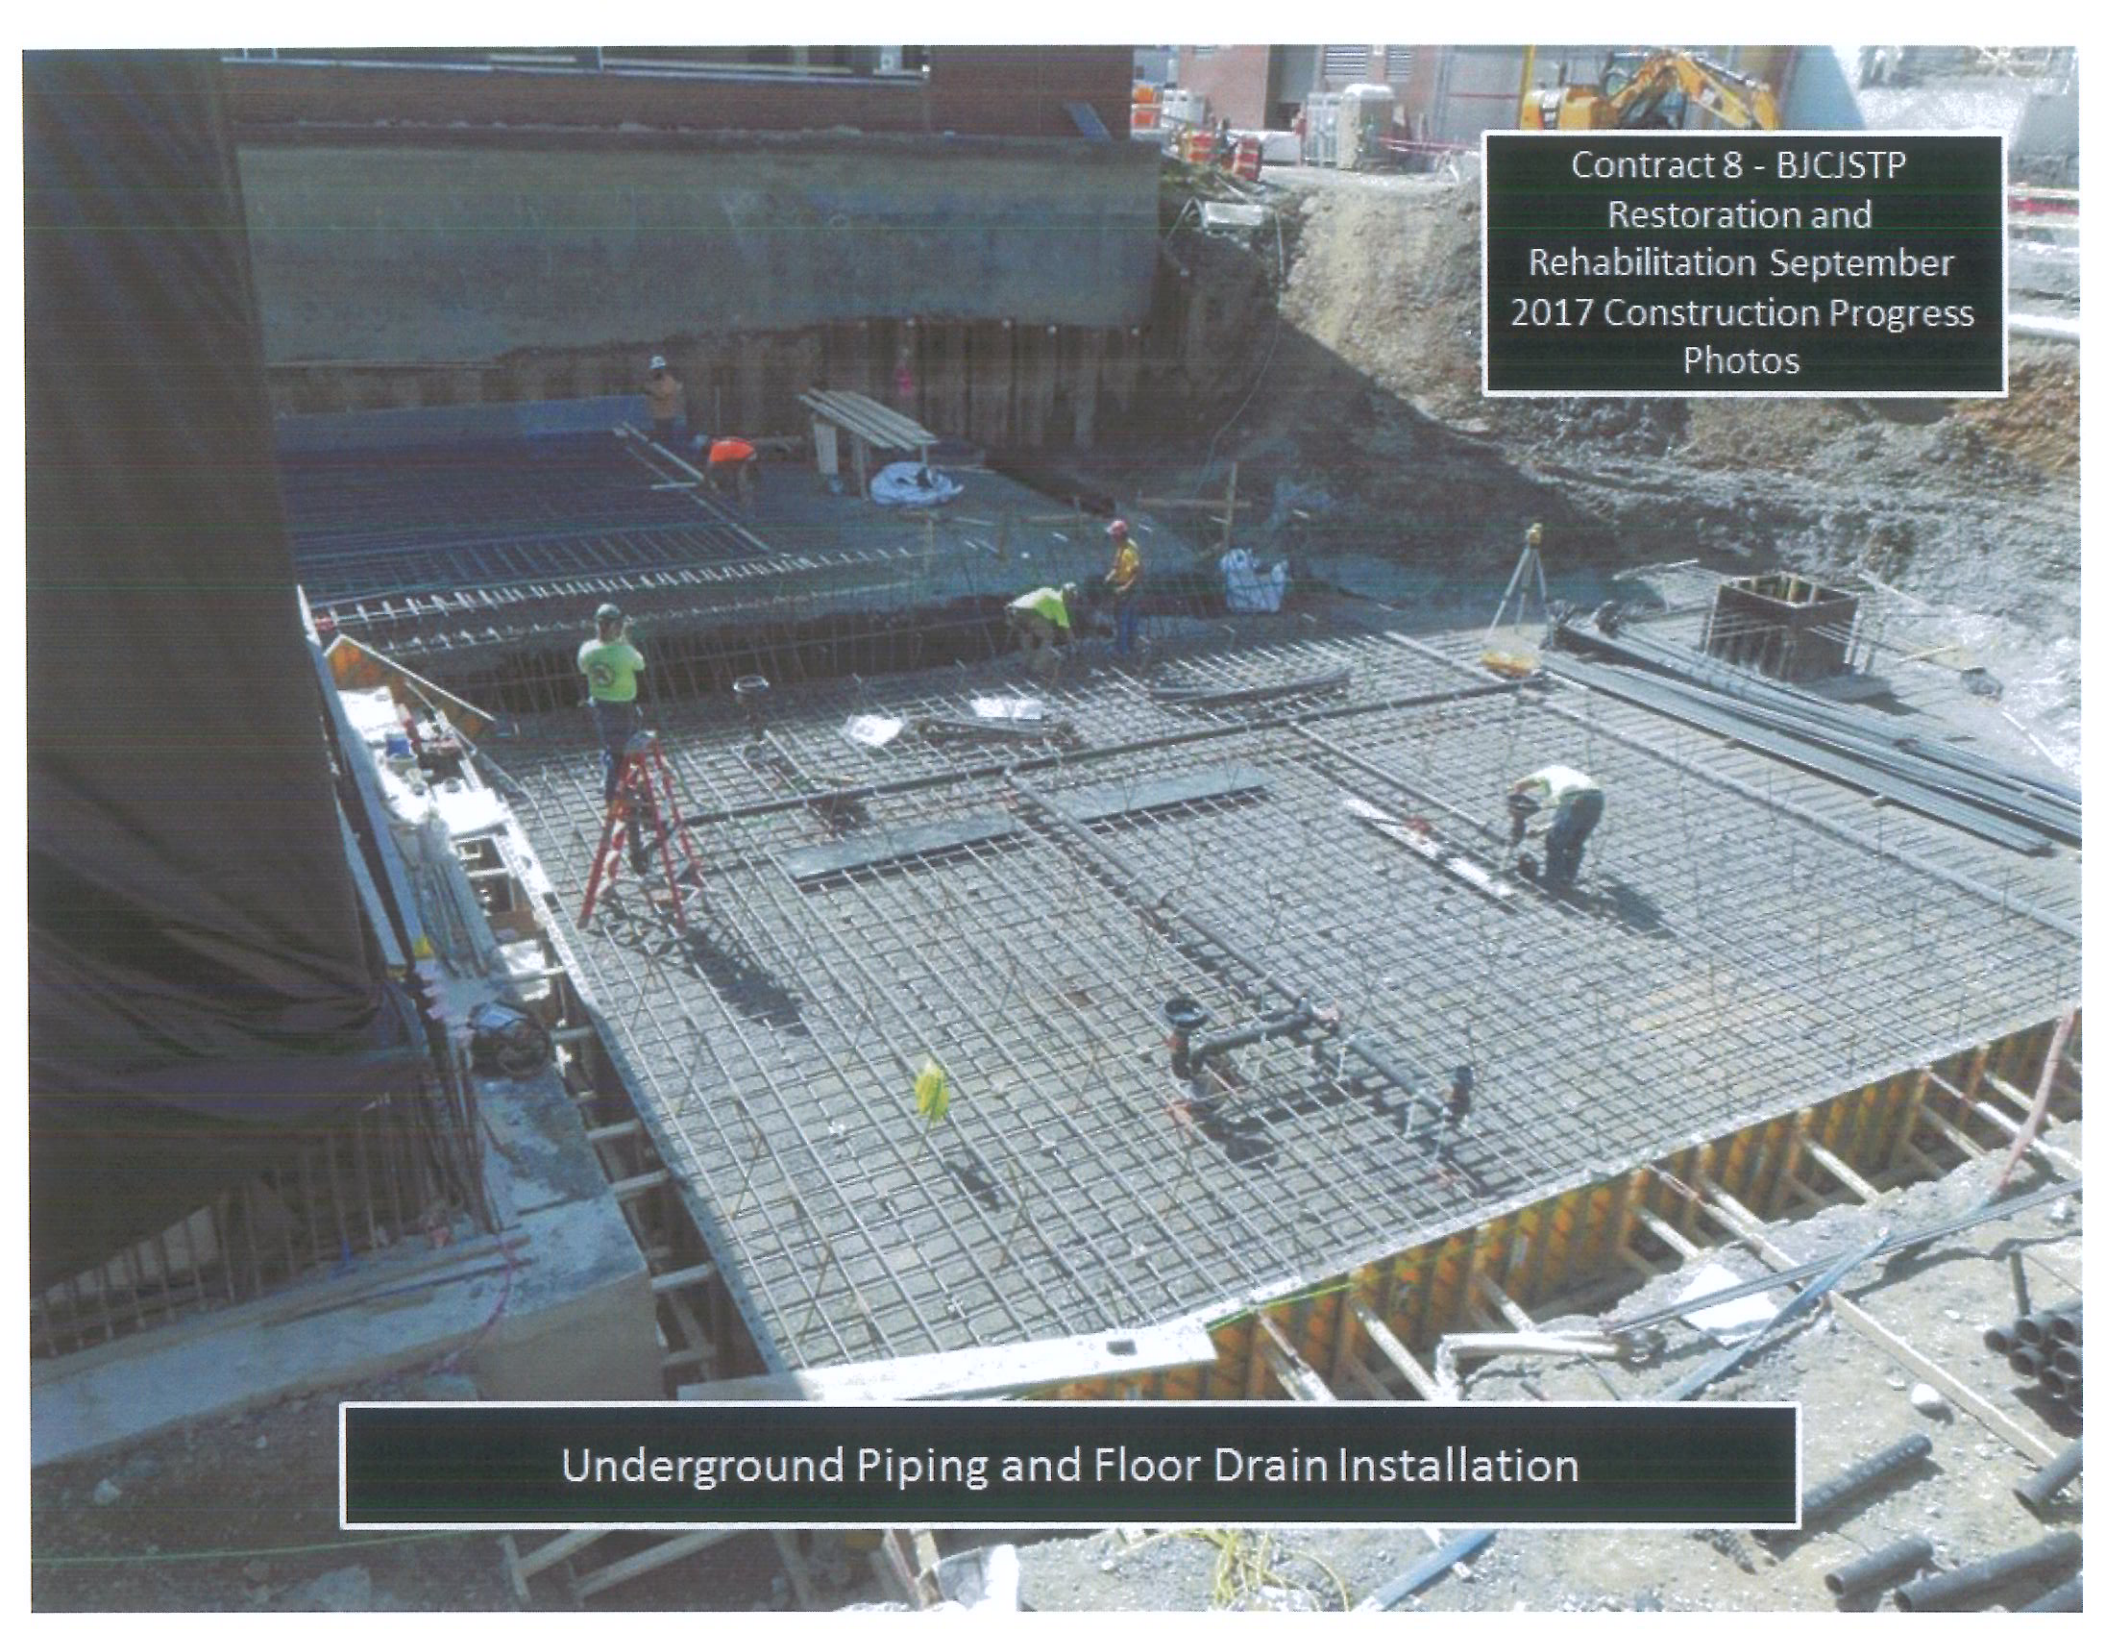
Contract 8 - BICJSTP
Restoration and
Rehabilitation September
2017 Construction Progress
Photos

Underground Piping and Floor Drain Installation

This quarter, they continued installing the plumbing in the new Maintenance, Administration, and the East Scrubber Building. They continued installing the plumbing in the new Headworks and BAF Backwash Treatment Facility. They continued installing the new potable water backflow preventer that will allow the potable water to be used as a back-up of the existing non-potable plant water system.

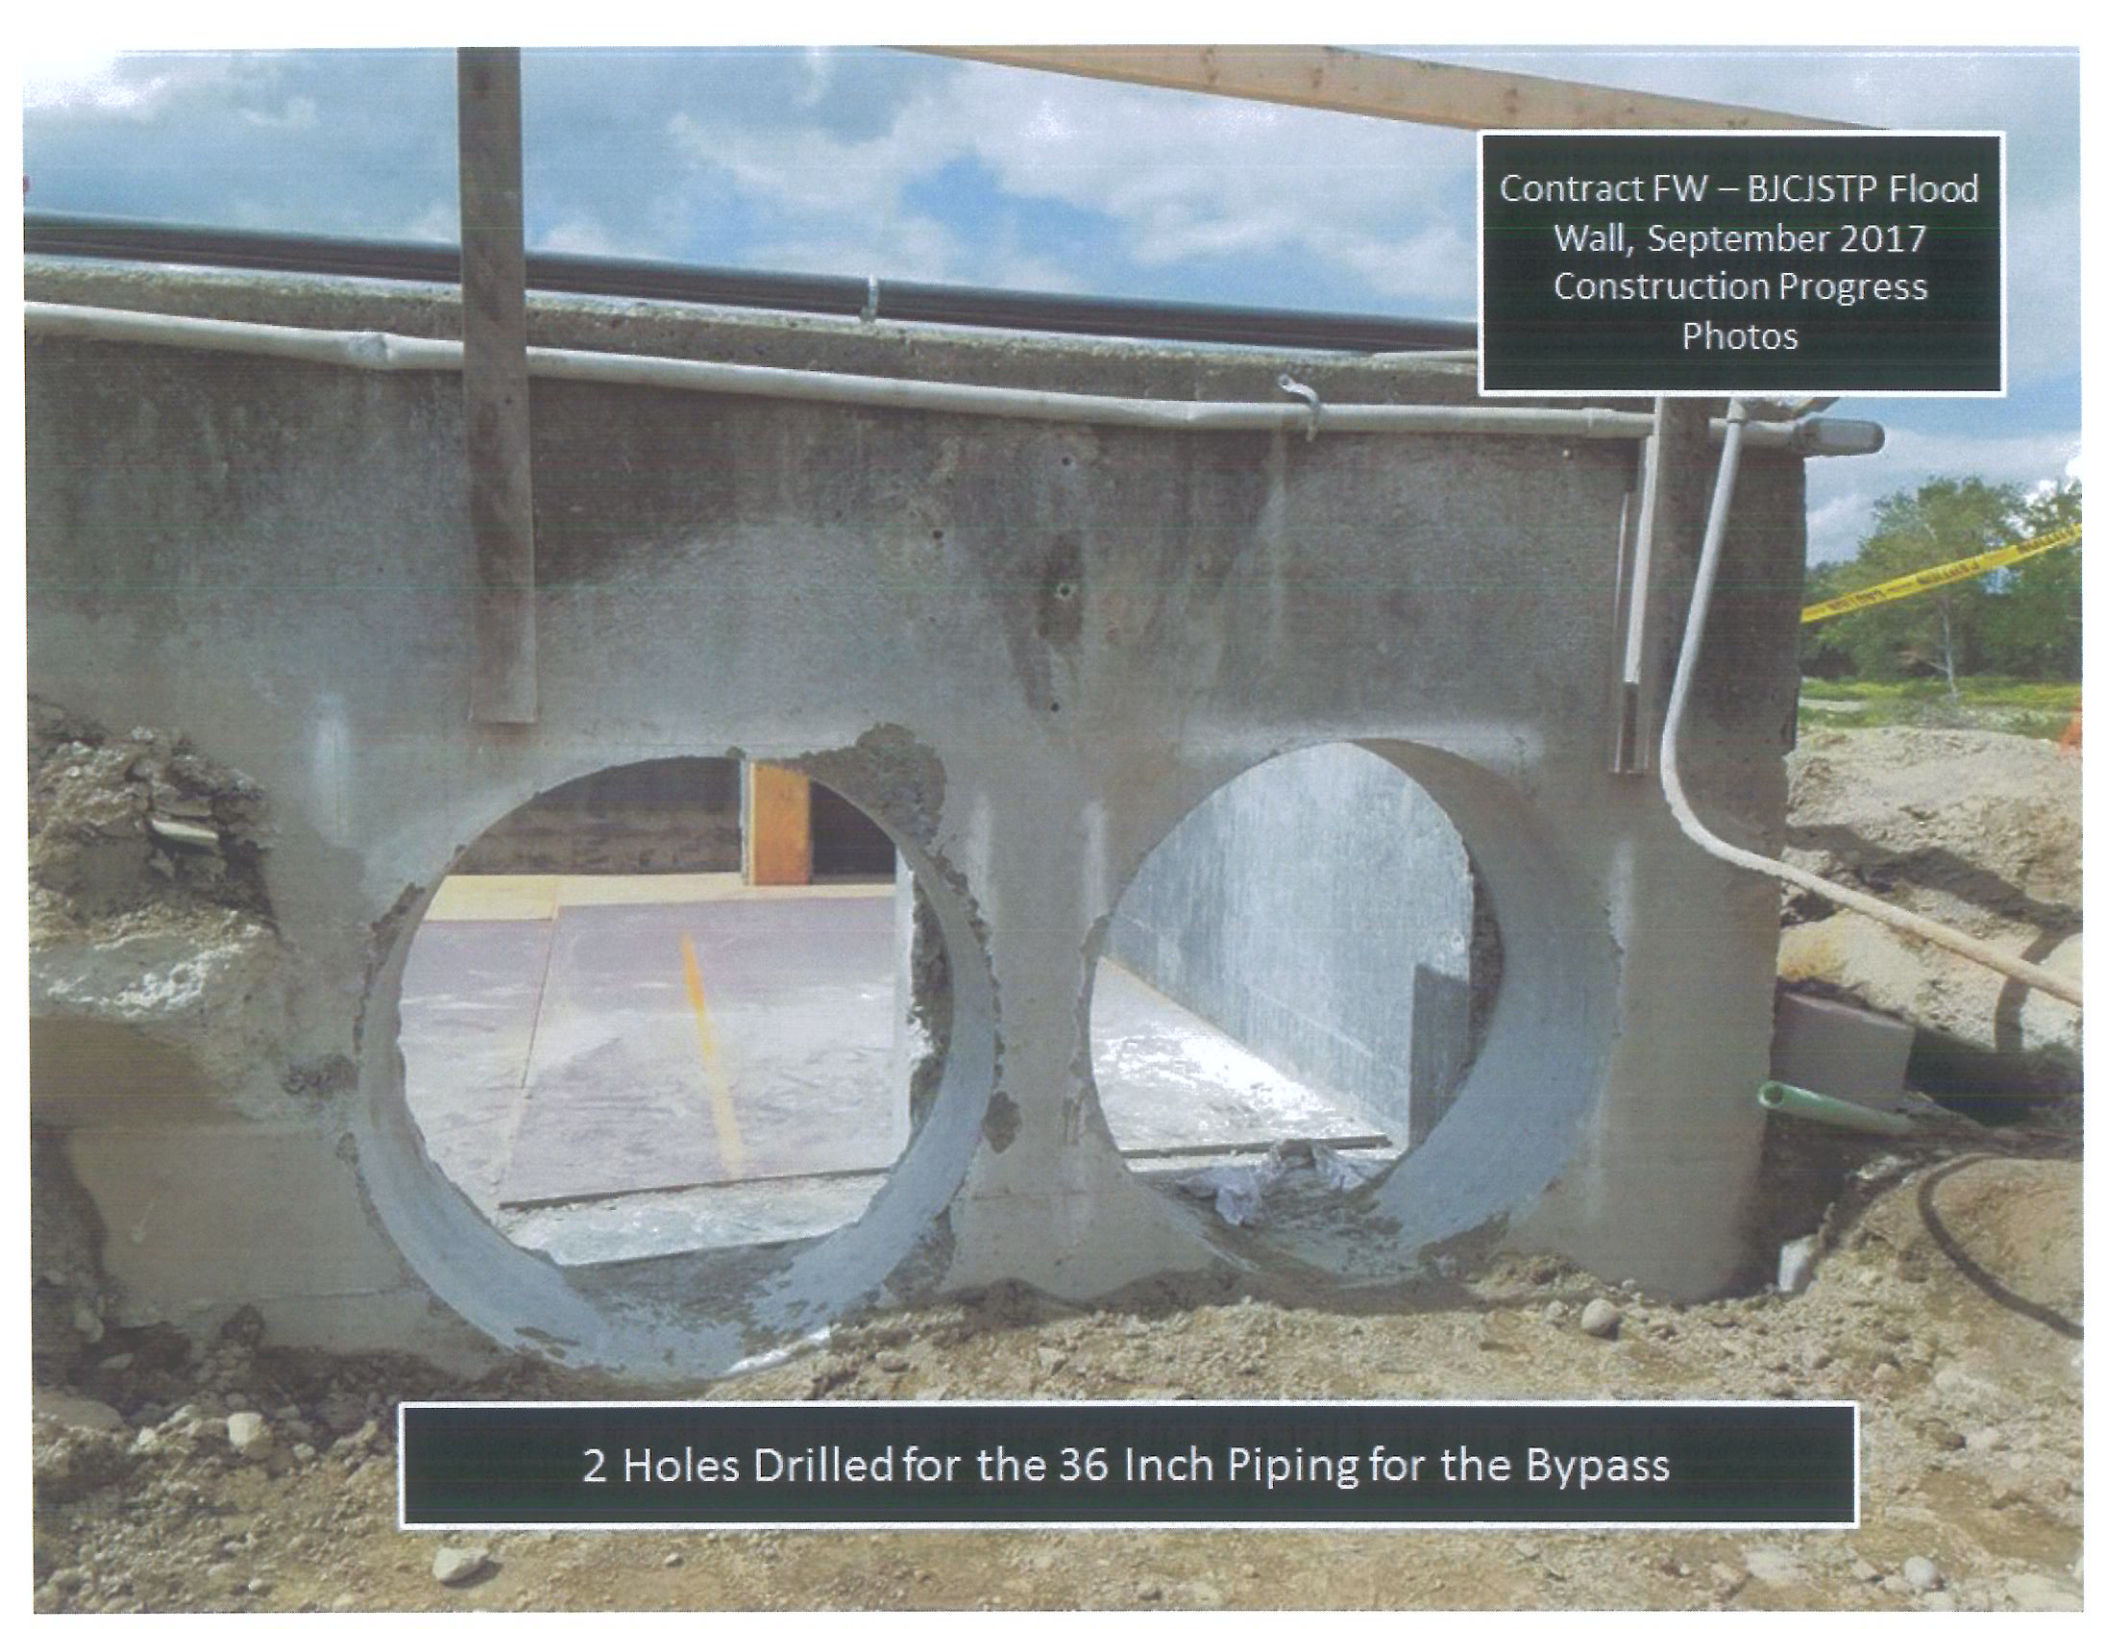
Contract FW – BJCJSTP Flood
Wall, September 2017
Construction Progress
Photos

2 Holes Drilled for the 36 Inch Piping for the Bypass

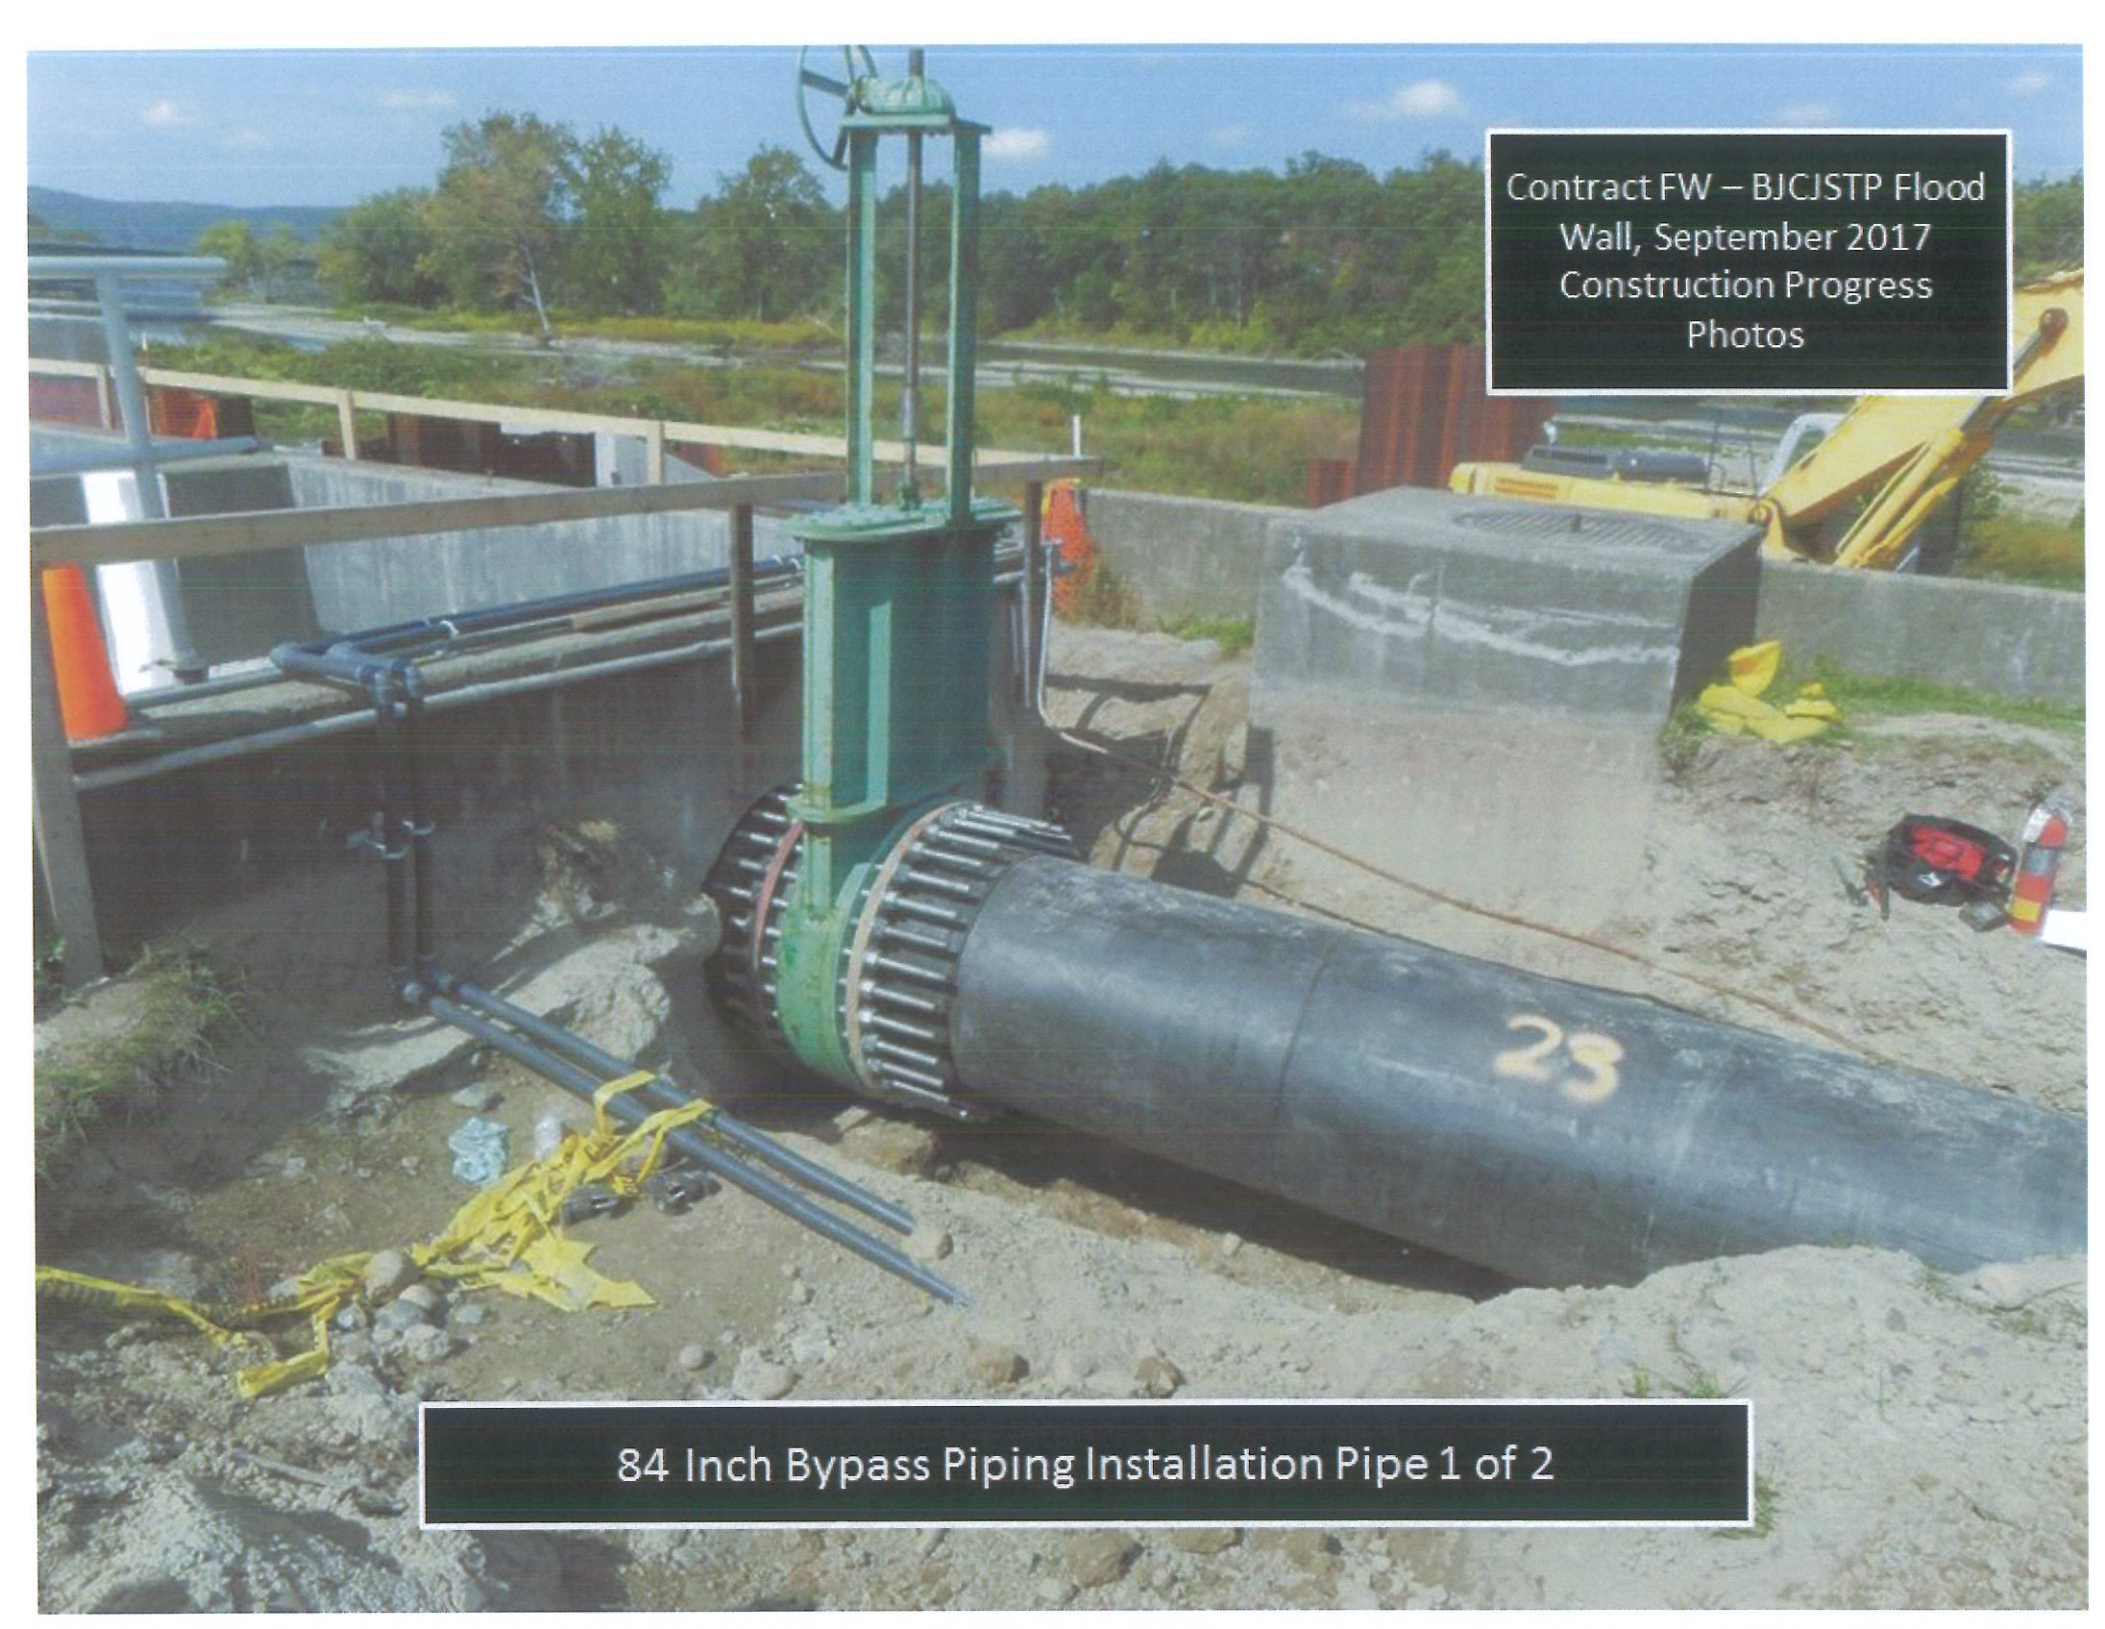
Contract FW – BJCJSTP Flood
Wall, September 2017
Construction Progress
Photos

84 Inch Bypass Piping Installation Pipe 1 of 2

3 Month Look Ahead: Streeter will continue construction of the floodwall after the existing 84" outfall is removed. This requires the diversion of the effluent out of the plant to the new 72" outfall that is being installed. The storm pump stations should be nearing completion. Relocation of the 10" sanitary sewer line from Vestal should be complete. Construction will begin on the diversion manhole for the 54" plant bypass as well as the 54" bypass line to the river. Work on the rehabilitation of digesters 1, 2, and 3 in advance of the Solids Handling Project is ongoing. This work is scheduled to be completed in December 2017.
