**Binghamton-Johnson City Joint Sewage
Treatment Plant Restoration and
Rehabilitation Project**

2017 Quarter 3 Report

*City of Binghamton
Village of Johnson City
Joint Sewage Board*

September 2017

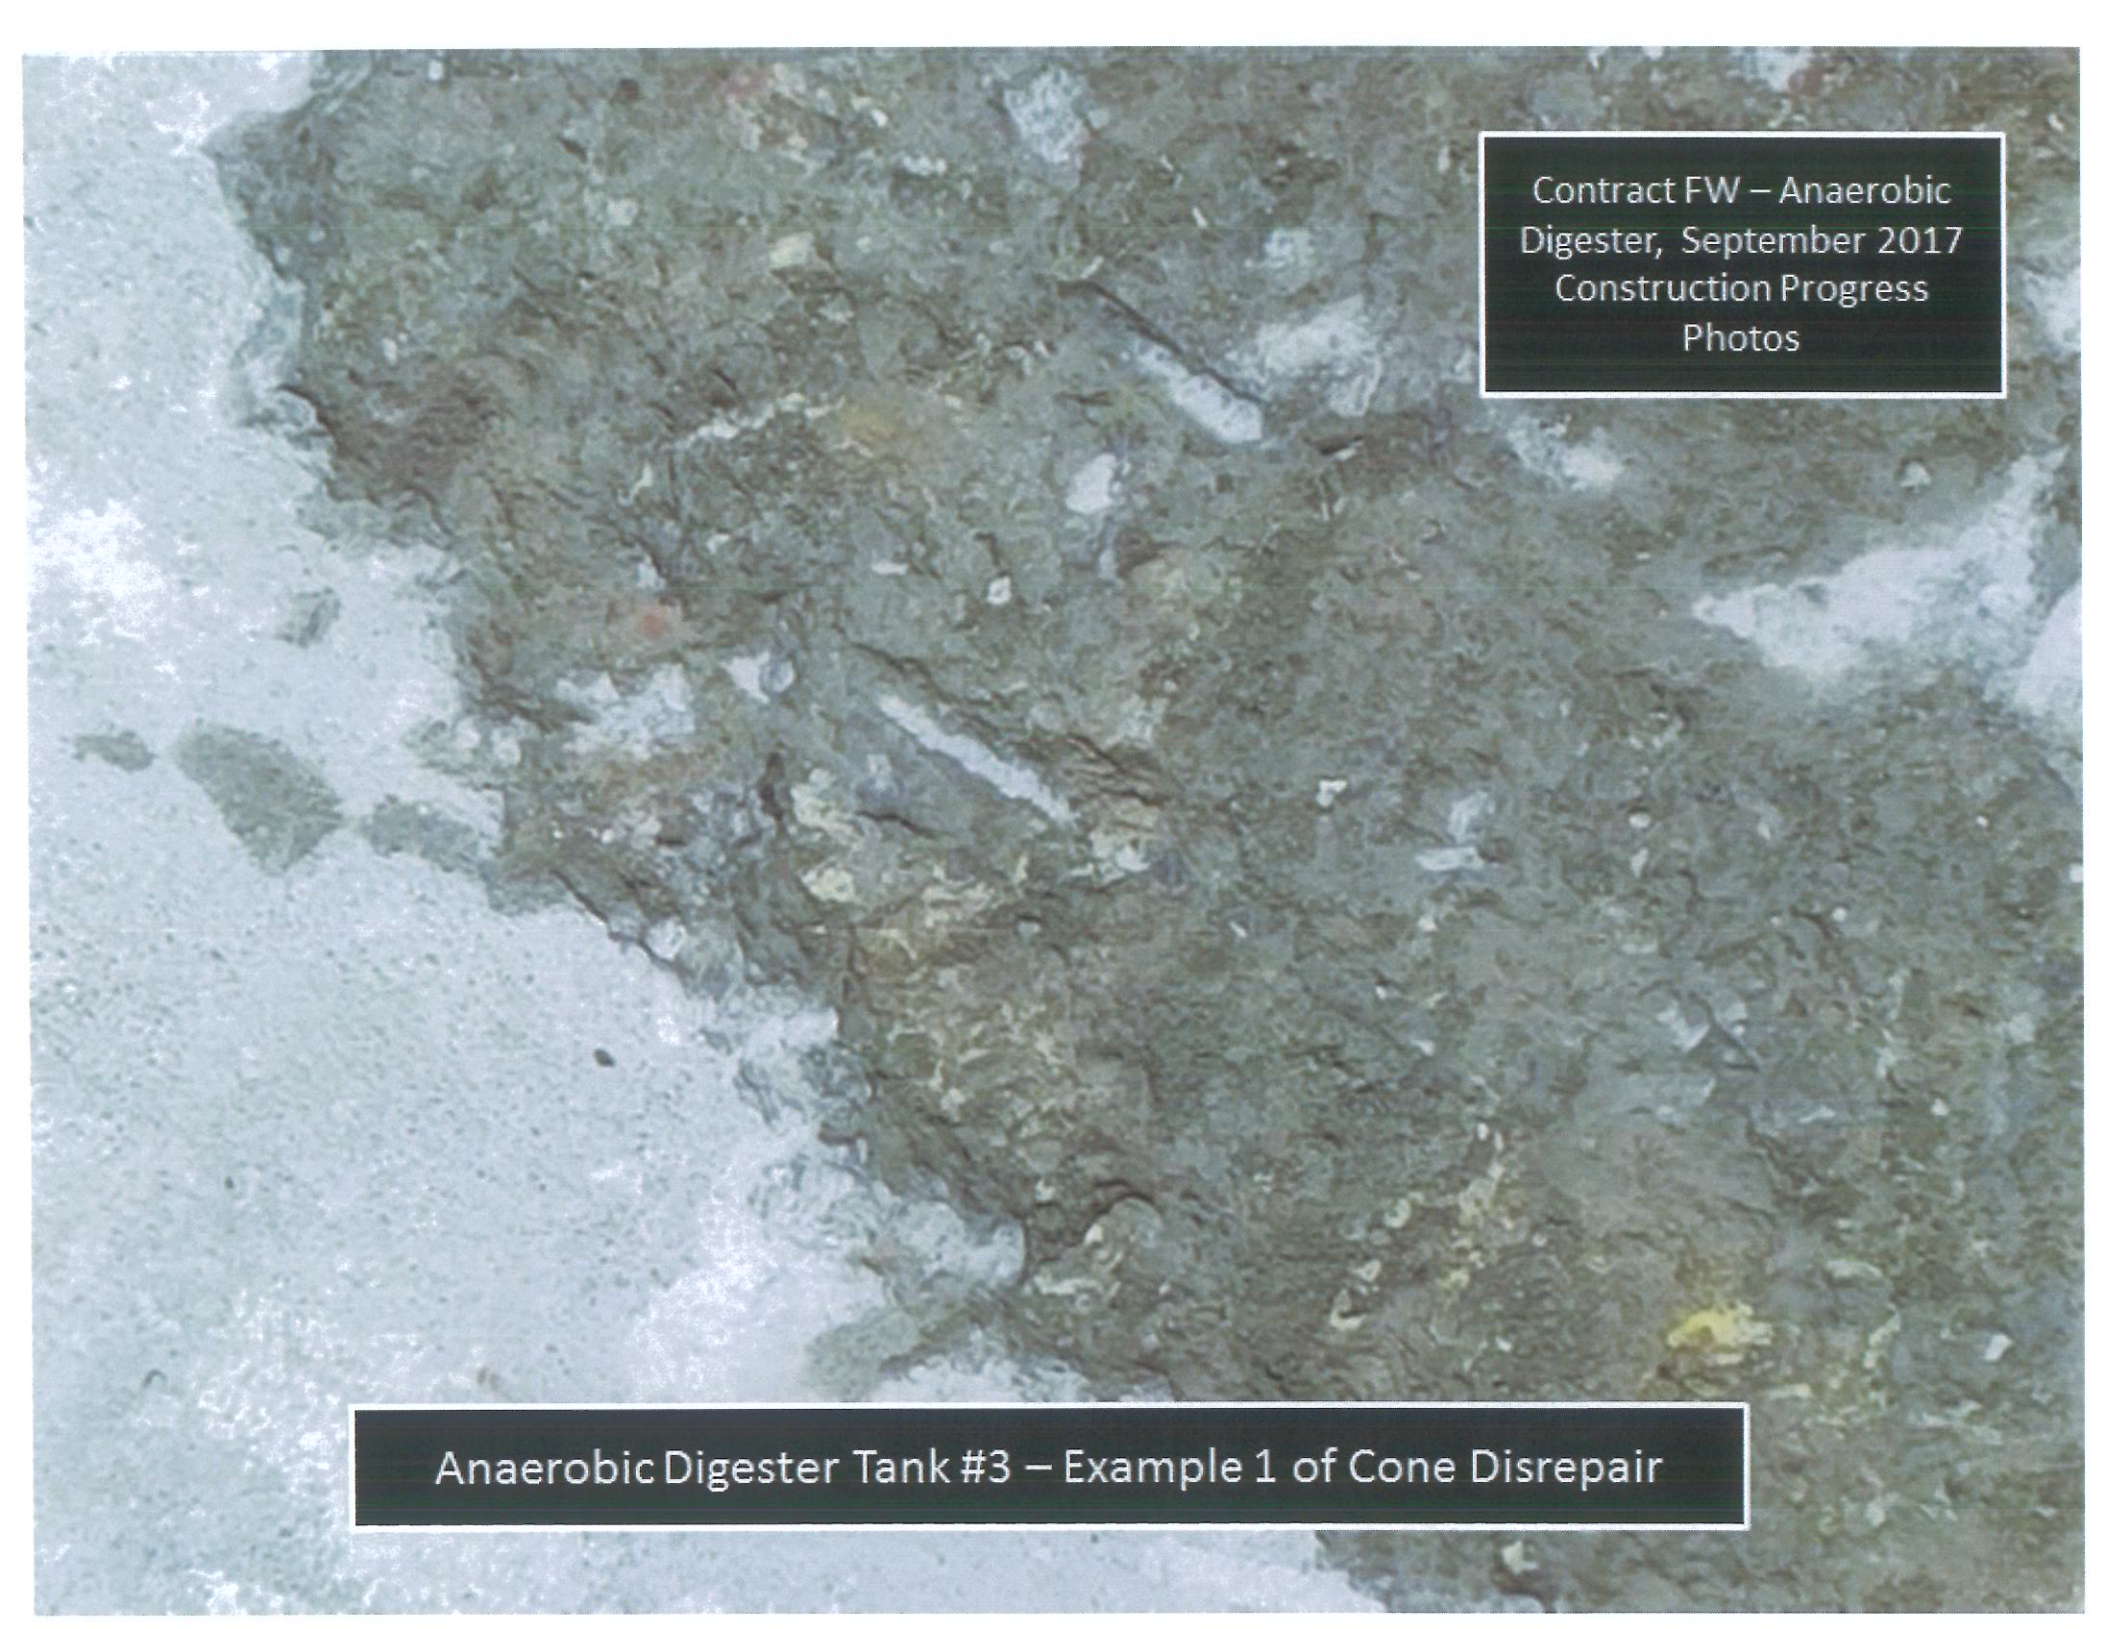
Contract FW – Anaerobic
Digester, September 2017
Construction Progress
Photos

Anaerobic Digester Tank #3 – Example 1 of Cone Disrepair
